ABANDONED MINE LAND RESTORATION IN A NORTH IDAHO STREAM: A GEOMORPHOLOGICAL PERSPECTIVE

ABSTRACT

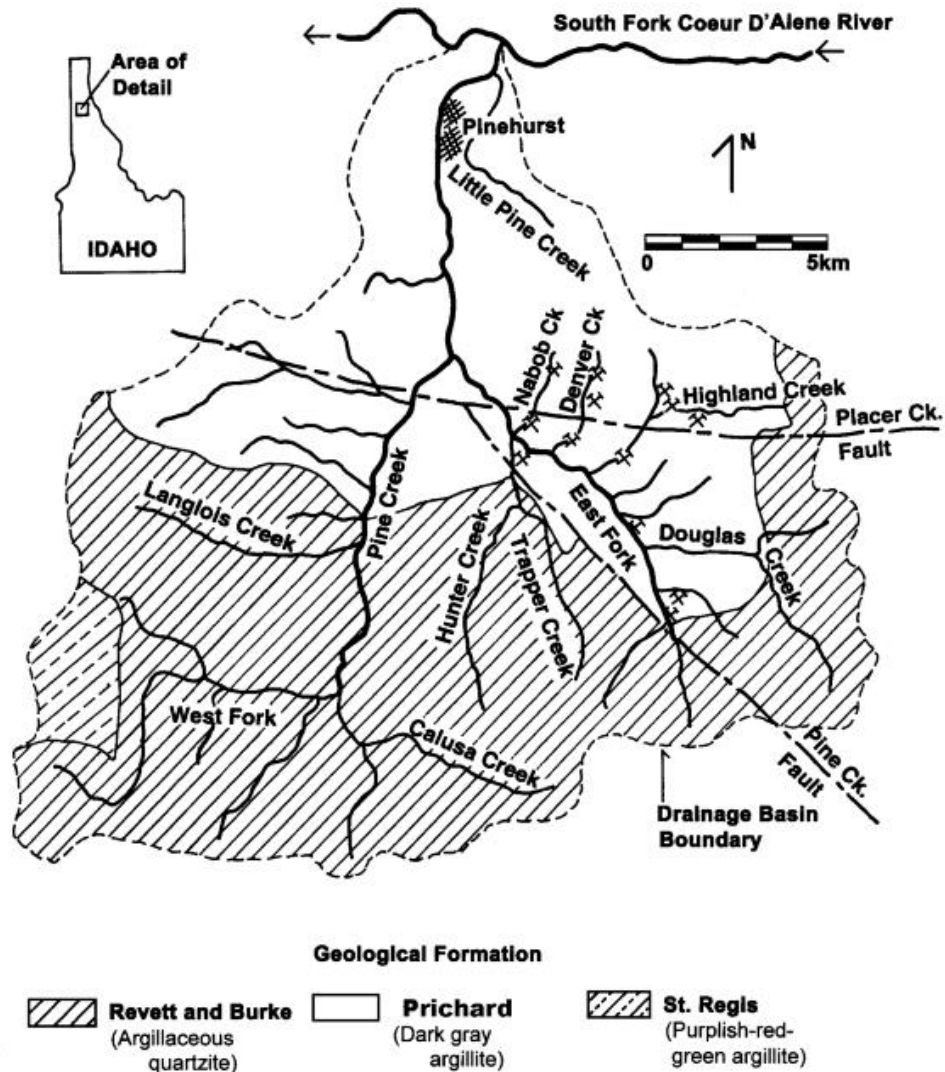
Figure 1. Generalized geologic map of the Pine Creek watershed (modified from Kondolf and others, 2002).

The geology of the Pine Creek watershed is dominated by metasedimentary rocks of the Precambrian Belt Supergroup. According to Lewis and others (2000), metasedimentary rocks exposed in the watershed are Middle Proterozoic, or approximately 1,600 to 900 million years old. Within the southern half of the Pine Creek watershed, headwater streams are underlain primarily by the Revett and Burke Formations (fig.1). A relatively small area of St. Regis Formation crops out in the upper reaches of the West Fork of Pine Creek. The lower, northern end of the watershed is underlain by the Prichard Formation. The relative stratigraphic positions and dominant lithologies are shown in Table 1. Structural controls include east-west- and northwest-trending faults. Mineralization in the Pine Creek area consists of lead-zinc-silver vein deposits occurring within the Prichard Formation in the East Fork of Pine Creek.
