Subject: White Oak Mine Reclamation with Biosolids

White Oak Stabilization Project Completion Report

State Procurement Solicitation #AR-1135
October 14, 2011
Priscilla Burton, Project Manager
Division of Oil, Gas, Mining

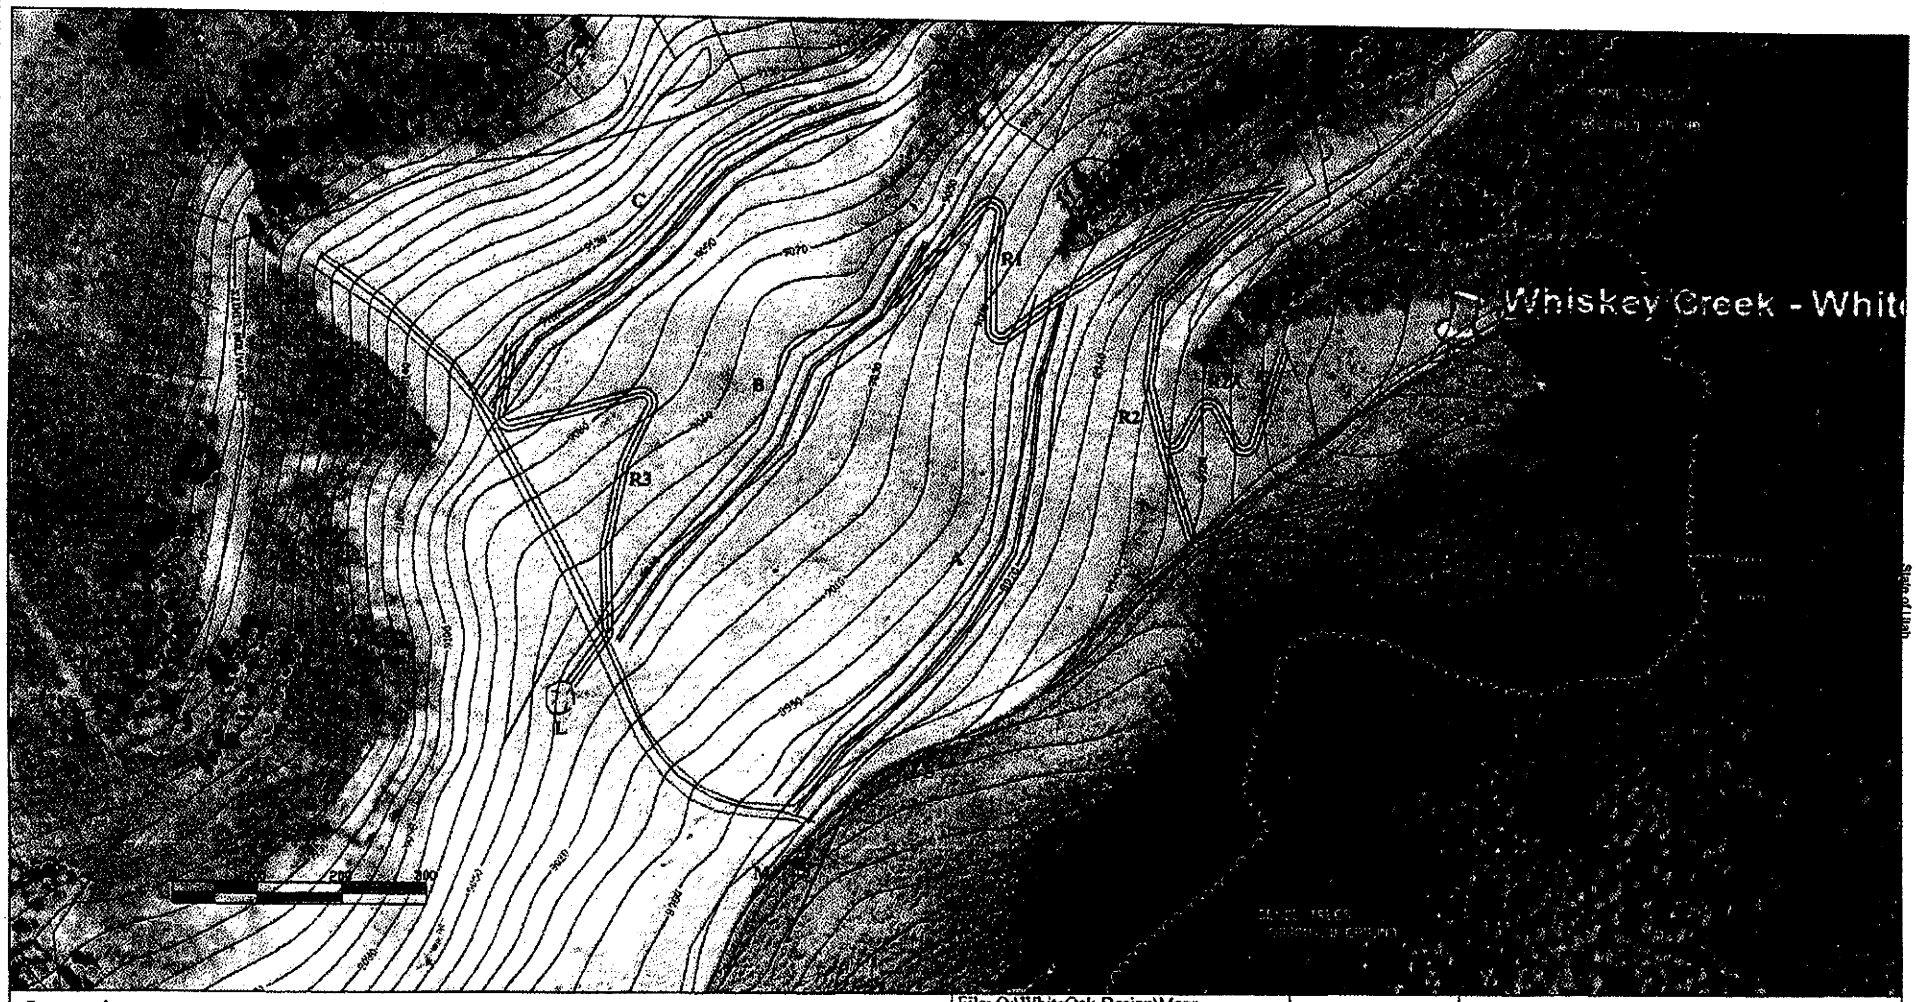
WO-8 | **Terraces & Access Roads**

The east facing slope was divided into three shorter slopes by the construction of terraces. Terraces allowed water to be held longer on the slope and also conveyed excess water to an existing, constructed side channel. Three access roads were temporarily constructed for equipment access. Map WO-8 in Attachment 1 shows the location of the terraces and access roads.
