IMPOUNDMENT INSPECTION AND CERTIFIED REPORT			
Permit Number	C/007/005	**Report Date**	February 6, 2017
Mine Name	Skyline Mine		
Company Name	Canyon Fuel Company		
Impoundment Identification	**Impoundment Name**	Mine Site Sediment Pond	
	Impoundment Number	001	
	UPDES Permit Number	UT0023540	
	MSHA ID Number	NA

IMPOUNDMENT INSPECTION

Inspection Date	December 19, 2016
Inspected By	Gregg Galecki
Reason for Inspection (Annual, Quarterly or Other Periodic Inspection, Critical Installation, or Completion of Construction)	Quarterly

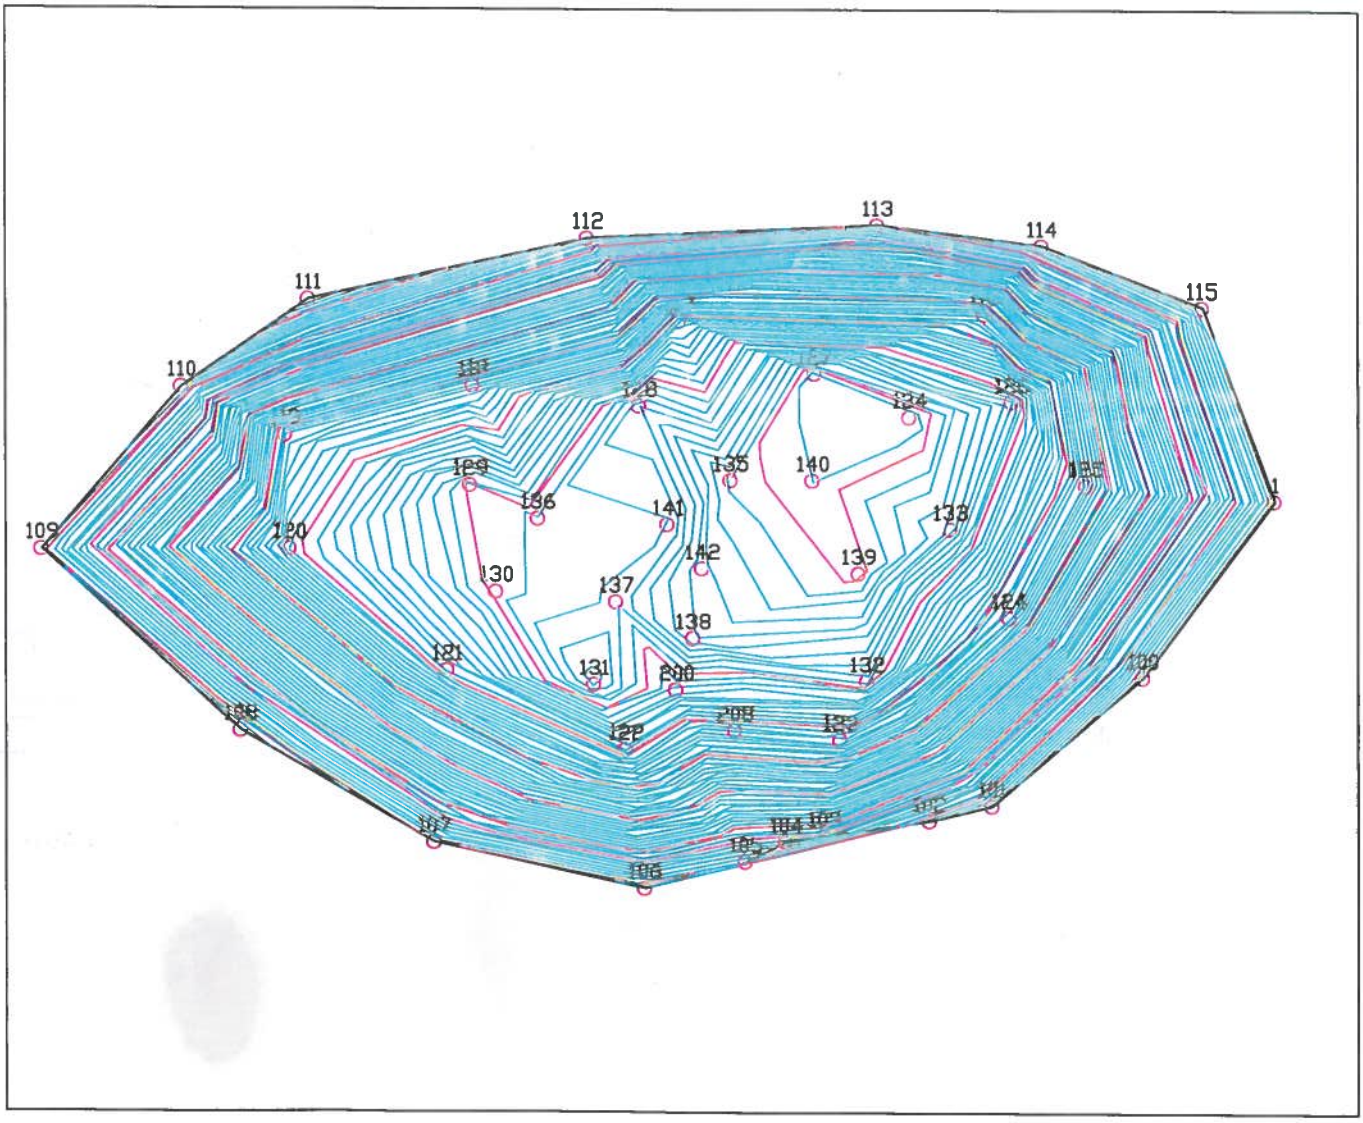
Maximum Spillway Containment Volume
11-11-16

Volume Report Wed Dec 07 15:03:32 2016
Comparing Grid: Y:\Survey\Sediment Ponds\004- WQ\WQ Pond 11-11-16\11-11-16 WQ Pond Base.grd
and Grid: Y:\Survey\Sediment Ponds\004- WQ\WQ Pond 11-11-16\11-11-16 WQ Pond Top.grd
Grid corner locations: 1602.95,962.75 to 1683.02,1027.94
Grid resolution X: 100, Y: 100 Grid cell size X: 0.80, Y: 0.65
Area in Cut : 338.2 S.F., 0.01 Acres
Area in Fill: 1,694.5 S.F., 0.04 Acres
Total inclusion area: 2,032.7 S.F., 0.05 Acres
Cut to Fill ratio: 0.04
Average Cut Depth: 0.62 Average Fill Depth: 2.96
Max Cut Depth: 2.11 Max Fill Depth: 5.49
Cut (C.Y.) / Area (acres): 166.89
Fill (C.Y.) / Area (acres): 3980.87
Cut volume: 210.3 C.F., 7.79 C.Y.
Fill volume: 5,015.7 C.F., 185.77 C.Y.
