IMPOUNDMENT INSPECTION AND CERTIFIED REPORT			
Permit Number	C/007/005	**Report Date**	February 20, 2020
Mine Name	Skyline Mine		
Company Name	Canyon Fuel Company		
Impoundment Identification	**Impoundment Name**	Mine Site Sediment Pond	
	Impoundment Number	001	
	UPDES Permit Number	UT0023540	
	MSHA ID Number	NA

IMPOUNDMENT INSPECTION

Inspection Date	December 17, 2019
Inspected By	Gregg Galecki
Reason for Inspection (Annual, Quarterly or Other Periodic Inspection, Critical Installation, or Completion of Construction)	Quarterly

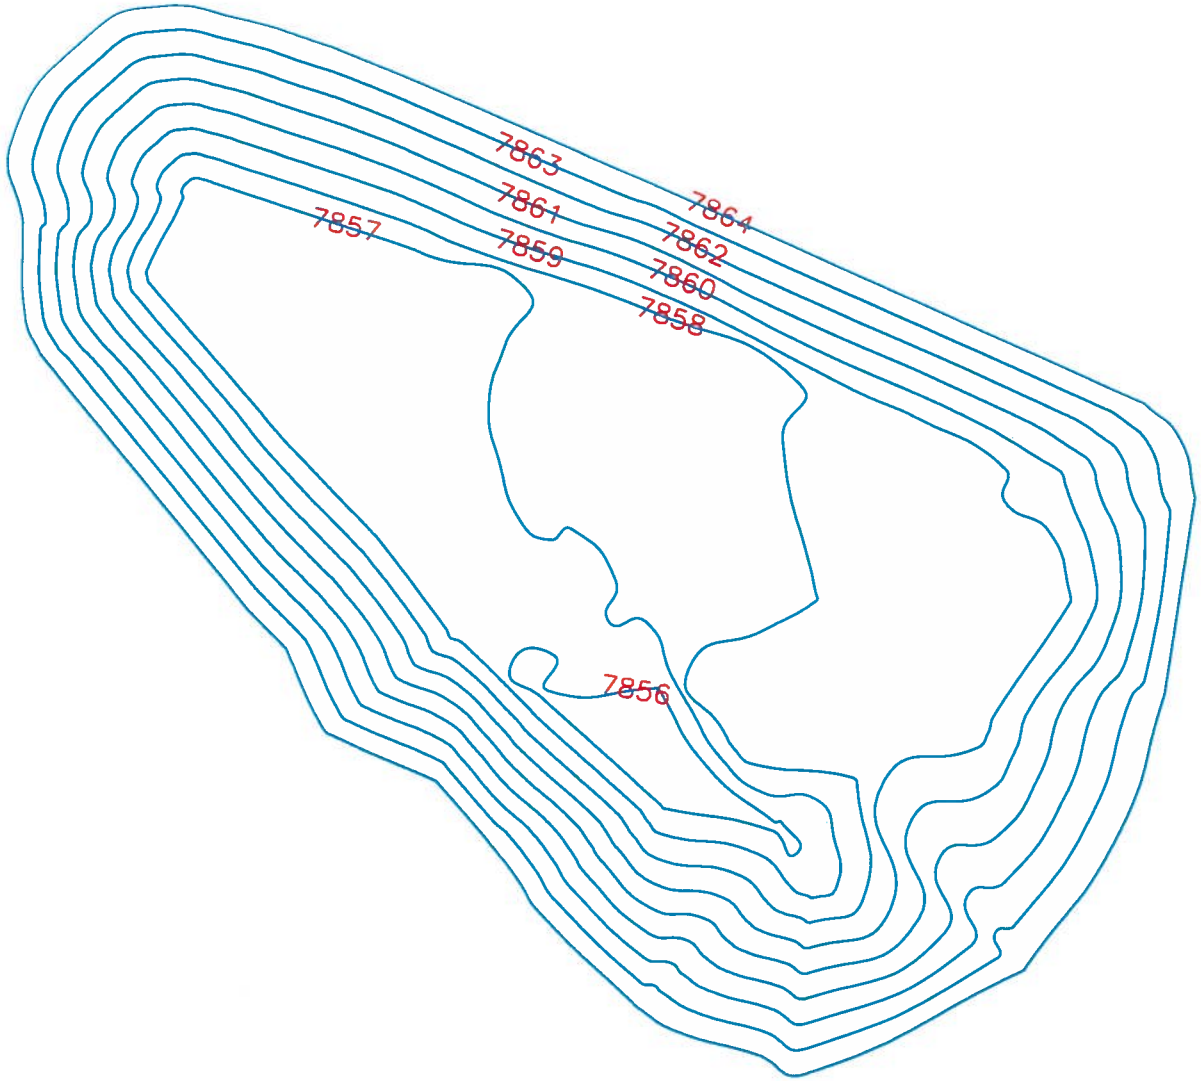
Waste Rock Sediment Pond

The current sediment storage capacity is based on a survey conducted during the 2019 survey and visual inspections. A close re-evaluation of the 2018 survey identified some errors in the survey. The current available volume as stated in the 2019 survey is correct. The perimeter footprint of the pond did not change during the cleaning project, only the depth of the pond was modified.

Water Elevation		Storage CF
7864.0	----	60008.9

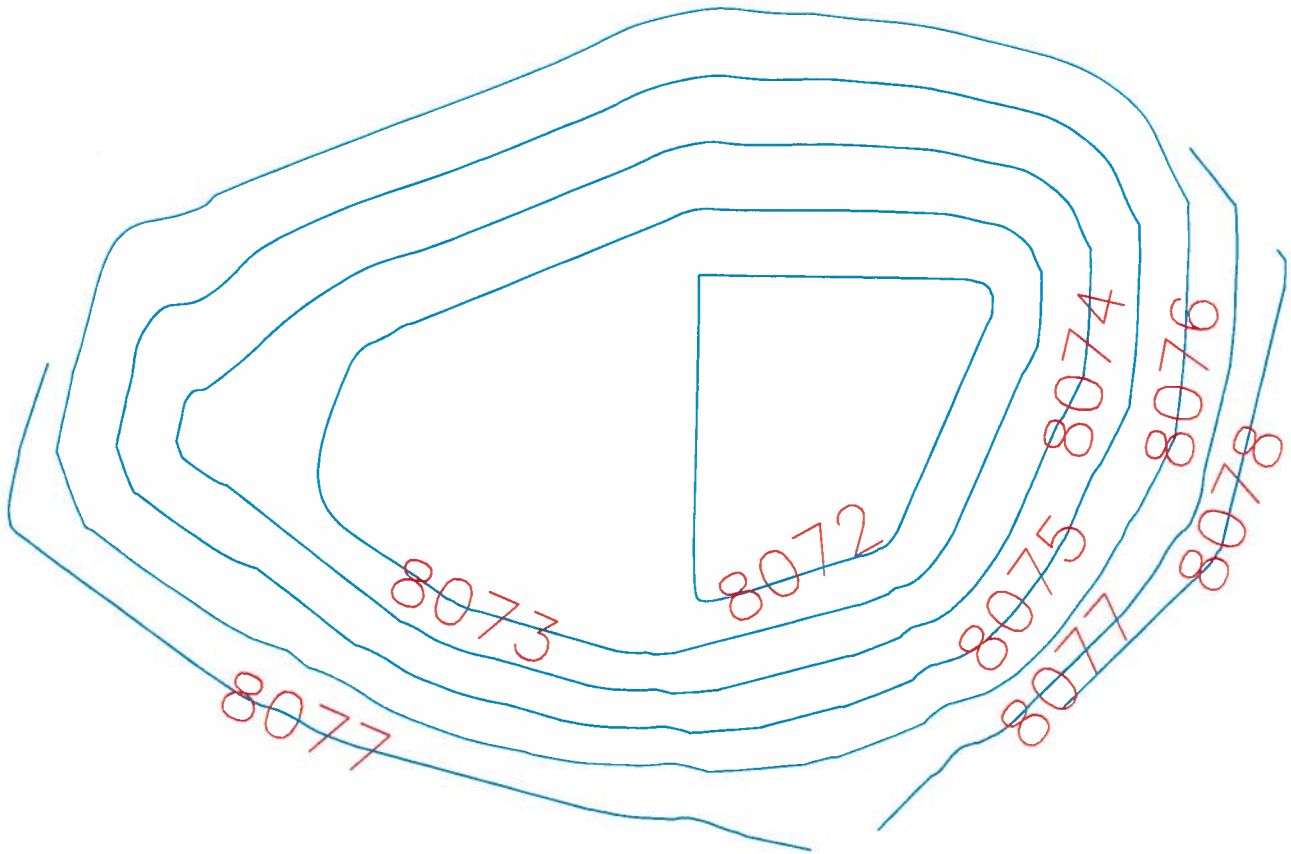
Winter Quarters
Sediment
Pond

The 2019 survey determined the sediment storage for the pond is approximately 873 cu-ft.

Water Elevation		Storage CF
8076.3	----	5055.3
