RE: VARIANCE SEDIMENT PONDS 3 & 5

RE: Information Requested by UDOGM for Sediment Ponds No.3 and No.5, Star Point Mines

Subject: Embankment Stability Analysis of Sedimentation Pond Nos. 3 and 5, Plateau Mining Company, Wattis, Utah.

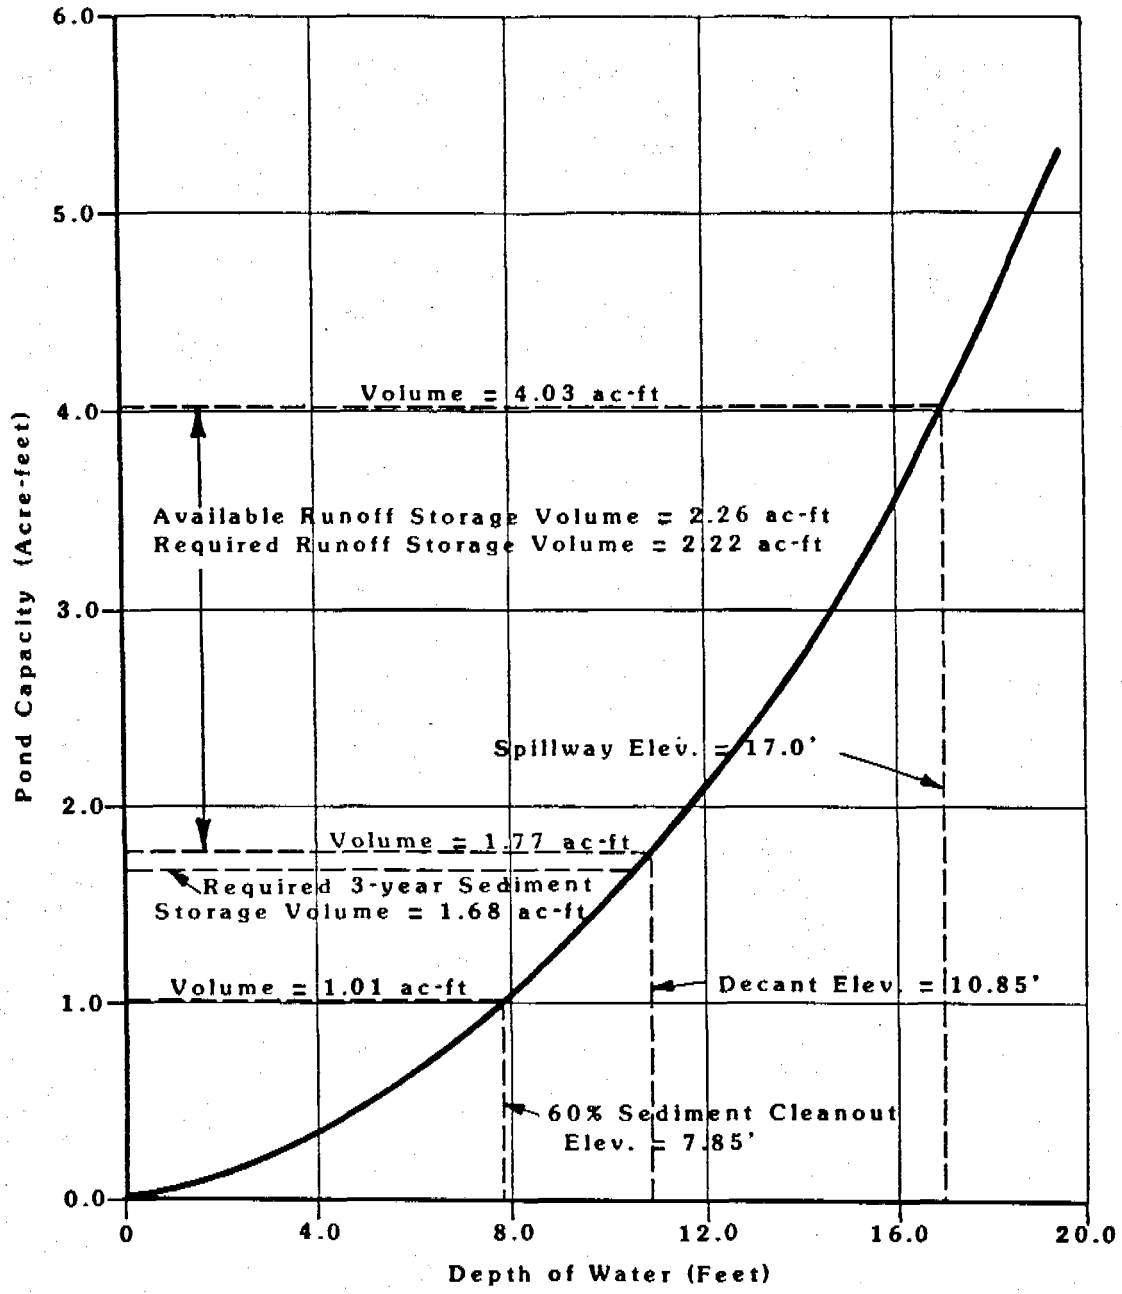
Figure 1. Stage capacity curve for Sediment Pond No. 3

From the "as built" survey conducted by Mr. Bruce Ware, an "as built" topographic map was prepared for each of the sediment ponds. The topographic maps for each of the ponds are attached hereto for your reference (Attachments 1 and 2). From the topographic maps prepared by Mr. Ware, stage capacity curves for each pond were developed. The stage capacity curves are attached hereto as Figures 1 and 2 (Attachments 3 and 4).

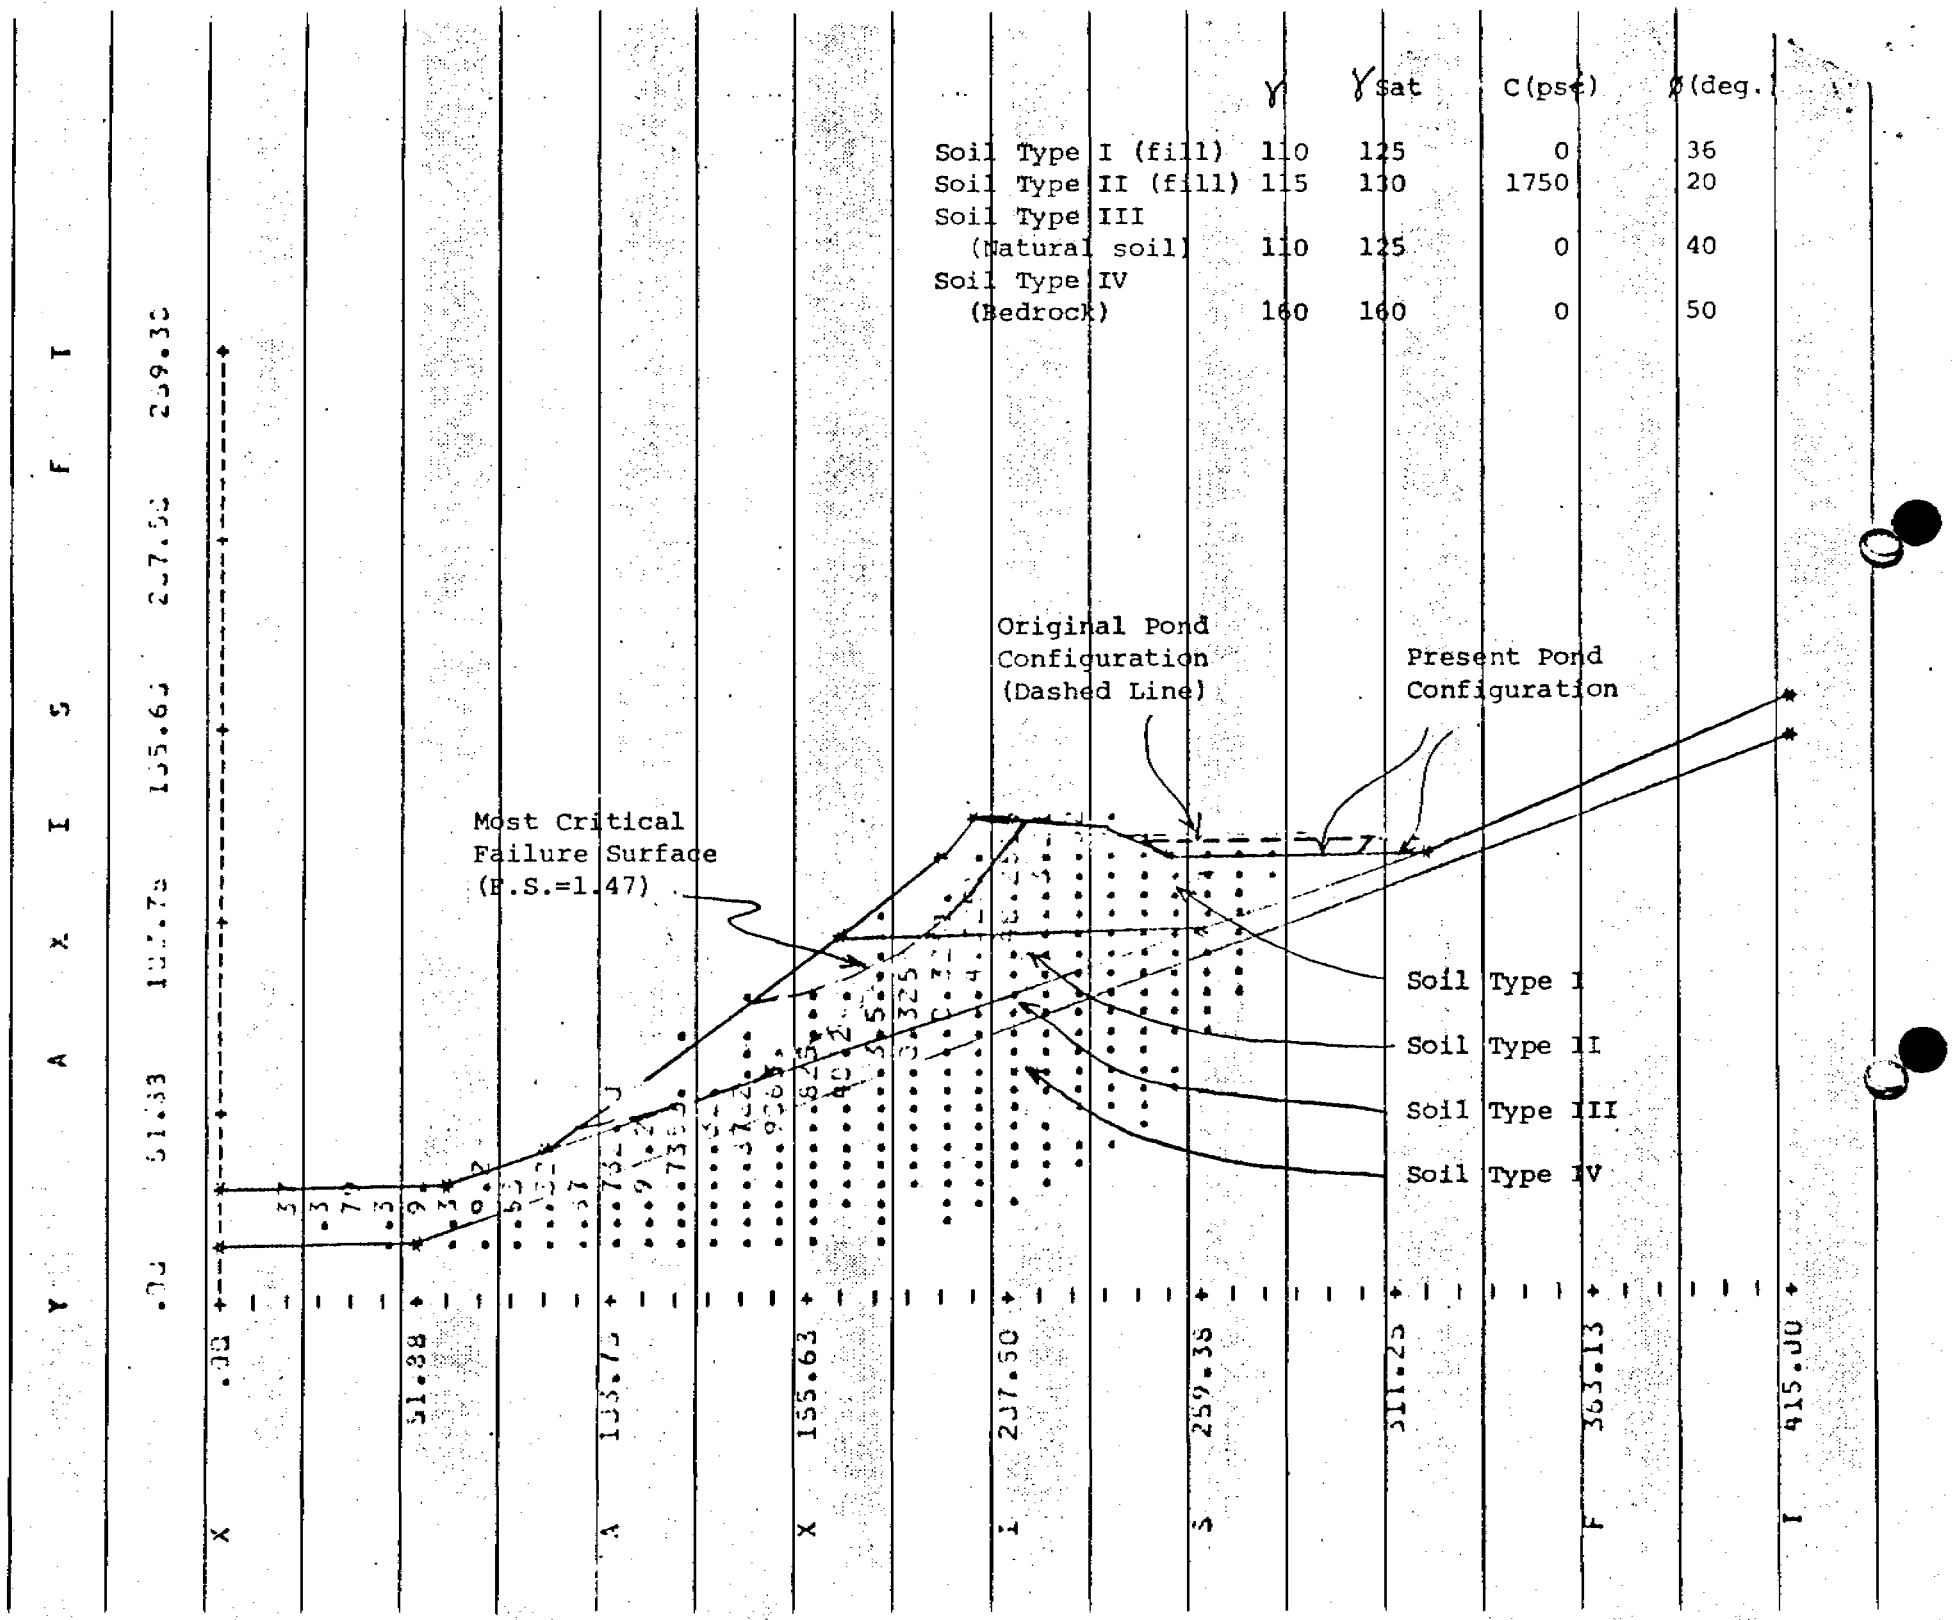
DRAWING NO. 1

Dry Pond (Factor of Safety)	Full Pond (Factor of Safety)
Pond No. 3	1.5	1.4
Pond No. 5	1.8	1.7

SEDIMENTATION POND NO. 3
DRY CONDITION

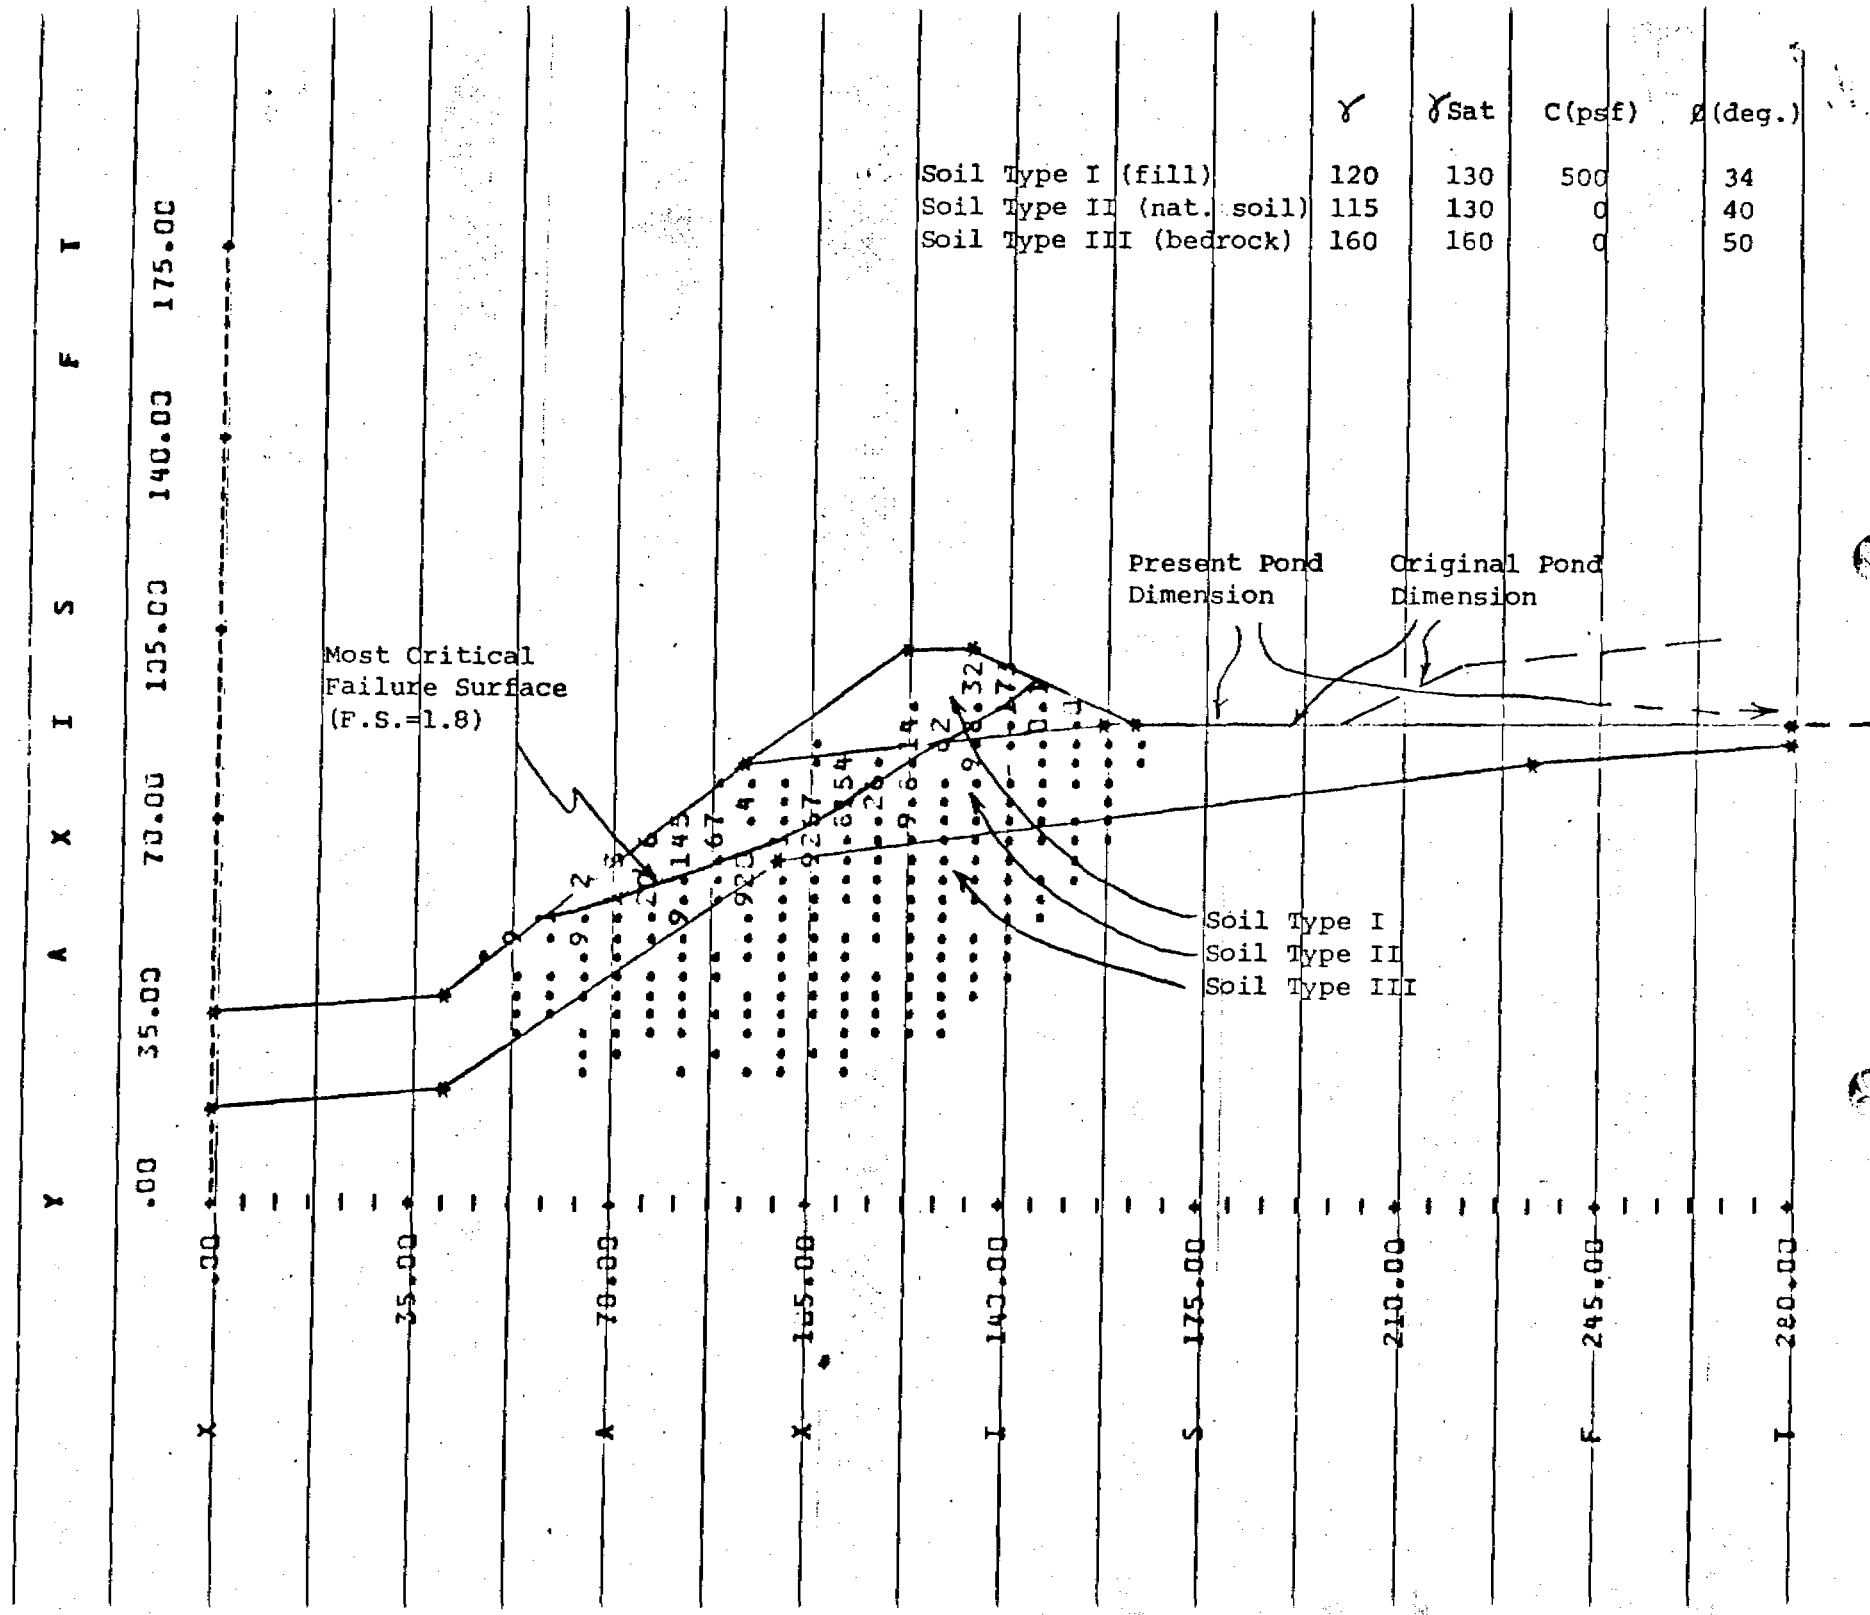
DRAWING NO. 3

SEDIMENTATION POND NO. 5
DRY CONDITION

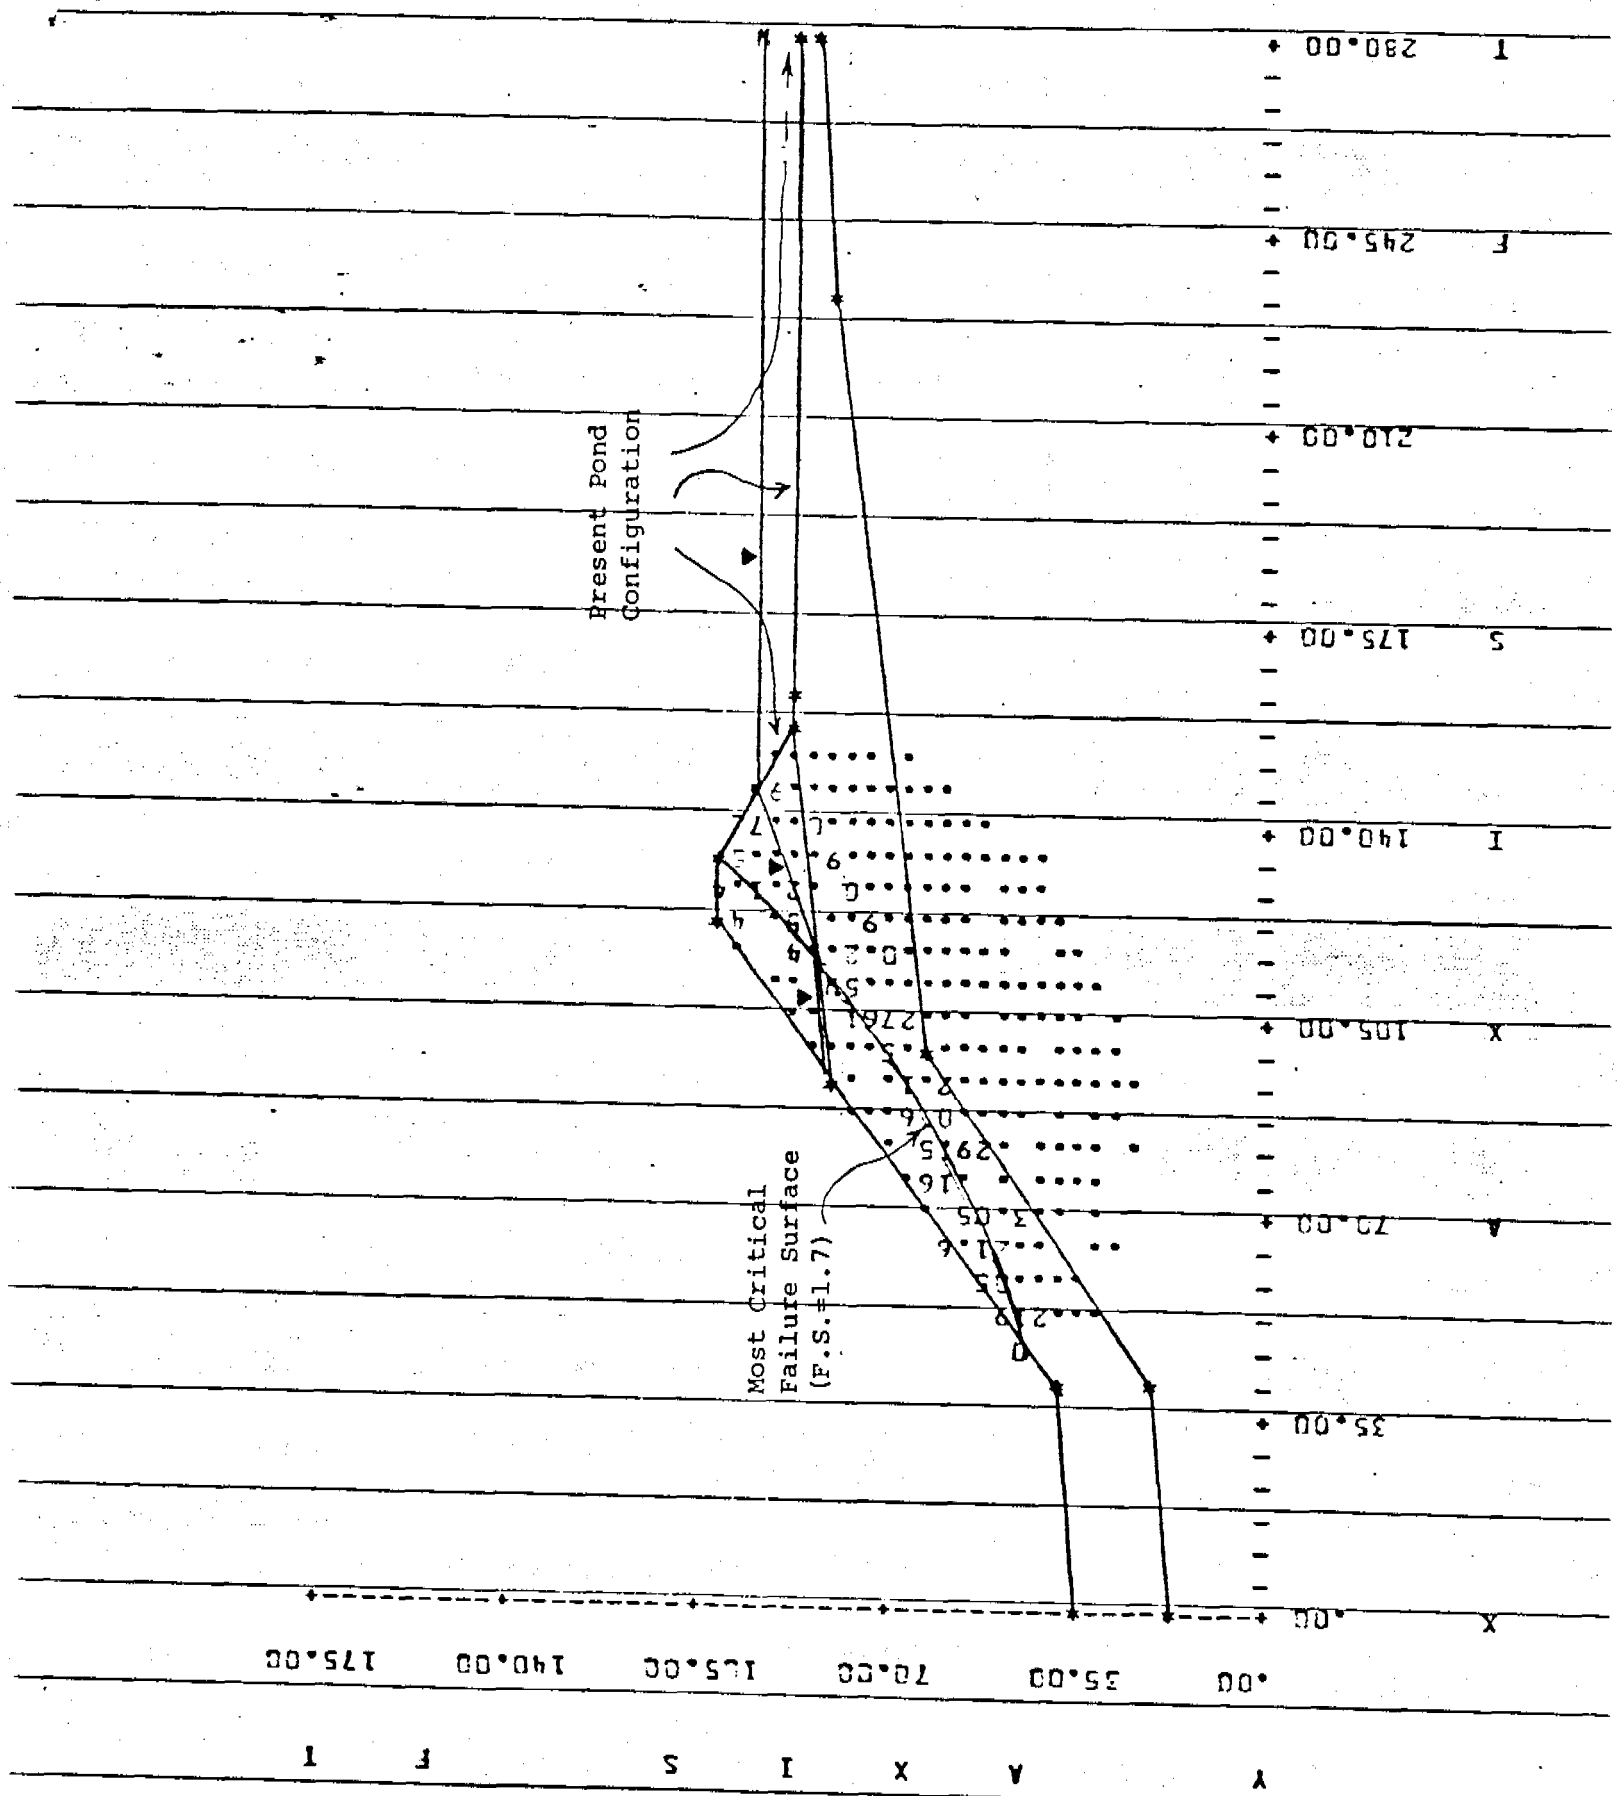
DRAWING NO. 4

SEDIMENTATION POND NO. 5
DRY POND
