State of Utah
DEPARTMENT OF NATURAL RESOURCES
DIVISION OF OIL, GAS AND MINING

April 6, 2000

RE: Birch Spring Findings for Technical Directive 005, Co-Op Mining Corporation, Bear Canyon Mine ACT/015/025, and Star Point Mine, ACT/007/006, Internal File

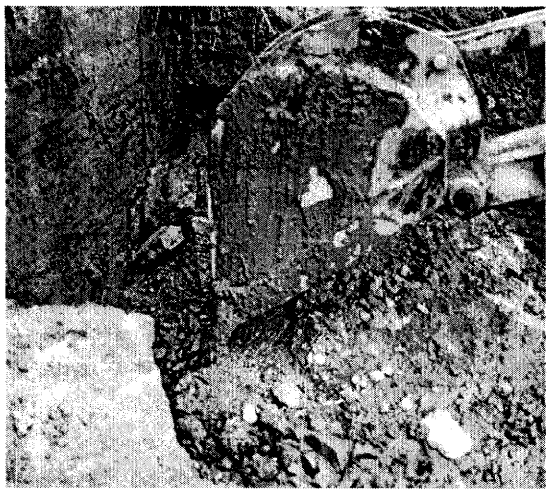
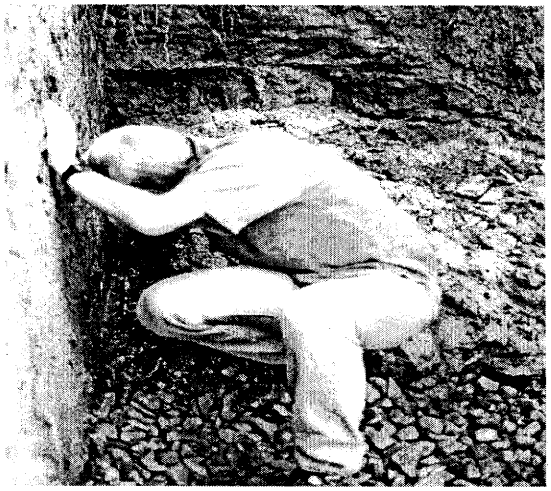
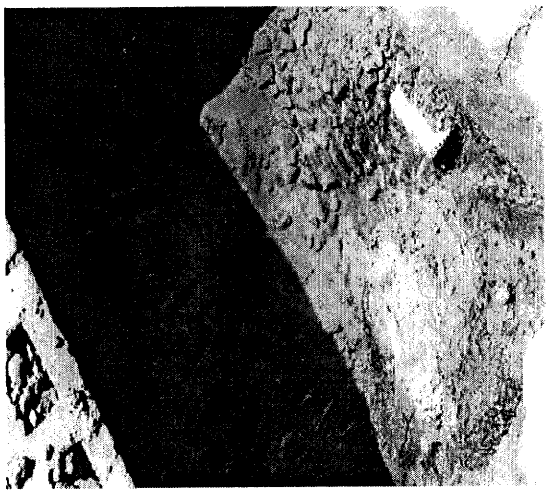
Birch Spring Investigation: Spring Source #1

In September 1998 NEWUA opened spring boxes #1 and #2. Mr. Peter Hess from the Division of Oil, Gas and Mining accompanied Jack Stoynoff from the NEWUA. Mr. Hess noted that at box #1 the collection box was full of gravel and sediment and water ran over the top of the collection box. It was estimated that approximately 15 gpm flowed from source #1 after cleaning the box. Mr. Hess took photos of these sites on September 21 and 24, 1998. These photos are in Appendix B.

Spring Source #1, as shown on Map 1, is located on the west side of the alcove and is the down gradient source (Figures 1-4). Water was running over the collection box in (Figure 2) prior to opening the box. Silt and sediments were noted in the fracture and collection box when it was unearthed (Figures 3 and 4). Charles Reynolds is removing silt from the fracture in Figure 3.

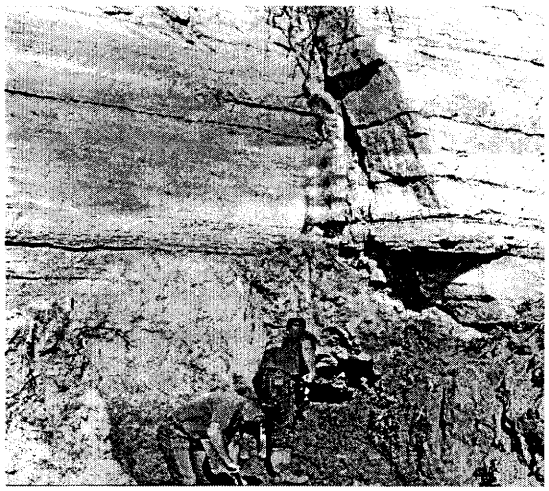
Birch Spring Investigation: Spring Source #2

Spring Source #2 is located on the west side of the alcove and is the up gradient source #2 as shown in Map 1. Silt and sediments were noted in the gravel filter.
