Sunnyside Coal Company

December 4, 1992

Re: NOV92-32-17-1 Failure To Maintain Diversions

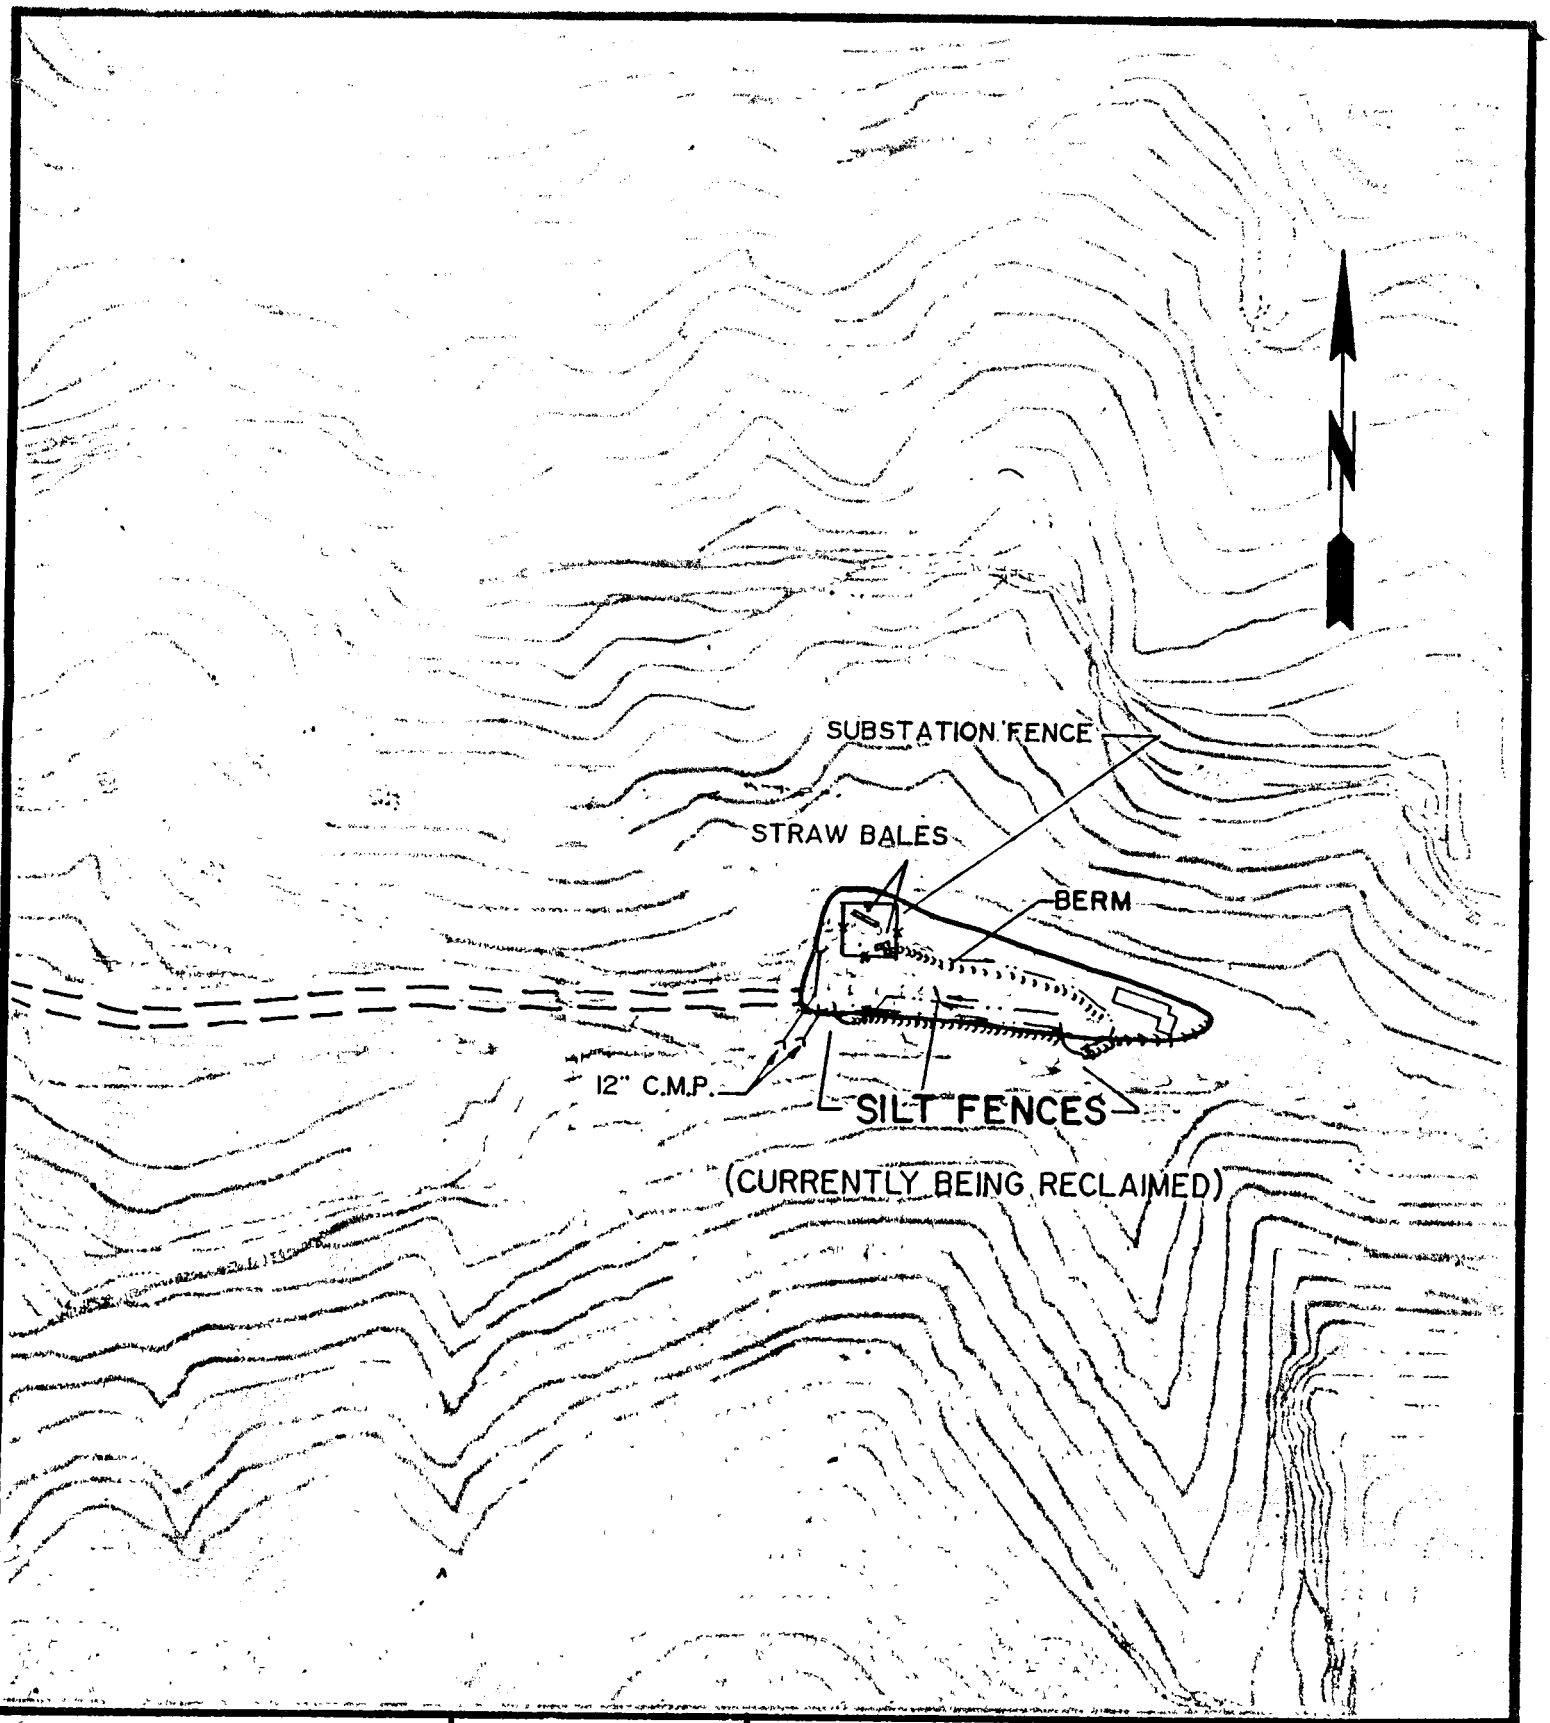
Sunnyside Coal Company	REVISIONS		NO. 2 MINE FAN		A5-0110
	No.	DATE	BY	B.T.C.A. AREA 0.95 ACRES	PLATE 5-5
		11/14/84	DCP		
		7/1/88	B.F.A.	DCP	11-21-83
SUNNYSIDE MINES					
					200'

The abatement of the area at the Fan Canyon B.T.C.A. presents another problem. We used a backhoe to probe the area west of the old substation searching for the twelve-inch CMP inlet that supposedly drained the undisturbed area to the wash as shown on Plate 5-5, A5-0110. We had no success. The other twelve-inch CMP from the edge of the road to the wash was not located either.

Neither Ernest Monson nor Dale Andrews (who are long-time surface compliance personnel at this operation) remember either culvert. It is our belief that the culverts were never installed.

Due to the hardness of the frozen ground and the limited reach of our backhoe, it would be extremely difficult to reinstall these culverts at this time. For this reason, we ask that abatement be extended until next spring.

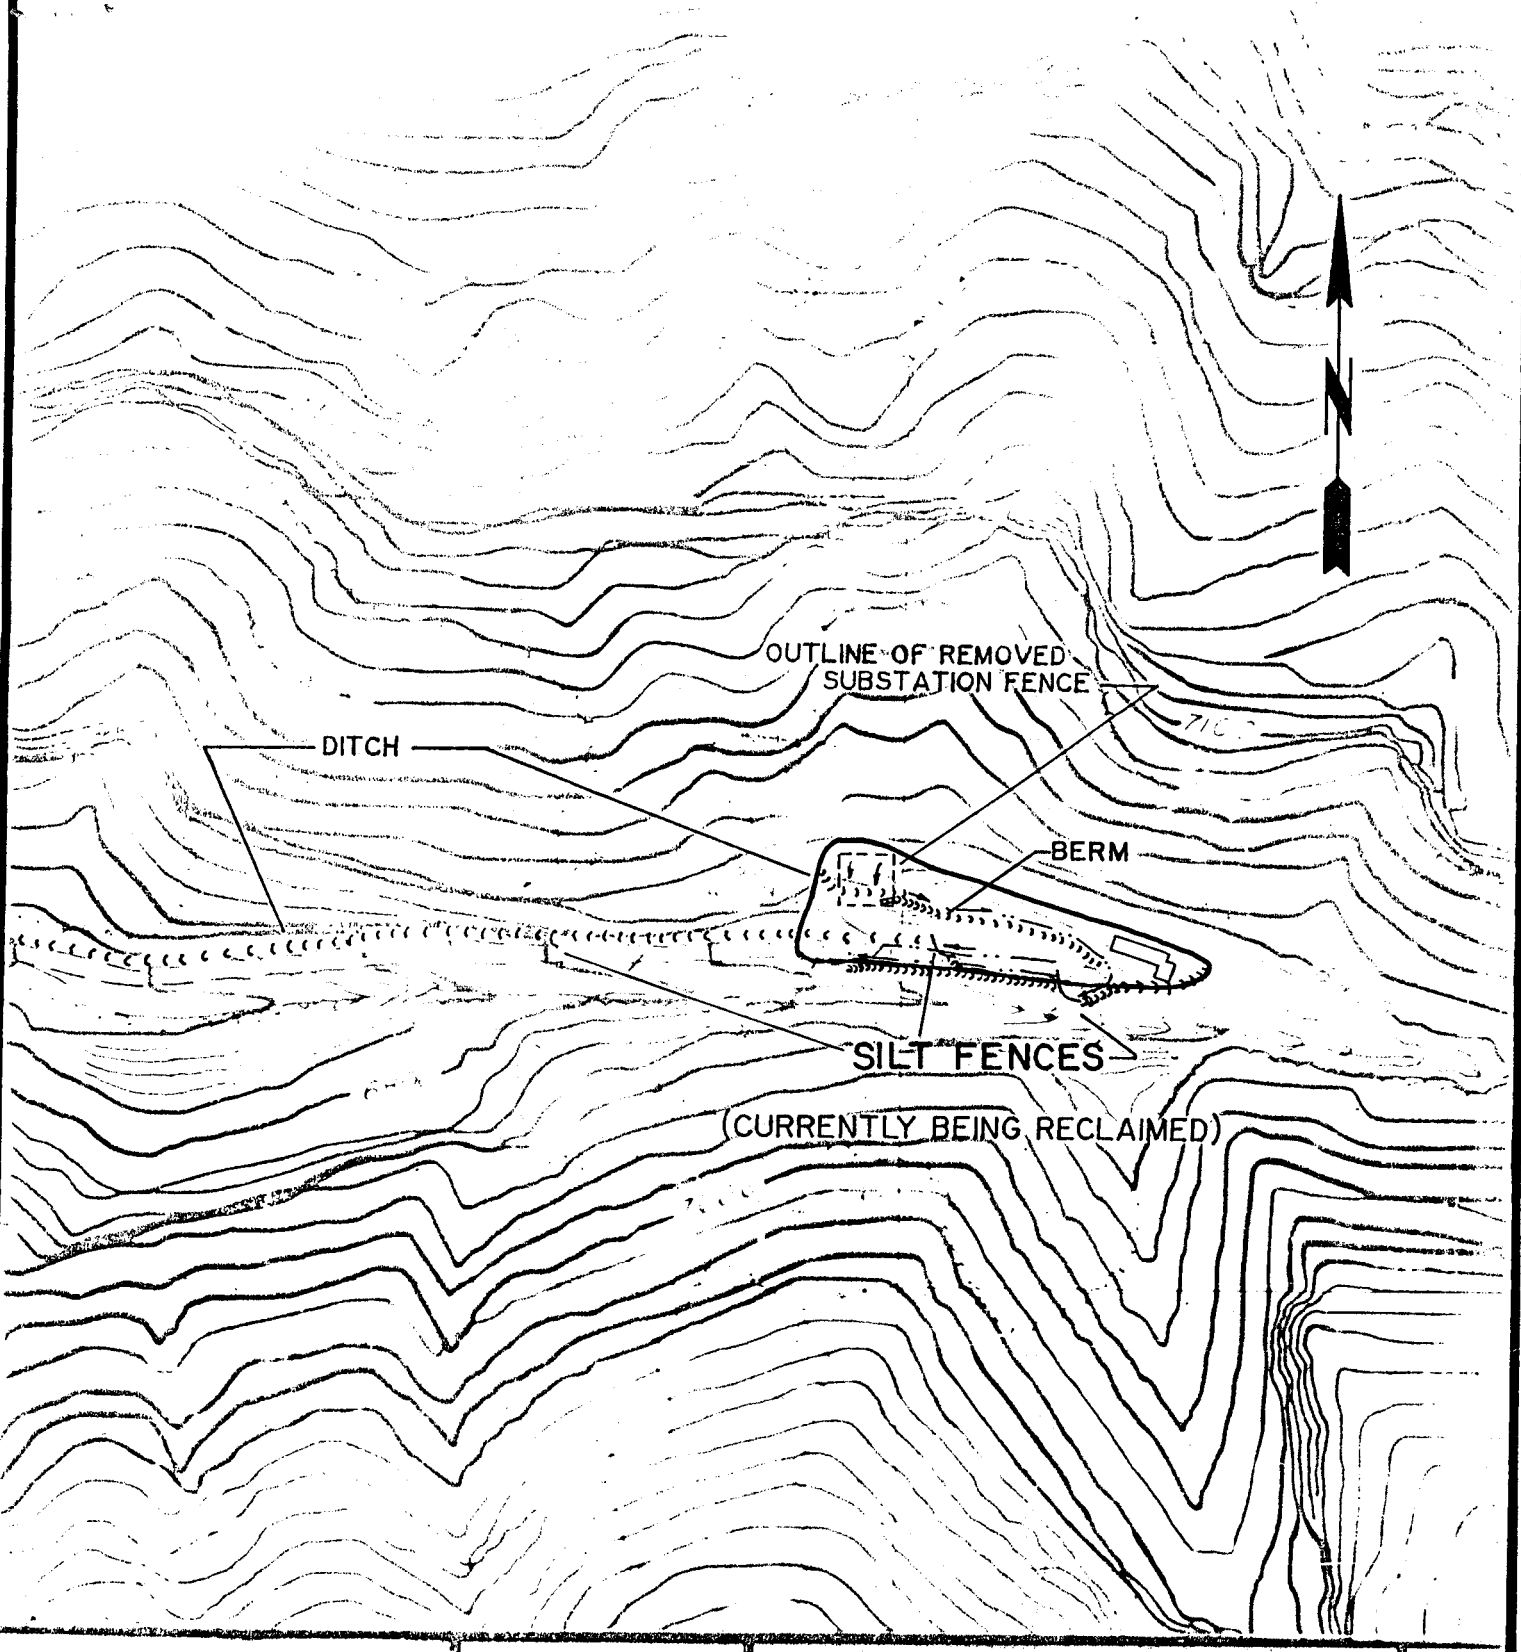
DRAWING NO. A5-0110-R

I have also revised Plate 5-5, A5-0110, to Plate 5-5, A5-0110-R, making the necessary changes. These are enclosed.

In order to provide temporary drainage for the disturbed area of the pad, Sunnyside Coal Company has removed two concrete pads inside the substation perimeter and cut a shallow ditch on an angle from the cliff wall on the west side of the old substation perimeter along the front of the pad and tied it into the berm which parallels the substation access road. All runoff would report to the silt fences below. We have also established a berm at the middle silt fence to the edge of the wash and redefined the ditch to the bottom fence.
