Evaluation report of Portals & Shafts of the Kaiser Steel and Sunnyside Coal Mines

MONTGOMERY WATSON

September 1997

SUNNYSIDE MINE RECLAMATION PROJECT
PORTAL EVALUATION AND INSPECTION

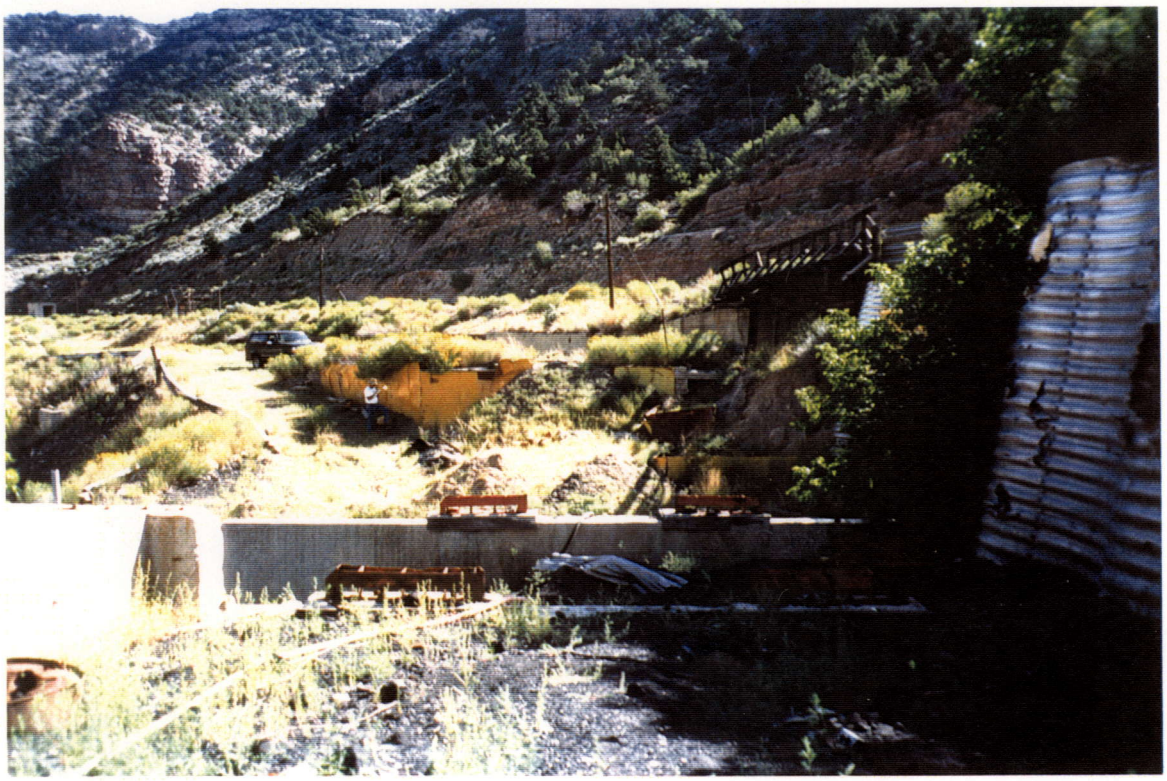
NO. 3 SLOPE PORTALS
NO. 1 MINE
P24

NO. 3 SLOPE PORTALS - LITTLE EVIDENCE OF ANY PORTAL
NO. 1 MINE
P24

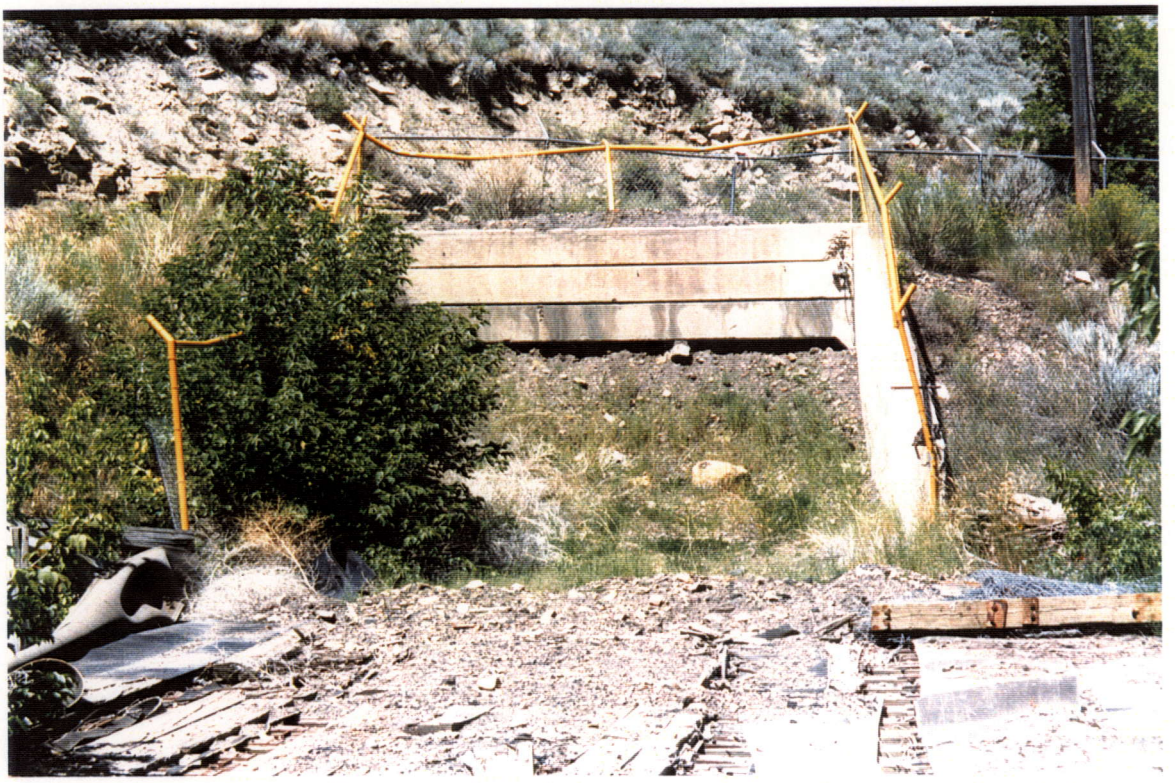
NO. 3 SLOPE PORTALS
NO. 1 MINE
P22 & P23

NO. 3 SLOPE PORTALS - ONE PORTAL FOR TWO ENTRIES
NO. 1 MINE
P22 & P23
