Hiawatha Inspection Report 6205

Inspection Report

Permit Number:	**C0070011**
Inspection Type:	PARTIAL
Inspection Date:	Tuesday, July 31, 2018
Start Date/Time:	7/31/2018 10:00:00 AM
End Date/Time:	7/31/2018 1:00:00 PM
Last Inspection:	Thursday, July 12, 2018

Permitee: **HIAWATHA COAL CO INC**
Operator: **HIAWATHA COAL CO INC**
Site: **HIAWATHA MINE**
Address: **PO BOX 1240, HUNTINGTON UT 84528**
County: **CARBON**
Permit Type: **PERMANENT COAL PROGRAM**
Permit Status: **INACTIVE**

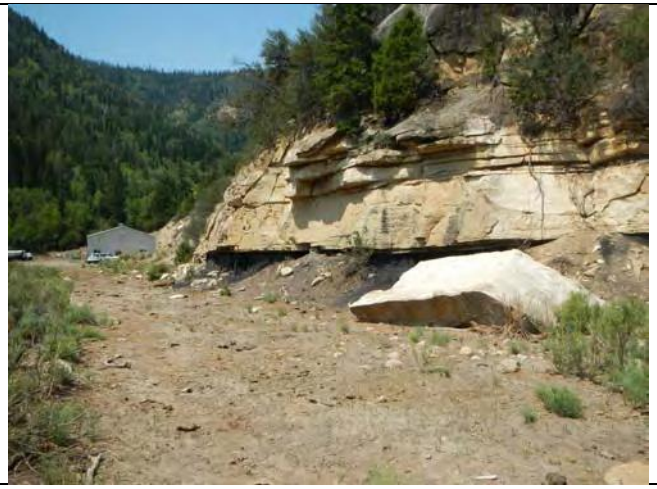
South Fork access to mine yard. AMR portals are backfilled on either side of the boulder
