State of Utah
DEPARTMENT OF NATURAL RESOURCES
DIVISION OF OIL, GAS AND MINING

Memorandum

RE: Technical Summary of Mr. Stamatakis' Concerns of Mining Related Impacts to Hydrologic Resources in Beaver and Gordon Creeks, Carbon County, Utah

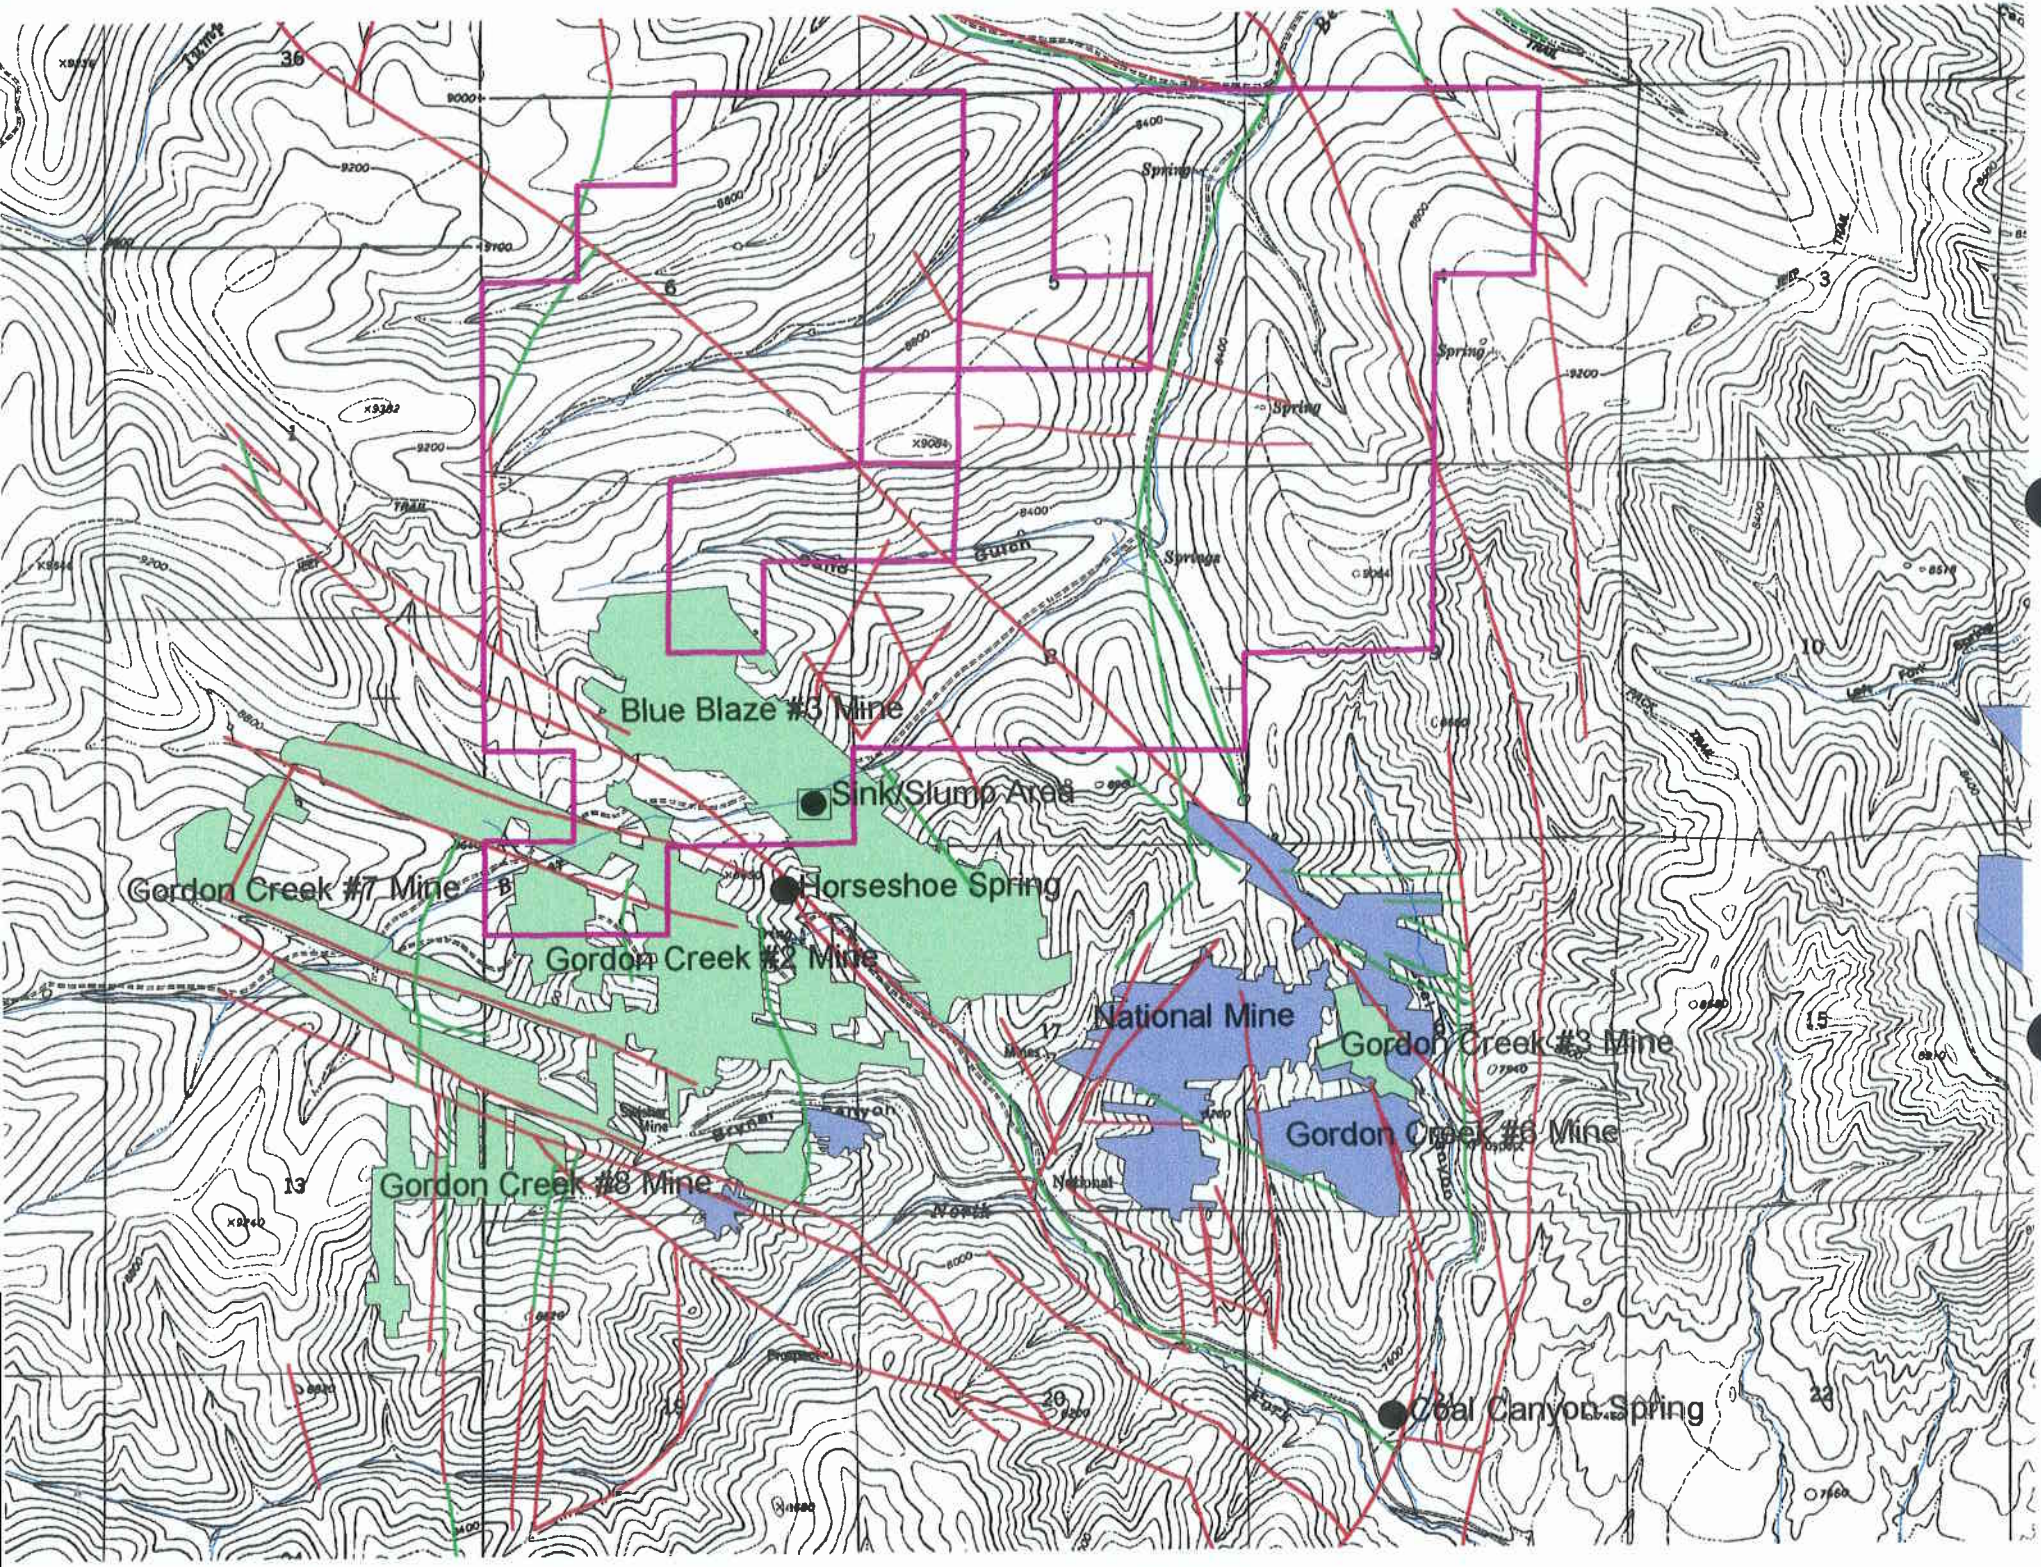
Blue Blaze #3 Mine
Sink/Slump Area
Horseshoe Spring
Gordon Creek #7 Mine
Gordon Creek #2 Mine
National Mine
Gordon Creek #3 Mine
Gordon Creek #6 Mine
Gordon Creek #8 Mine
Coal Canyon Spring
