INSPECTION REPORT

Mine Name: Gordon Creek Mines #3 & # 6 County: Carbon Permit **Number: ACT/007/017**
Permittee and/or Operator's Name: Mountain Coal Company
Business Address: P.O. Box 591 Somerset, Colorado 81434
Type of Mining Activity: Underground X Surface__ Prep. Plant__ Other_
State Officials(s): David W. Darby
Company Official(s): Dan Guy
Federal Official(s): none
Weather Conditions: Cloudy,light rain
Existing Acreage: Permitted- 668 Disturbed- 28 Regraded-_ Seeded- 28 Bonded-28
Increased/Decreased: Permitted-_ Disturbed-_ Regraded-_ Seeded-_ Bonded-_
Status: _Exploration/_Active/_Inactive/_Temporary Cessation/_Bond Forfeiture
Reclamation (X Phase I/ X Phase II/_Final Bond Release/_Liability Year)

RE: Technical Summary of Mr. Stamatakis' Concerns of Mining Related Impacts to Hydrologic Resources in Beaver and Gordon Creeks, Carbon County, Utah

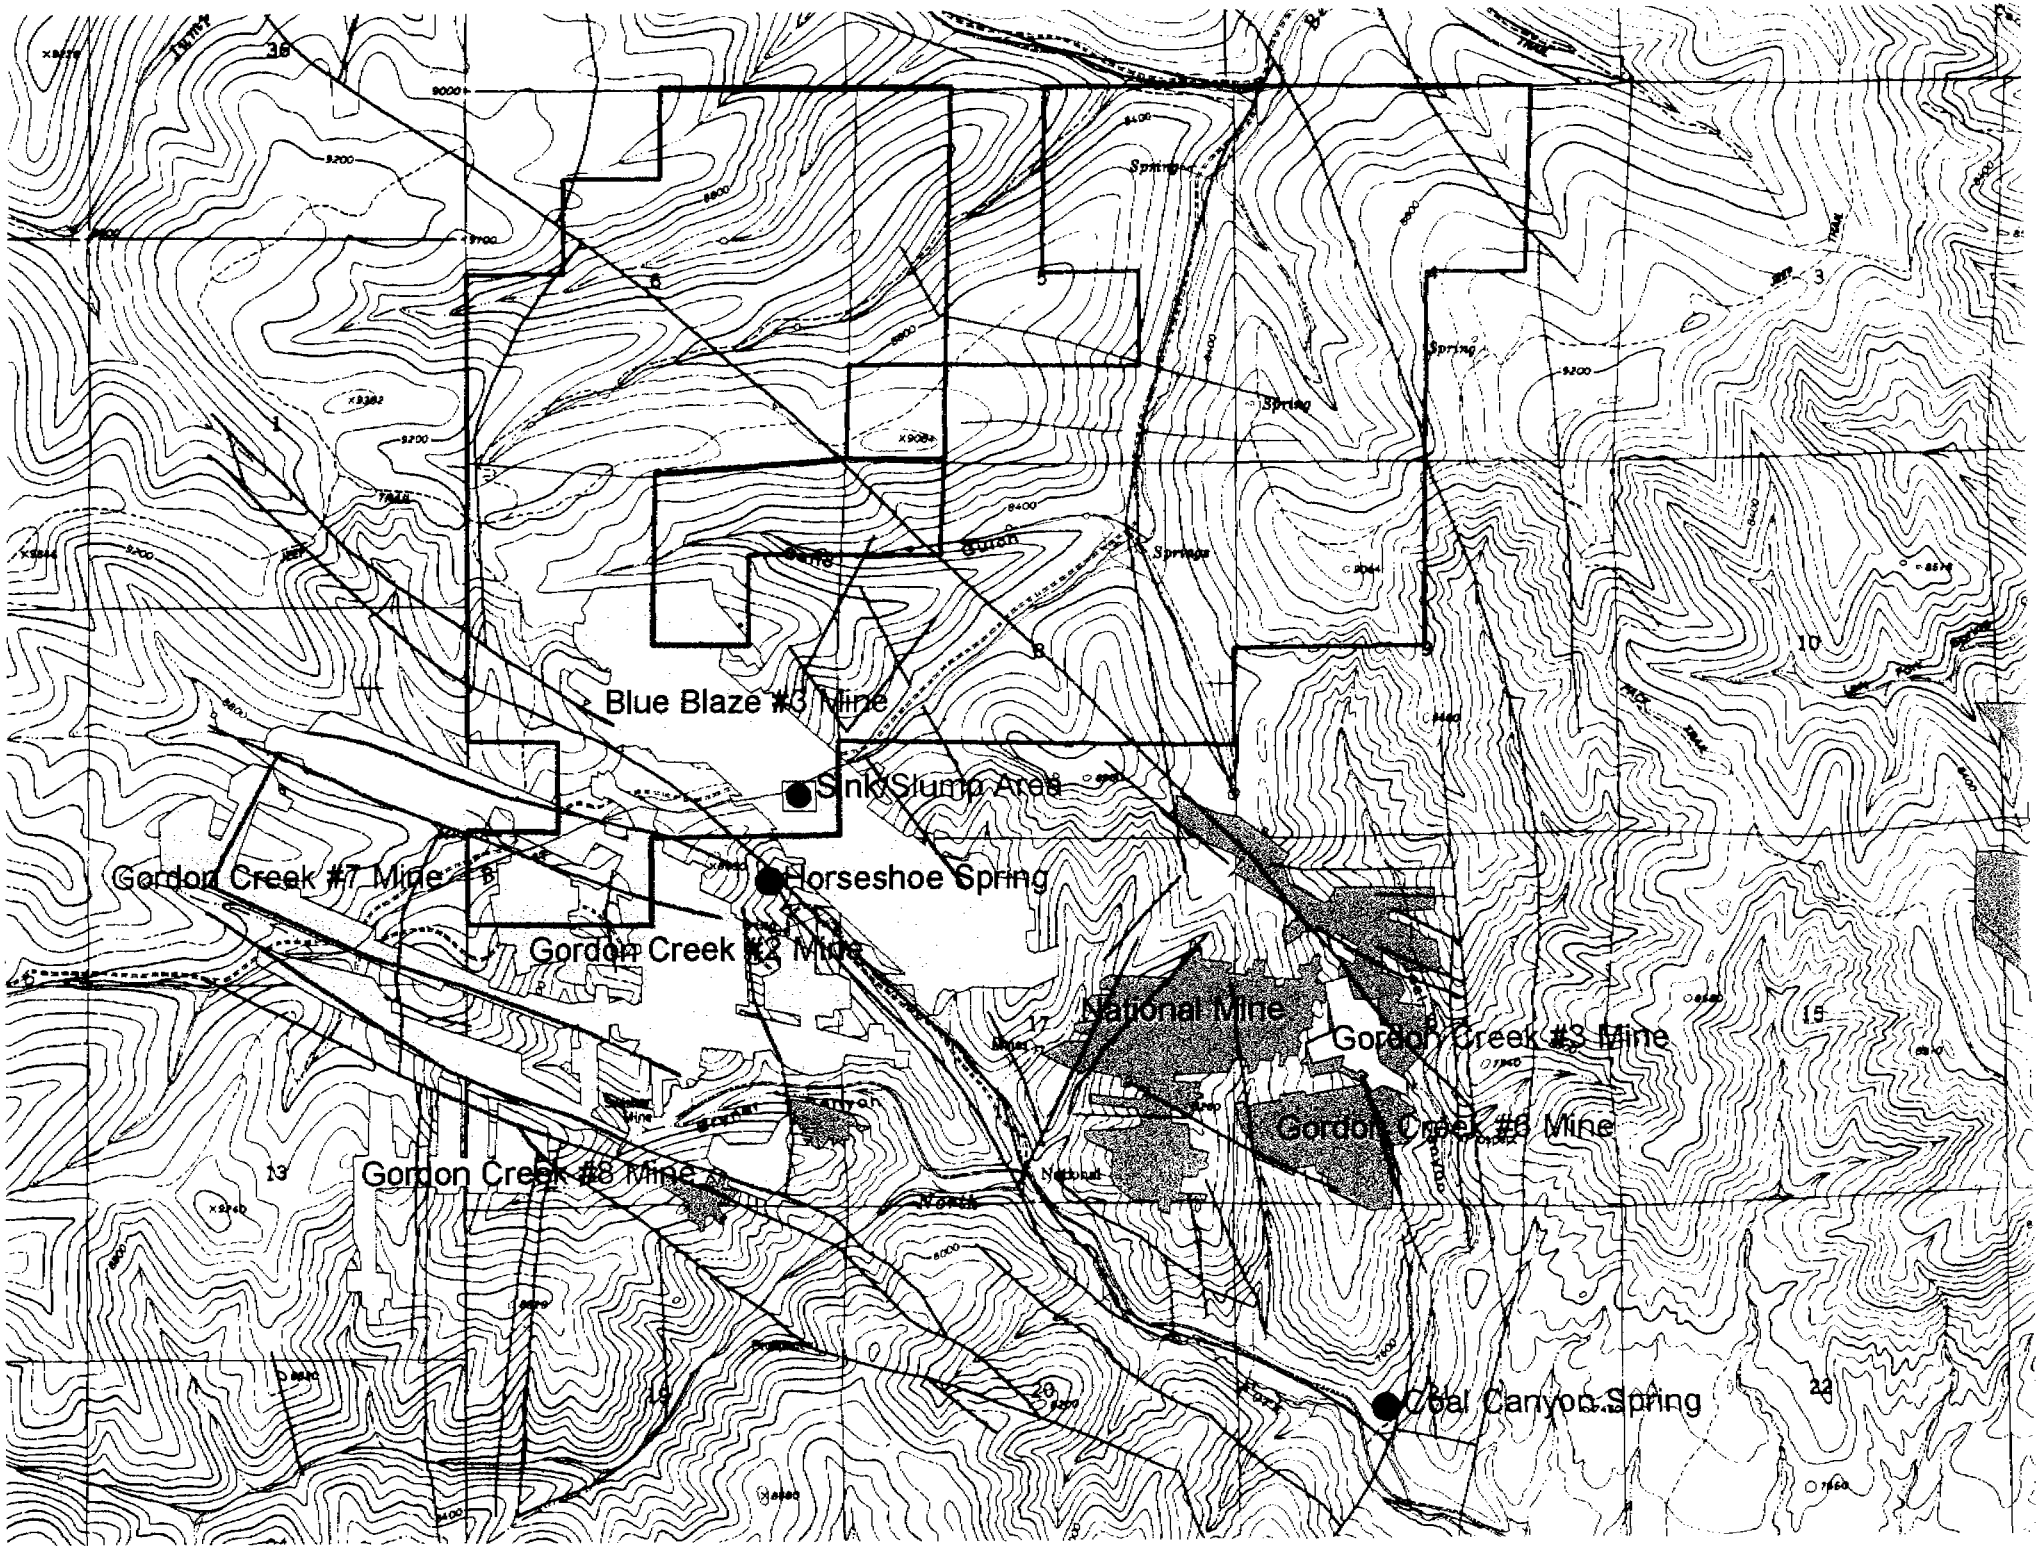
The sink/escarpment location on Beaver Creek was measured by vehicle mileage and GPS readings. Both readings marked the location over the old Blue Blaze #3 Mine. There is in this area 700 to 800 feet of overburden above the old workings. When previously observed the features resembled fractures with a pattern more representative of tension cracks. There was no definitive findings that this area was disturbed by mine subsidence.

We hiked down a slope from the county road to the Gordon Creek #2 Mine pad. We found a fracture approximately 60 feet long that had opened about 2 feet wide. The fracture had filled in substantially with some of the surrounding earth. Some animals had burrowed into the fill material of the fracture. The fracture overlies some entries that don't appear to be second mined, according to Plate 3-3 of the Gordon Creek #2 Mine Map. There is less than 200 feet of overburden.

During the site visit on October 3, 1997, Mr. Stamatakis pointed out a stand of aspen trees at the mouth of Coal Canyon, the same canyon in which the Gordon Creek #3 and #6 mine portals are located. A stand of aspen, all similar in age and occupying the valley floor, apparently died abruptly. Mr. Stamatakis claims that the ground surrounding the trees became saturated with groundwater produced as a result of mining, killing the trees. He proposed that the water issuing from the seeps came from Beaver Creek, reducing the flows in Beaver Creek and increasing the flow of Gordon Creek.

Blue Blaze #3 Mine
Sink/Slump Area
Horseshoe Spring
Gordon Creek #7 Mine
Gordon Creek #2 Mine
National Mine
Gordon Creek #3 Mine
Gordon Creek #6 Mine
Gordon Creek #8 Mine
Coal Canyon Spring

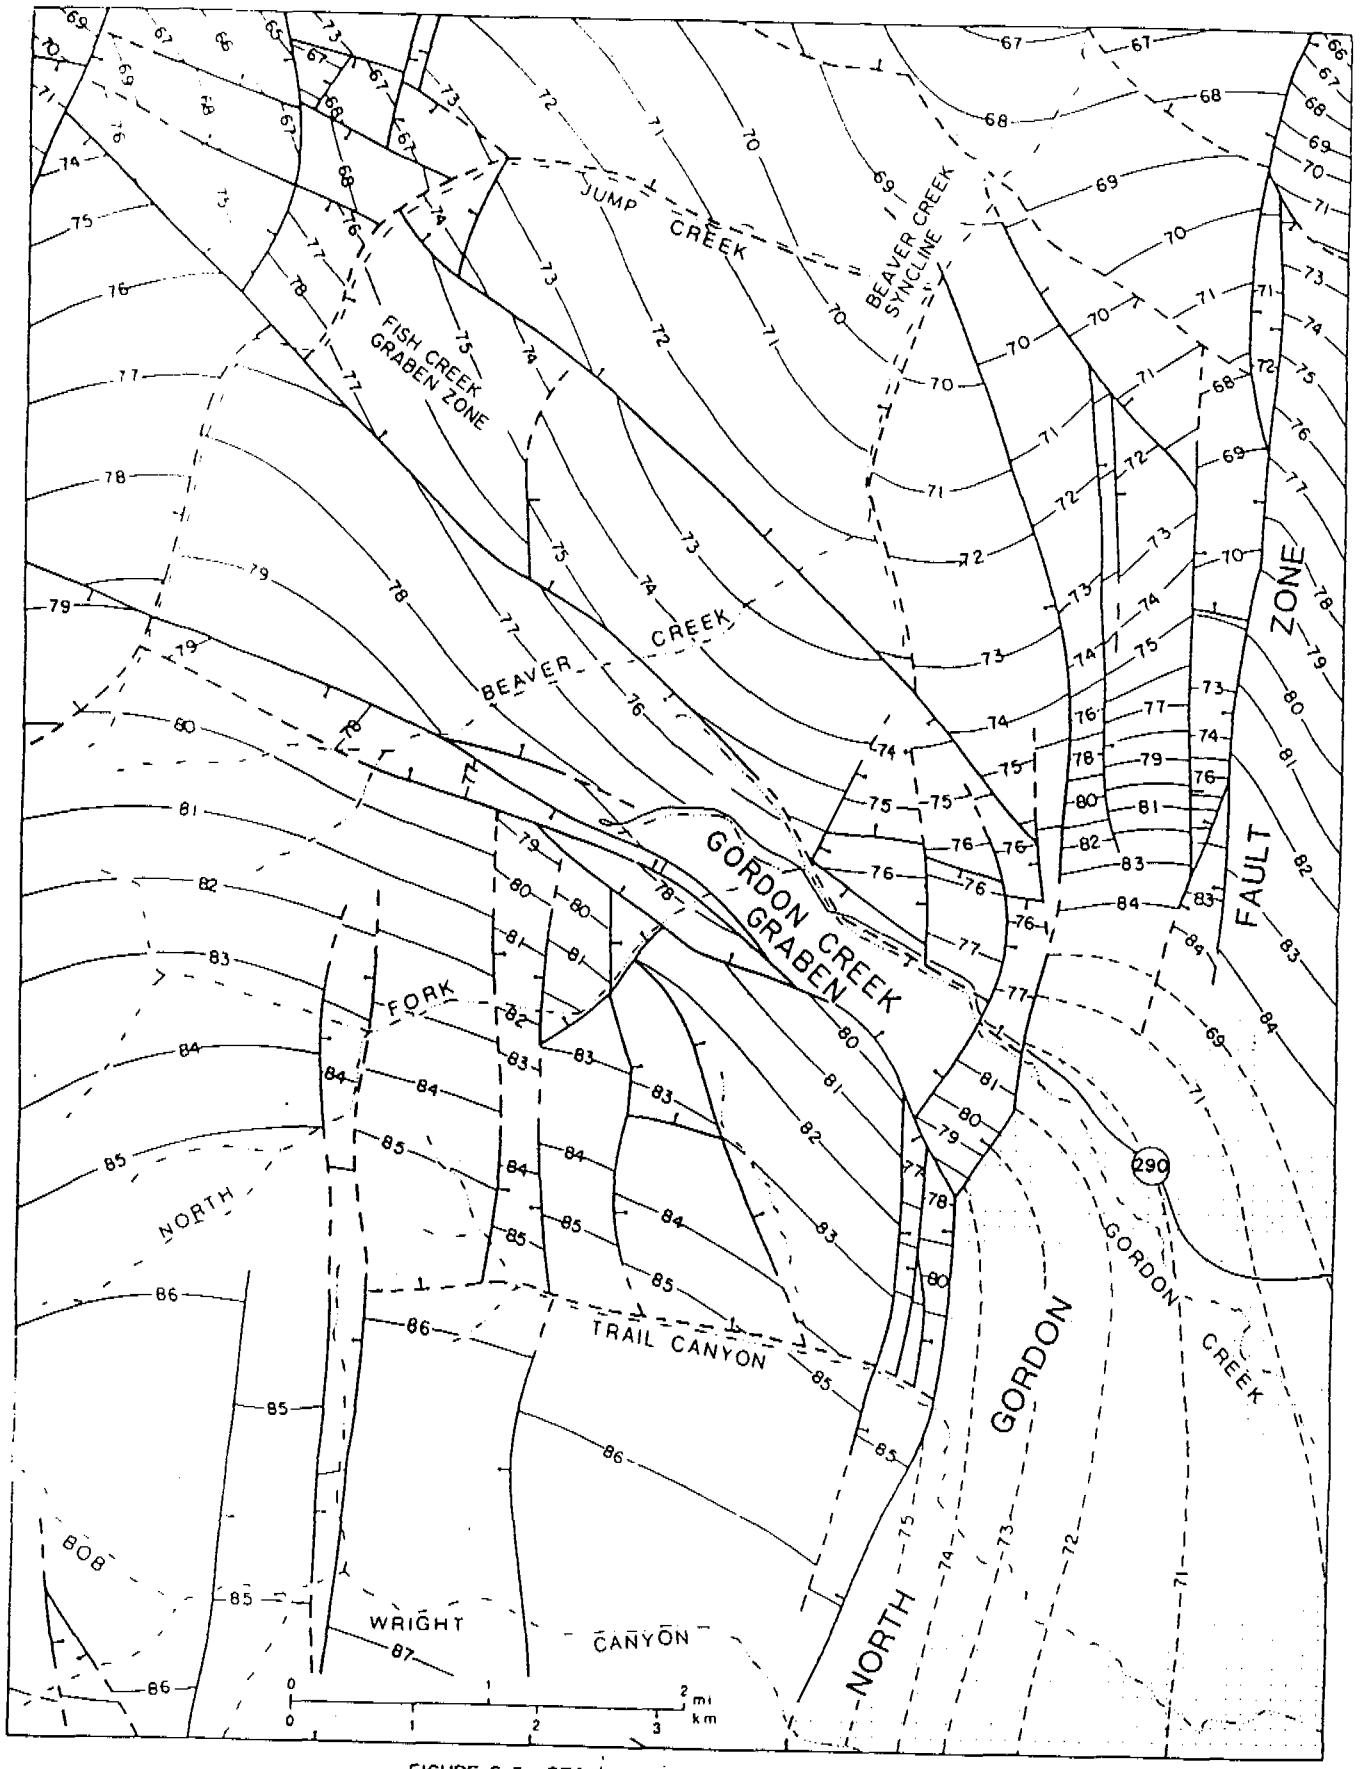
FIGURE 6-3. REGIONAL STRUCTURAL CONTOUR MAP.

The Gordon Creek/Beaver Creek area is highly faulted. The faulting dictated the way mines were developed. In some instances faulting prohibited mining. Several of these faults cross Beaver Creek, and two of them form the edge of a horst which runs northeast through the Stamatakis property. The relationship between groundwater movement and the faults is not well known. According to Dan Guy, no major flows were contacted in the Gordon Creek #2 Mine.

At least three monitoring wells should be located along the northeastern side of the Fish Creek Graben Zone northwest of Beaver Creek (Figure 6-3. Regional Structure Contour Map, Horizon Mining and Reclamation Plan), one of which should be located northwest of Jump Creek. Another three monitoring wells should be located in the Jump Creek Graben (or fault block) northwest of Beaver Creek, of those one well should be located northwest of Jump Creek.
