WATER QUALITY
M E M O R A N D U M

Utah Coal Regulatory Program

September 23, 2015

SUBJECT: First Quarter 2015 Water Monitoring, Andalex Resources, Centennial Mine, C/007/0019, Task ID #4828

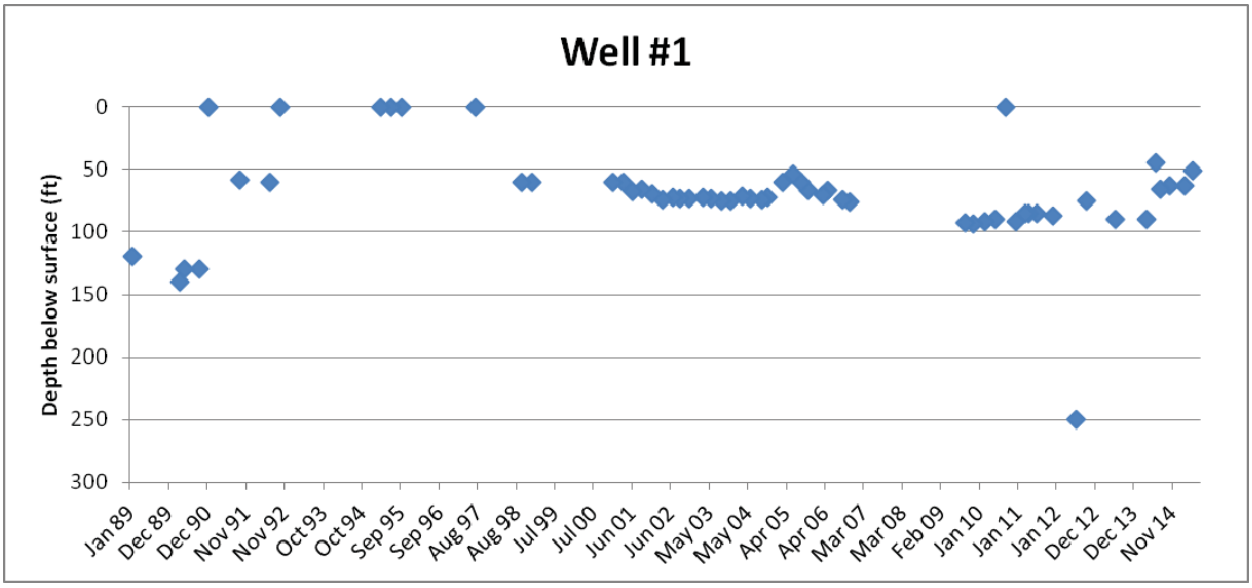
The Q1 2015 depth to water level measured 63 feet, which appears to be consistent with data from previous year's seasonal data.

Figure 1. Surface to ground water levels, 1989-2015

The continued examination of the depth to water at Well #1 is required.
