State of Utah
DEPARTMENT OF NATURAL RESOURCES
DIVISION OF OIL, GAS AND MINING

Memorandum

RE: Technical Summary of Mr. Stamatakis' Concerns of Mining Related Impacts to Hydrologic Resources in Beaver and Gordon Creeks, Carbon County, Utah

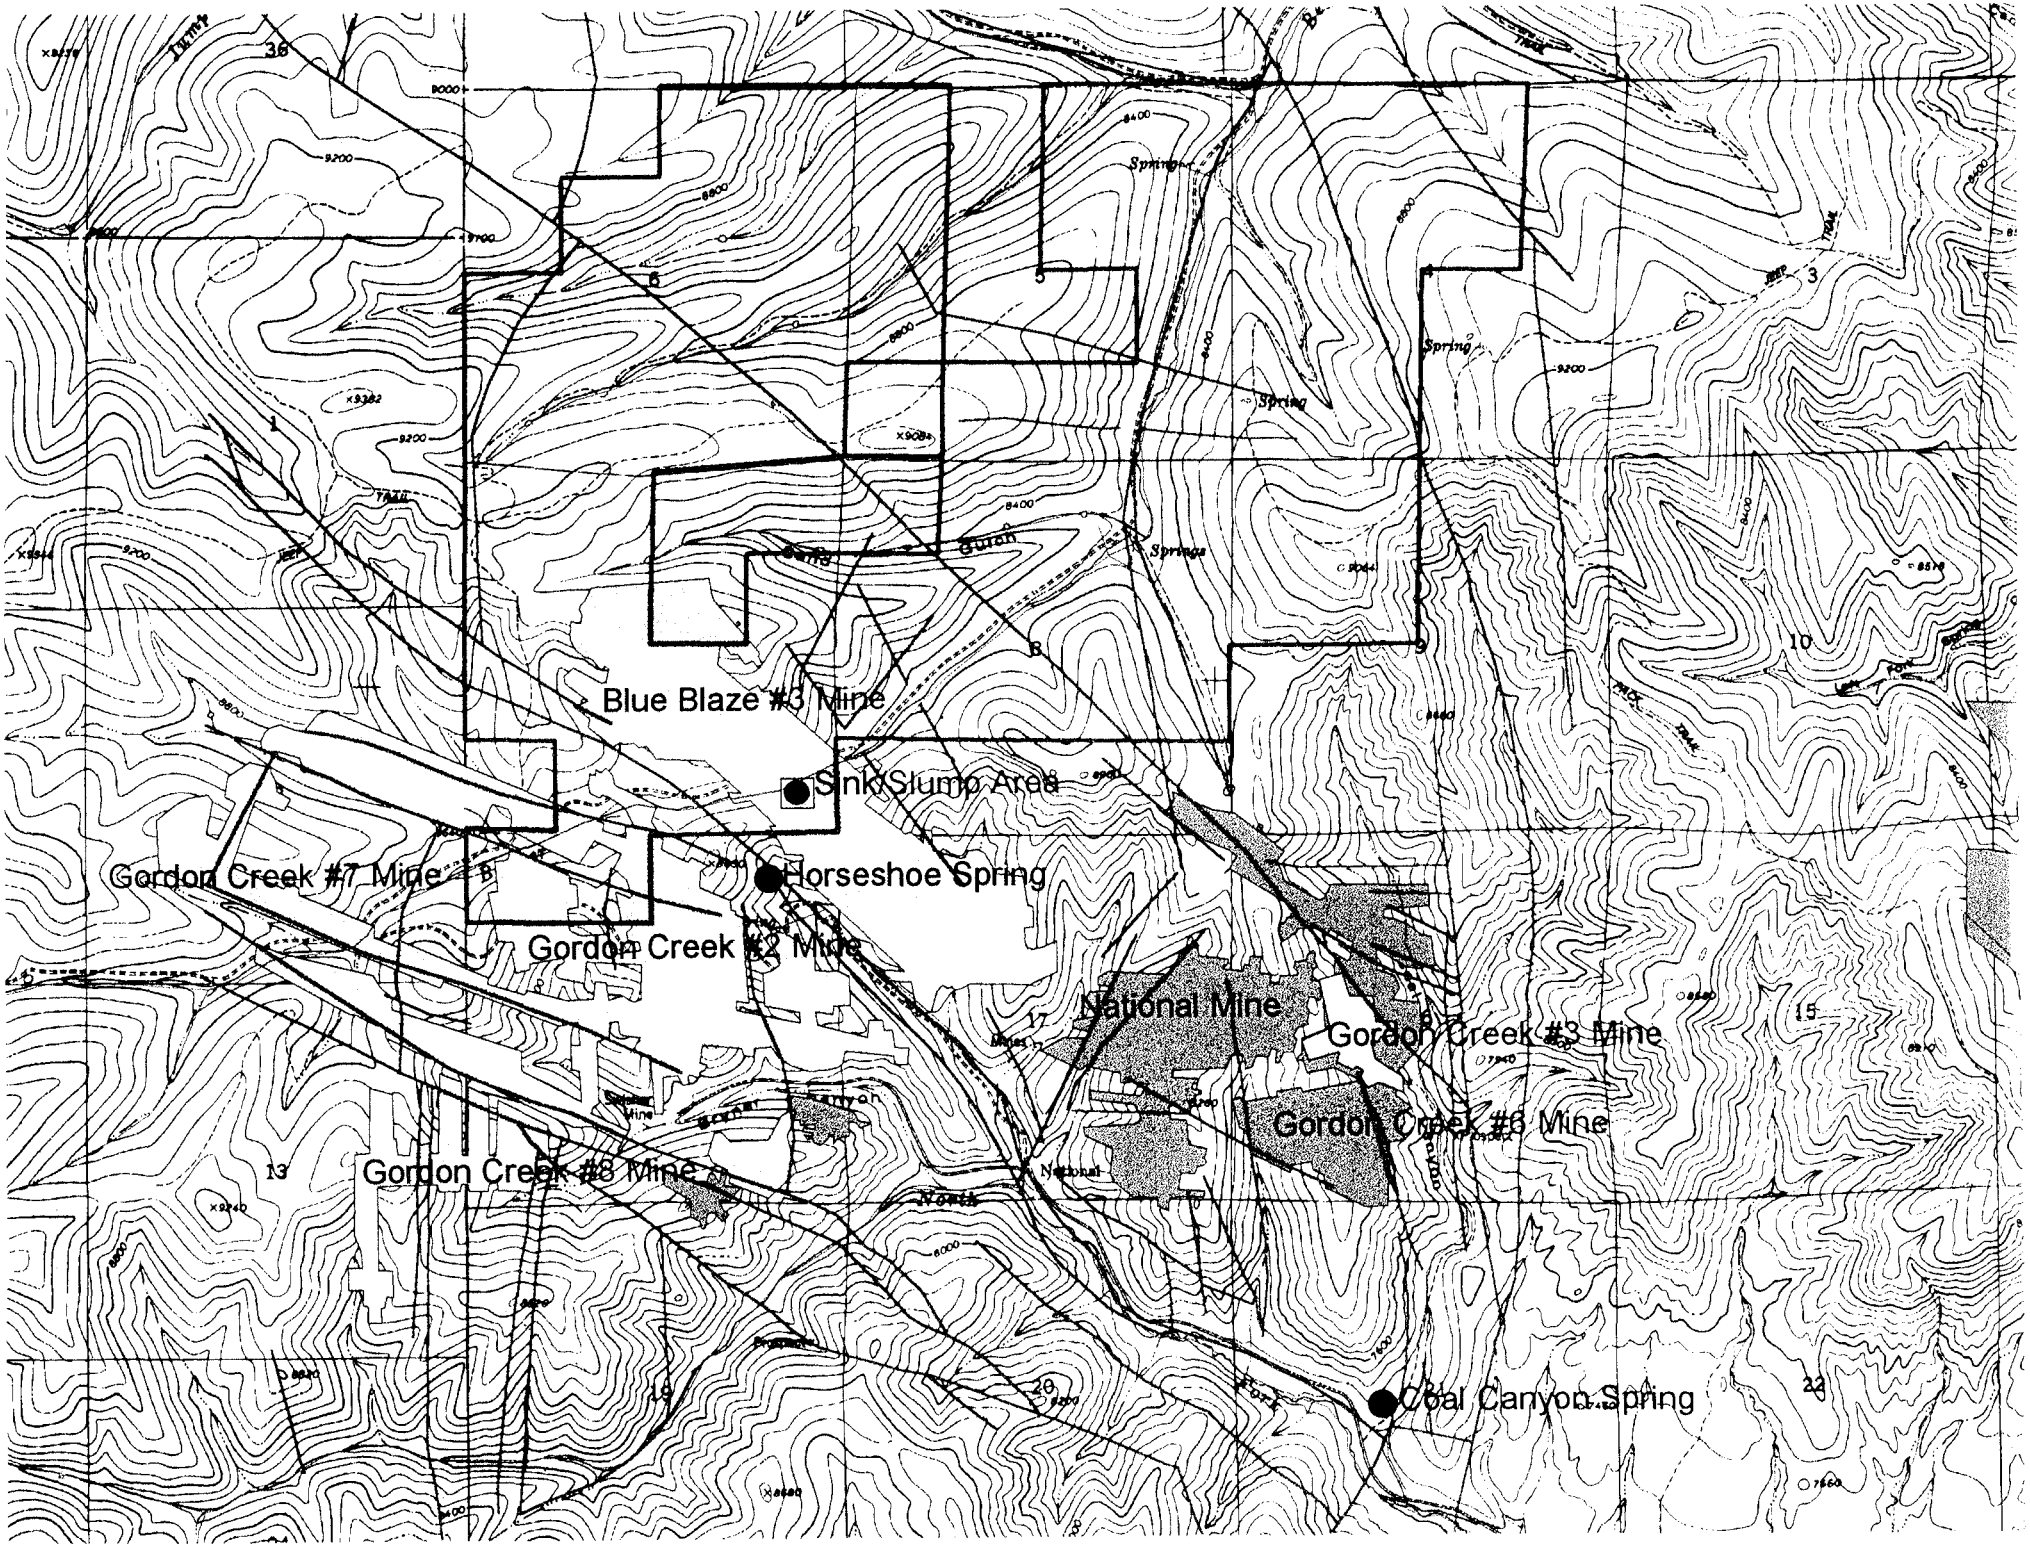
The sink/escarpment location on Beaver Creek was measured by vehicle mileage and GPS readings. Both readings marked the location over the old Blue Blaze #3 Mine. There is in this area 700 to 800 feet of overburden above the old workings. When previously observed the features resembled fractures with a pattern more representative of tension cracks. There was no definitive findings that this area was disturbed by mine subsidence.

The location of the sink/escarpment features overlies the Blue Blaze #3 Mine. Considering that overburden depth ranges from 750 feet to 850 feet and the height of mining is approximately 8 feet, it is unlikely that subsidence occurred on the surface at such a late date. No definite link could be concluded between the features and mining. The features could be caused by droughts and poor land management practices.

Steve Stamatakis pointed out an area along the county road in the NE 1/4 NE1/4 Section 18 which he claims had slumped over the last few years The slump area lies between the Gordon Creek #2 Mine and the Blue Blaze #3 Mine. Spring sources have been noted on the U.S.G.S. quadrangle, dated 1979. A spring box just below the bend in the road was built to supply some of the early mines and towns. The elevation of the slump area ranges from 7920 feet to 8240 feet. Several faults appear to intersect at the spring site coming from the horst that transects the area.

During the site visit on October 3, 1997, Mr. Stamatakis pointed out a stand of aspen trees at the mouth of Coal Canyon, the same canyon in which the Gordon Creek #3 and #6 mine portals are located. A stand of aspen, all similar in age and occupying the valley floor, apparently died abruptly. Mr. Stamatakis claims that the ground surrounding the trees became saturated with groundwater produced as a result of mining, killing the trees. He proposed that the water issuing from the seeps came from Beaver Creek, reducing the flows in Beaver Creek and increasing the flow of Gordon Creek.

Blue Blaze #3 Mine
Sink/Slump Area
Horseshoe Spring
Gordon Creek #7 Mine
Gordon Creek #2 Mine
National Mine
Gordon Creek #3 Mine
Gordon Creek #6 Mine
Gordon Creek #8 Mine
Coal Canyon Spring
