From: "Michael Hansen" <Mhansen@rbgengineering.com>
To: <James_Kohler@blm.gov>, <Jeff_McKenzie@blm.gov>, <Stan_Perkes@blm.gov>, <Steve_Falk@blm.gov>, <steve_rigby@blm.gov>, <jllewelyn@co.carbon.ut.us>, <ecc@emerytelcom.net>, <sunny1@emerytelcom.net>, "Brad Price" <bprice@rbgengineering.com>, "Rob johnson" <robj@rbgengineering.com>, <bretdixon@utah.gov>, <davemarble@utah.gov>, <karlhouskeeper@utah.gov>, <marcstilson@utah.gov>, <pamgrubaughlittig@utah.gov>, <petehess@utah.gov>, <waynehedberg@utah.gov>, <dshaver@utahamerican.com>
Date: 8/21/2006 7:24:49 PM
Subject: Grassy Trail Dam Monitoring Information 08-19-06 Seepage Readings and Site Photos

GRASSY TRAIL DAM SEEPAGE READINGS

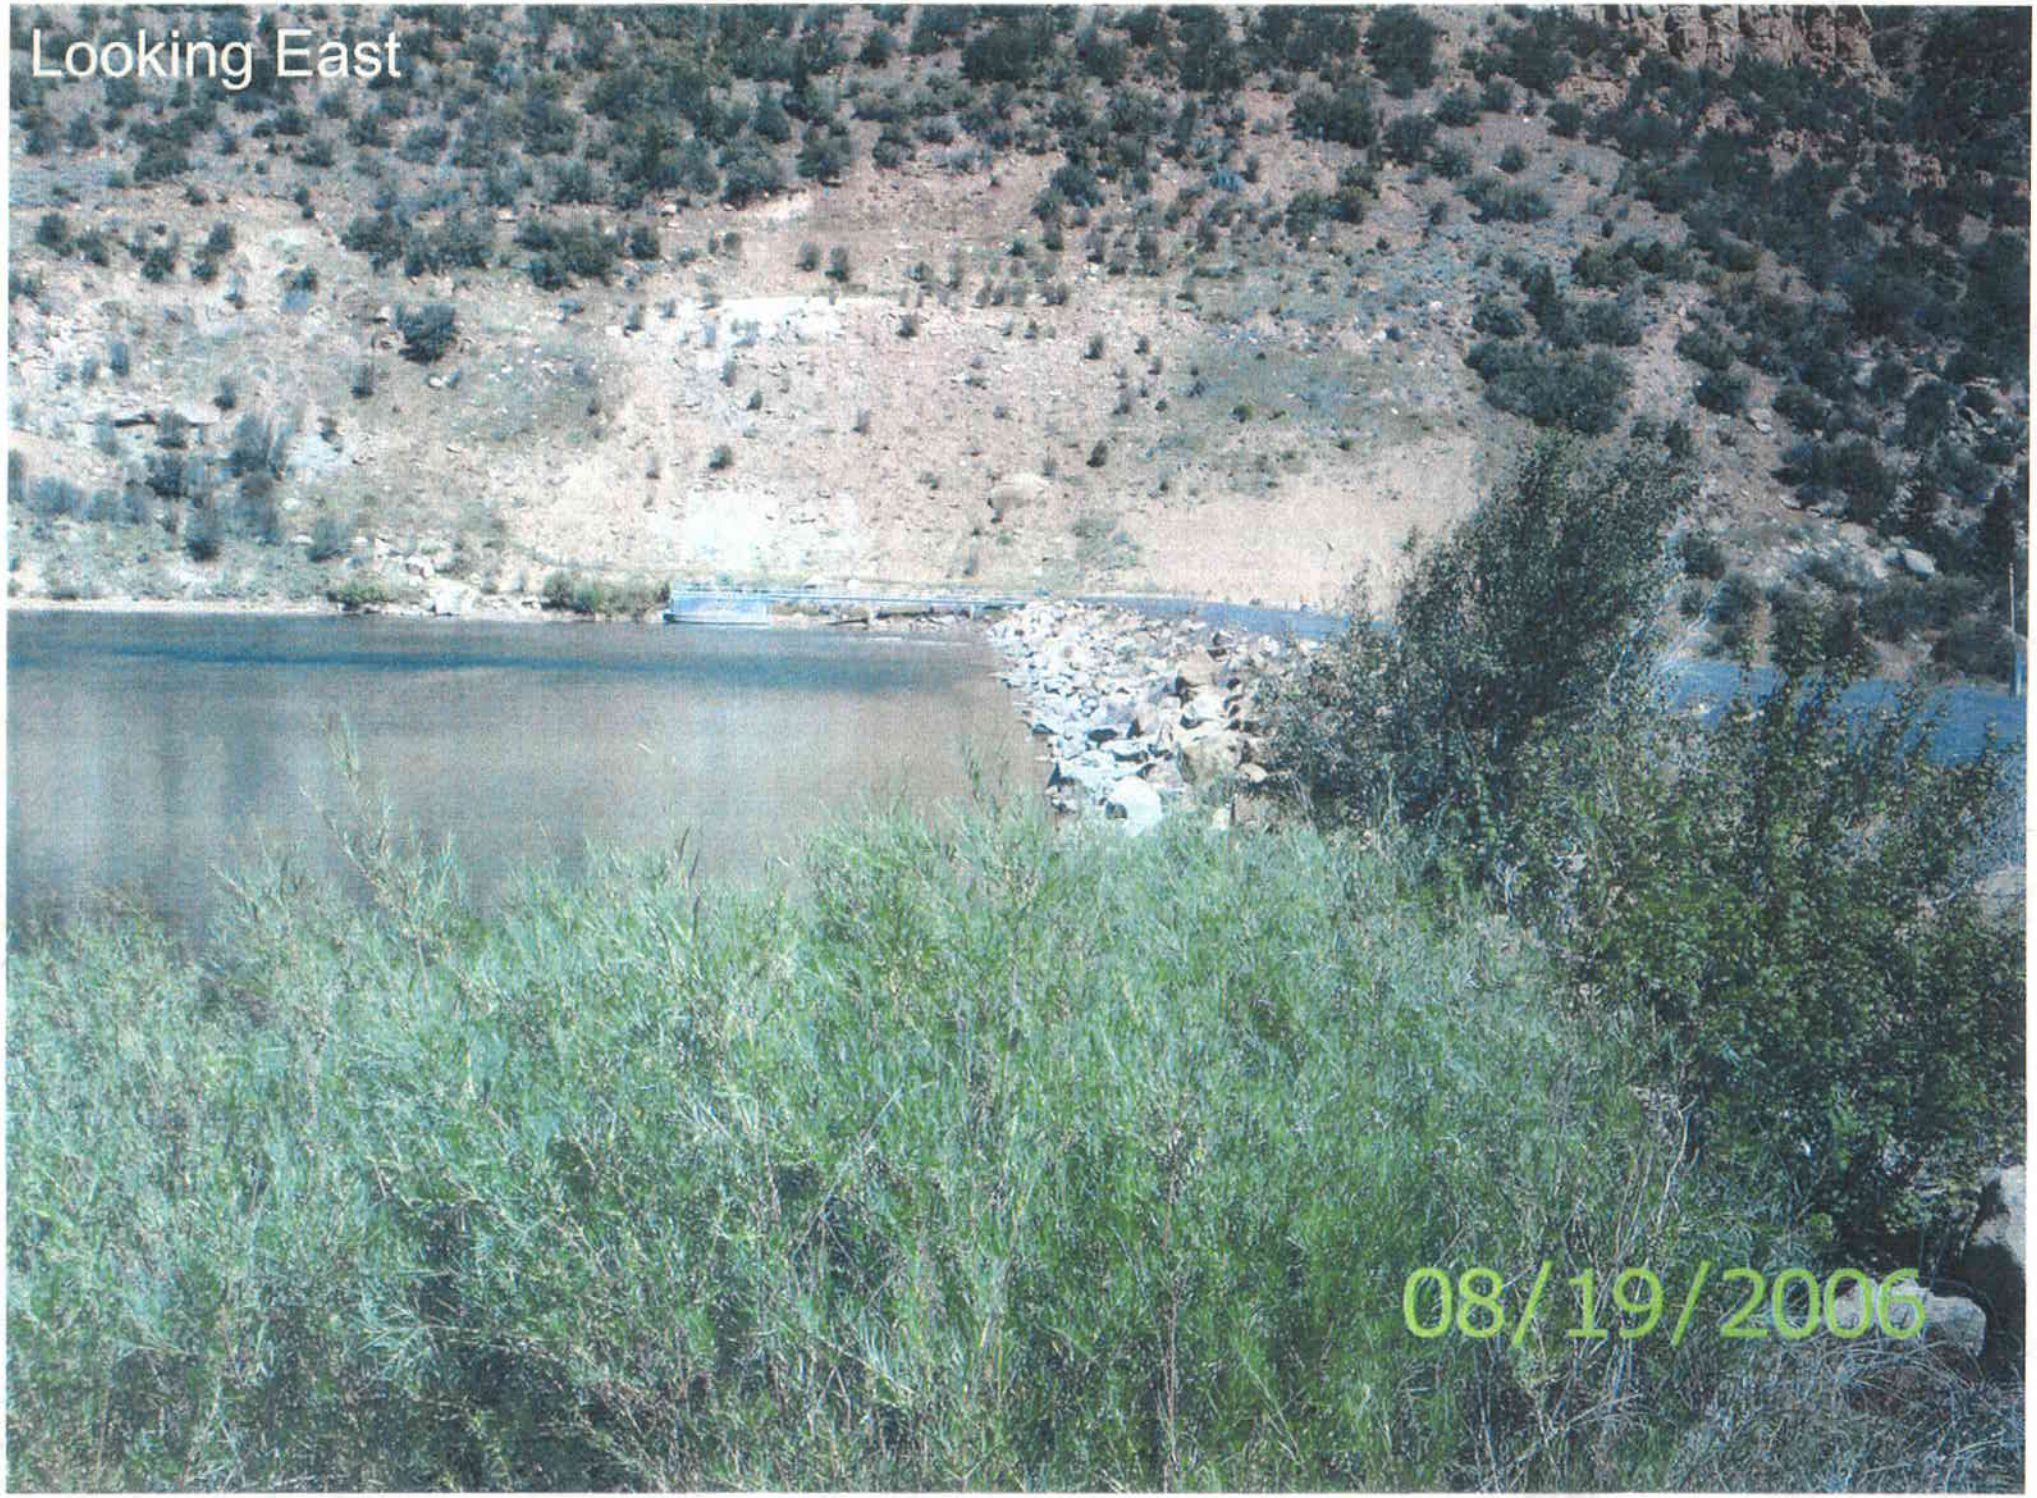
Looking West
08/19/2006
