Sunnyside Cogeneration Associates

RE: First Quarter 2006 Inspection Report
Star Point Refuse Pile C/007/042

INSPECTION AND CERTIFIED REPORT ON EXCESS SPOIL PILE OR REFUSE PILE		Coarse Refuse Pile
Permit Number	C/007/042	**Report Date 4/14/06**
Mine Name	STAR POINT WASTE FUEL	
Company Name	SUNNYSIDE COGENERATION ASSOCIATES	
Excess Spoil Pile or Refuse Pile Identification	**Pile Name:**	Coarse Refuse Pile
	Pile Number	N/A
	MSHA ID Number	Abandoned by MSHA Jan 2004
Inspection Date	March 9, 2006	
Inspected By	Rusty Netz	
Reason for Inspection (Annual, Quarterly or Other Periodic Inspection, Critical Installation, or Completion of Construction)		First Quarter Inspection 2006
		Attachments to Report? ☐ No X Yes

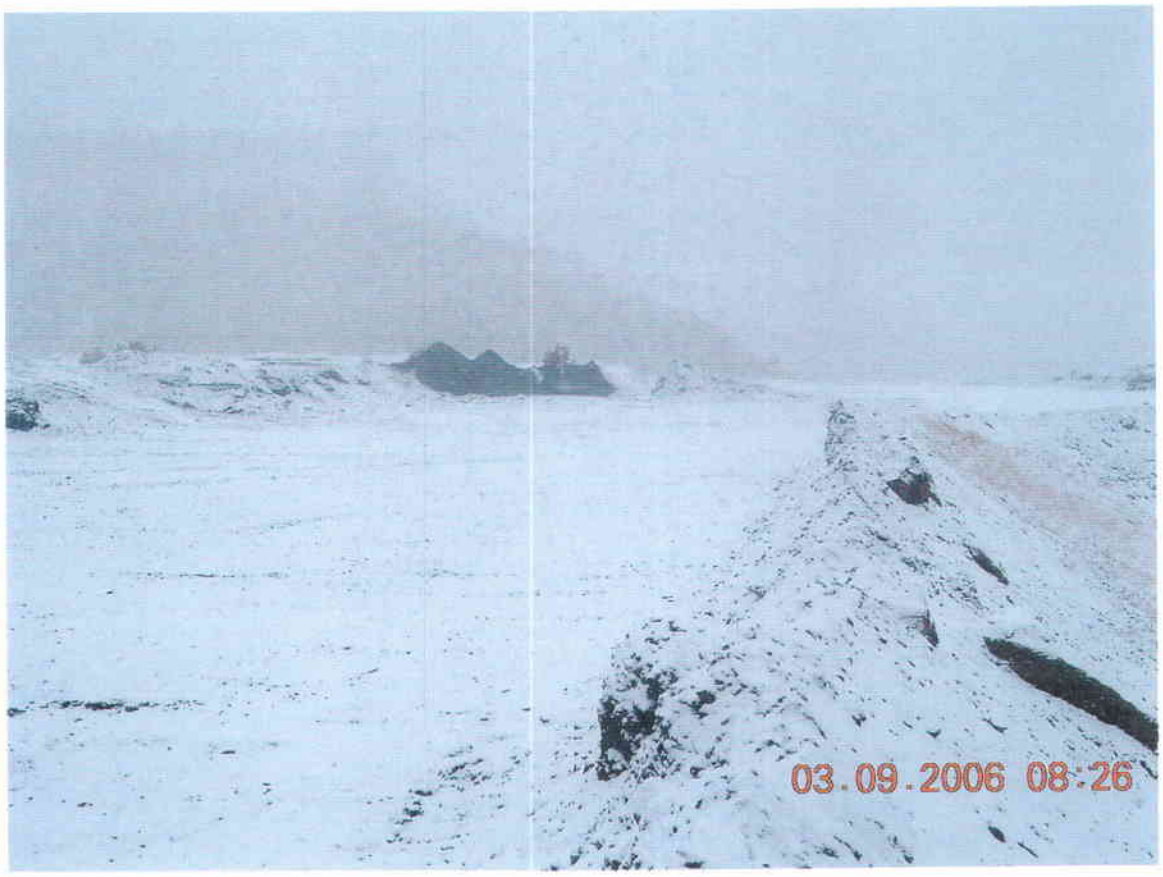
No smokers visible

Waste Coal Removal
Excavation and hauling operations are occurring from the top of the pile

Coarse Refuse Pile – looking easterly
