Sunnyside Cogeneration Associates

RE: Fourth Quarter 2007 Inspection Report
Star Point Refuse Pile C/007/042

IMPOUNDMENT INSPECTION AND CERTIFIED REPORT

Report Date	January 18, 2008
Permit Number	C/007/042
Mine Name	Star Point Waste Fuel
Company Name	Sunnyside Cogeneration Associates

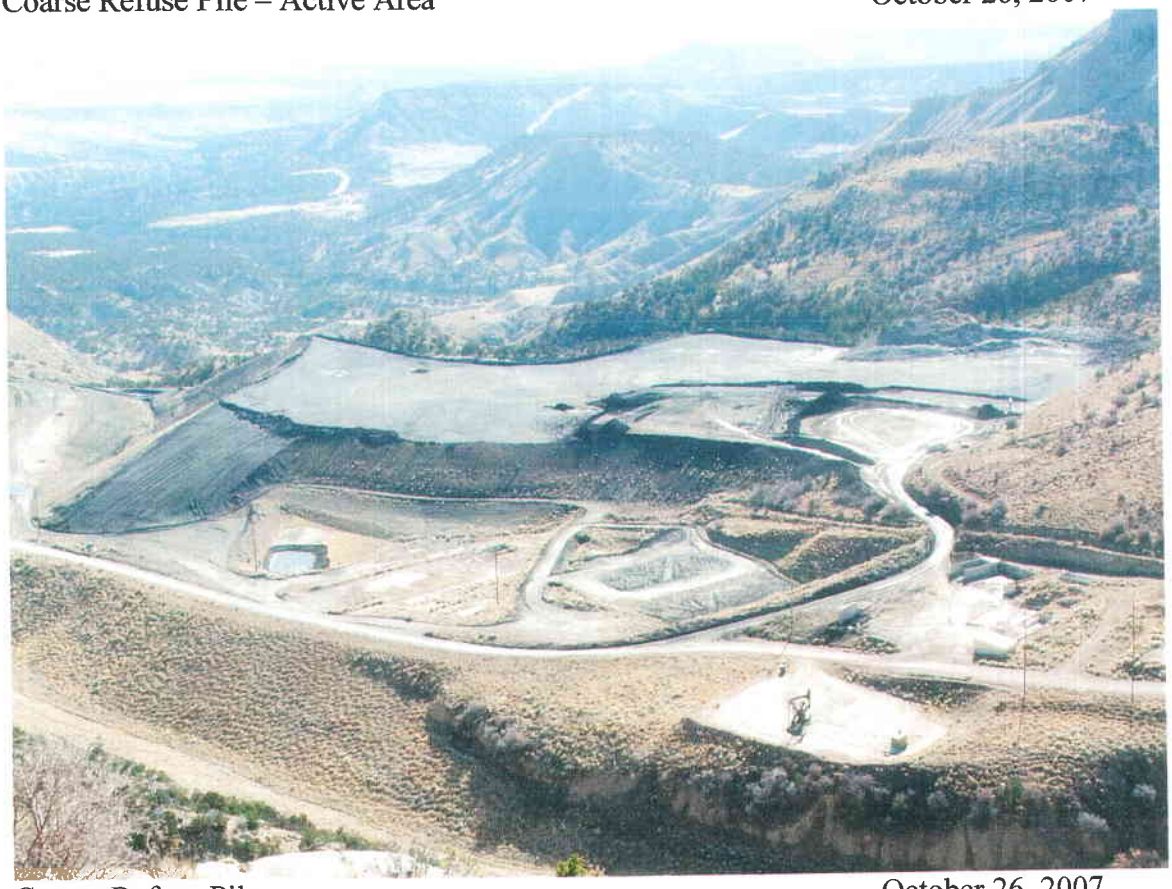
Refuse material is actively being excavated and removed from the top of the pile

Coarse Refuse Pile – Active Area October 26, 2007
