inspection report

Permit No. ACT/015/009
Inspection Date 7/31/90

Permittee/Operator Name Beaver Creek Coal Co.
Business Address P.O. Box 1378
City Price State Utt Zip 84501
Mine Trail Mtn #9 ☐ Surface ☒ Underground ☐ Other
County Emery State
Company Official(s) Dan Guy
State Official(s) Bill Malencik, John Pappus / OSM - Rad Crull
Time of inspection 7:00 ☒ a.m. ☐ p.m. to 6:00 ☐ a.m. ☒ p.m. ☐ Partial ☒ Complete
Date of last inspection 7/12/90 Weather conditions Clear / Warm
Acreage 1415 ☒ Permitted 88 ☐ Disturbed ☐ Regraded ☐ Seeded 88 ☒ Bonded
Enforcement Action None - TDNs on permit or paperwork (3)
✓ (Followup Items For The Operator's Attention)

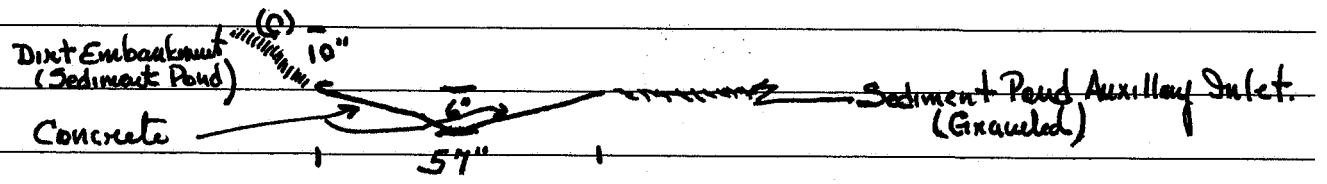
III. The Ditch Segement - lower Gate To & Into Sediment Pond (SKETCH).

Dimensions. The concrete lined ditch that drains the mine pad and lying adjacent to the chain link fence as shown in the mine plan is different than exists on the ground.

II. As Measured On The Ground

A = 10" B = 42"

The conditions on the ground indicated that the ditch as currently existing is adequately handling the runoff. It is suggested that the operator as a preventative measure provide protection. This should be done on the dirt embankment noted as (C) above, discussed with the Division hydrologist before any on the ground work is performed.

Also, the current map should be updated to show the correct measurements and ditch shape. Also, it should be noted that the lower segement while still a V shaped ditch is different than the upper ditch. Also, the culvert symbol should be deleted on the undisturbed diversion near the portal. Diversion noted herein were the subject of a TON issued by the oversight inspector.
