Inspection Report

Permit Number:	**C0150015**
Inspection Type:	COURTESY
Inspection Date:	Wednesday, February 25, 2015
Start Date/Time:	2/25/2015 1:30:00 PM
End Date/Time:	2/25/2015 3:30:00 PM
Last Inspection:	Thursday, February 19, 2015

Permitee: **CONSOL MINING COMPANY, LLC**
Operator: **CONSOL MINING COMPANY, LLC**
Site: **EMERY DEEP MINE**
Address: **1000 CONSOL ENERGY DRIVE, CANONSBURG PA 15317**
County: **EMERY**
Permit Type: **PERMANENT COAL PROGRAM**
Permit Status: **INACTIVE**

Technical Inspection Report #4118
February 25, 2015
Attachment A

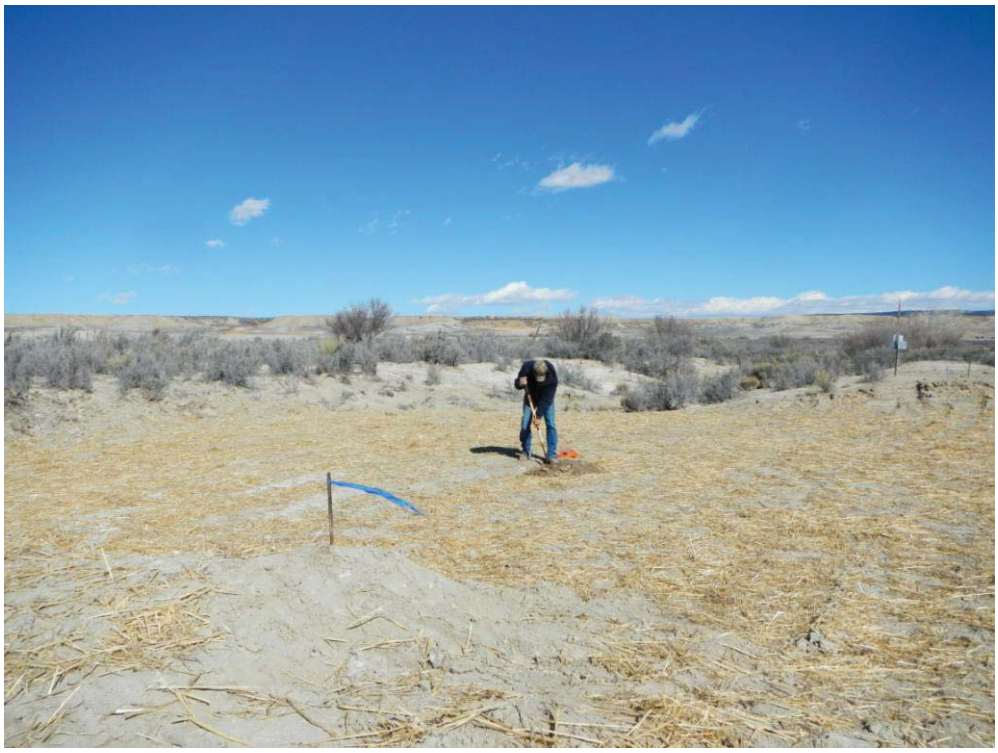
Pond #1 Subsoil Berm Photos

February 25, 2015. James Sage III sampling 0-6 and 6-12 inches at the pond #1 subsoil berm.

Both the graded and ungraded berm soils were moist below the surface.

A compacted layer was encountered six inches below the graded surface of the subsoil berm .
The image below is a close up of the sample location above.

The ring in the sample hole denotes the six inch depth and corresponds with increased compaction. It is likely that the original ground surface was encountered at six inches.
