EnergyWest Mining Co.

2002 ANNUAL REPORT

COTTONWOOD MINE C/015/019

DES-BEE-DOVE MINES C/015/017

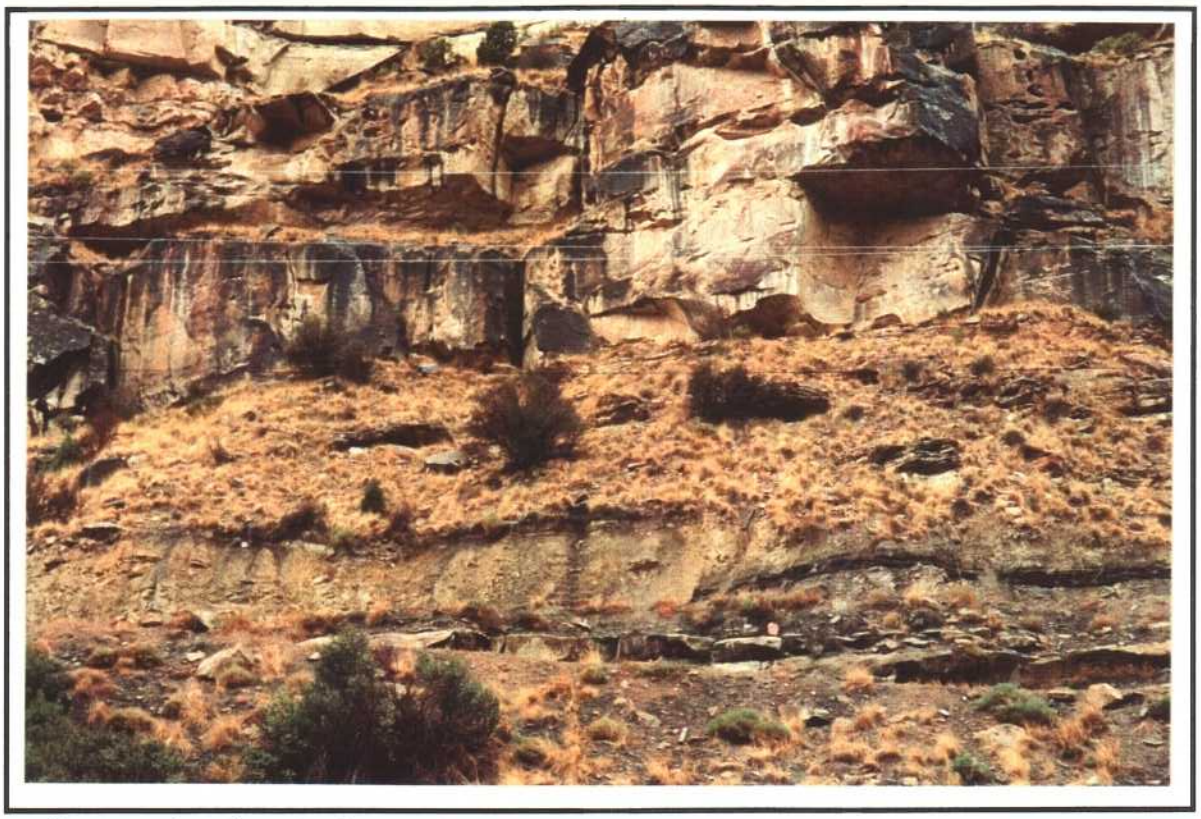
Trail Mountain Mine - Reference Area

2) Site had good cover comprising mostly of grasses

3) Diversity was fair..
