Annual Subsidence Monitoring Report
East/Trail Mountain Properties
2001

SUBSIDENCE MONITORING PROGRAM

ANNUAL REPORT FOR 2001

March, 2002

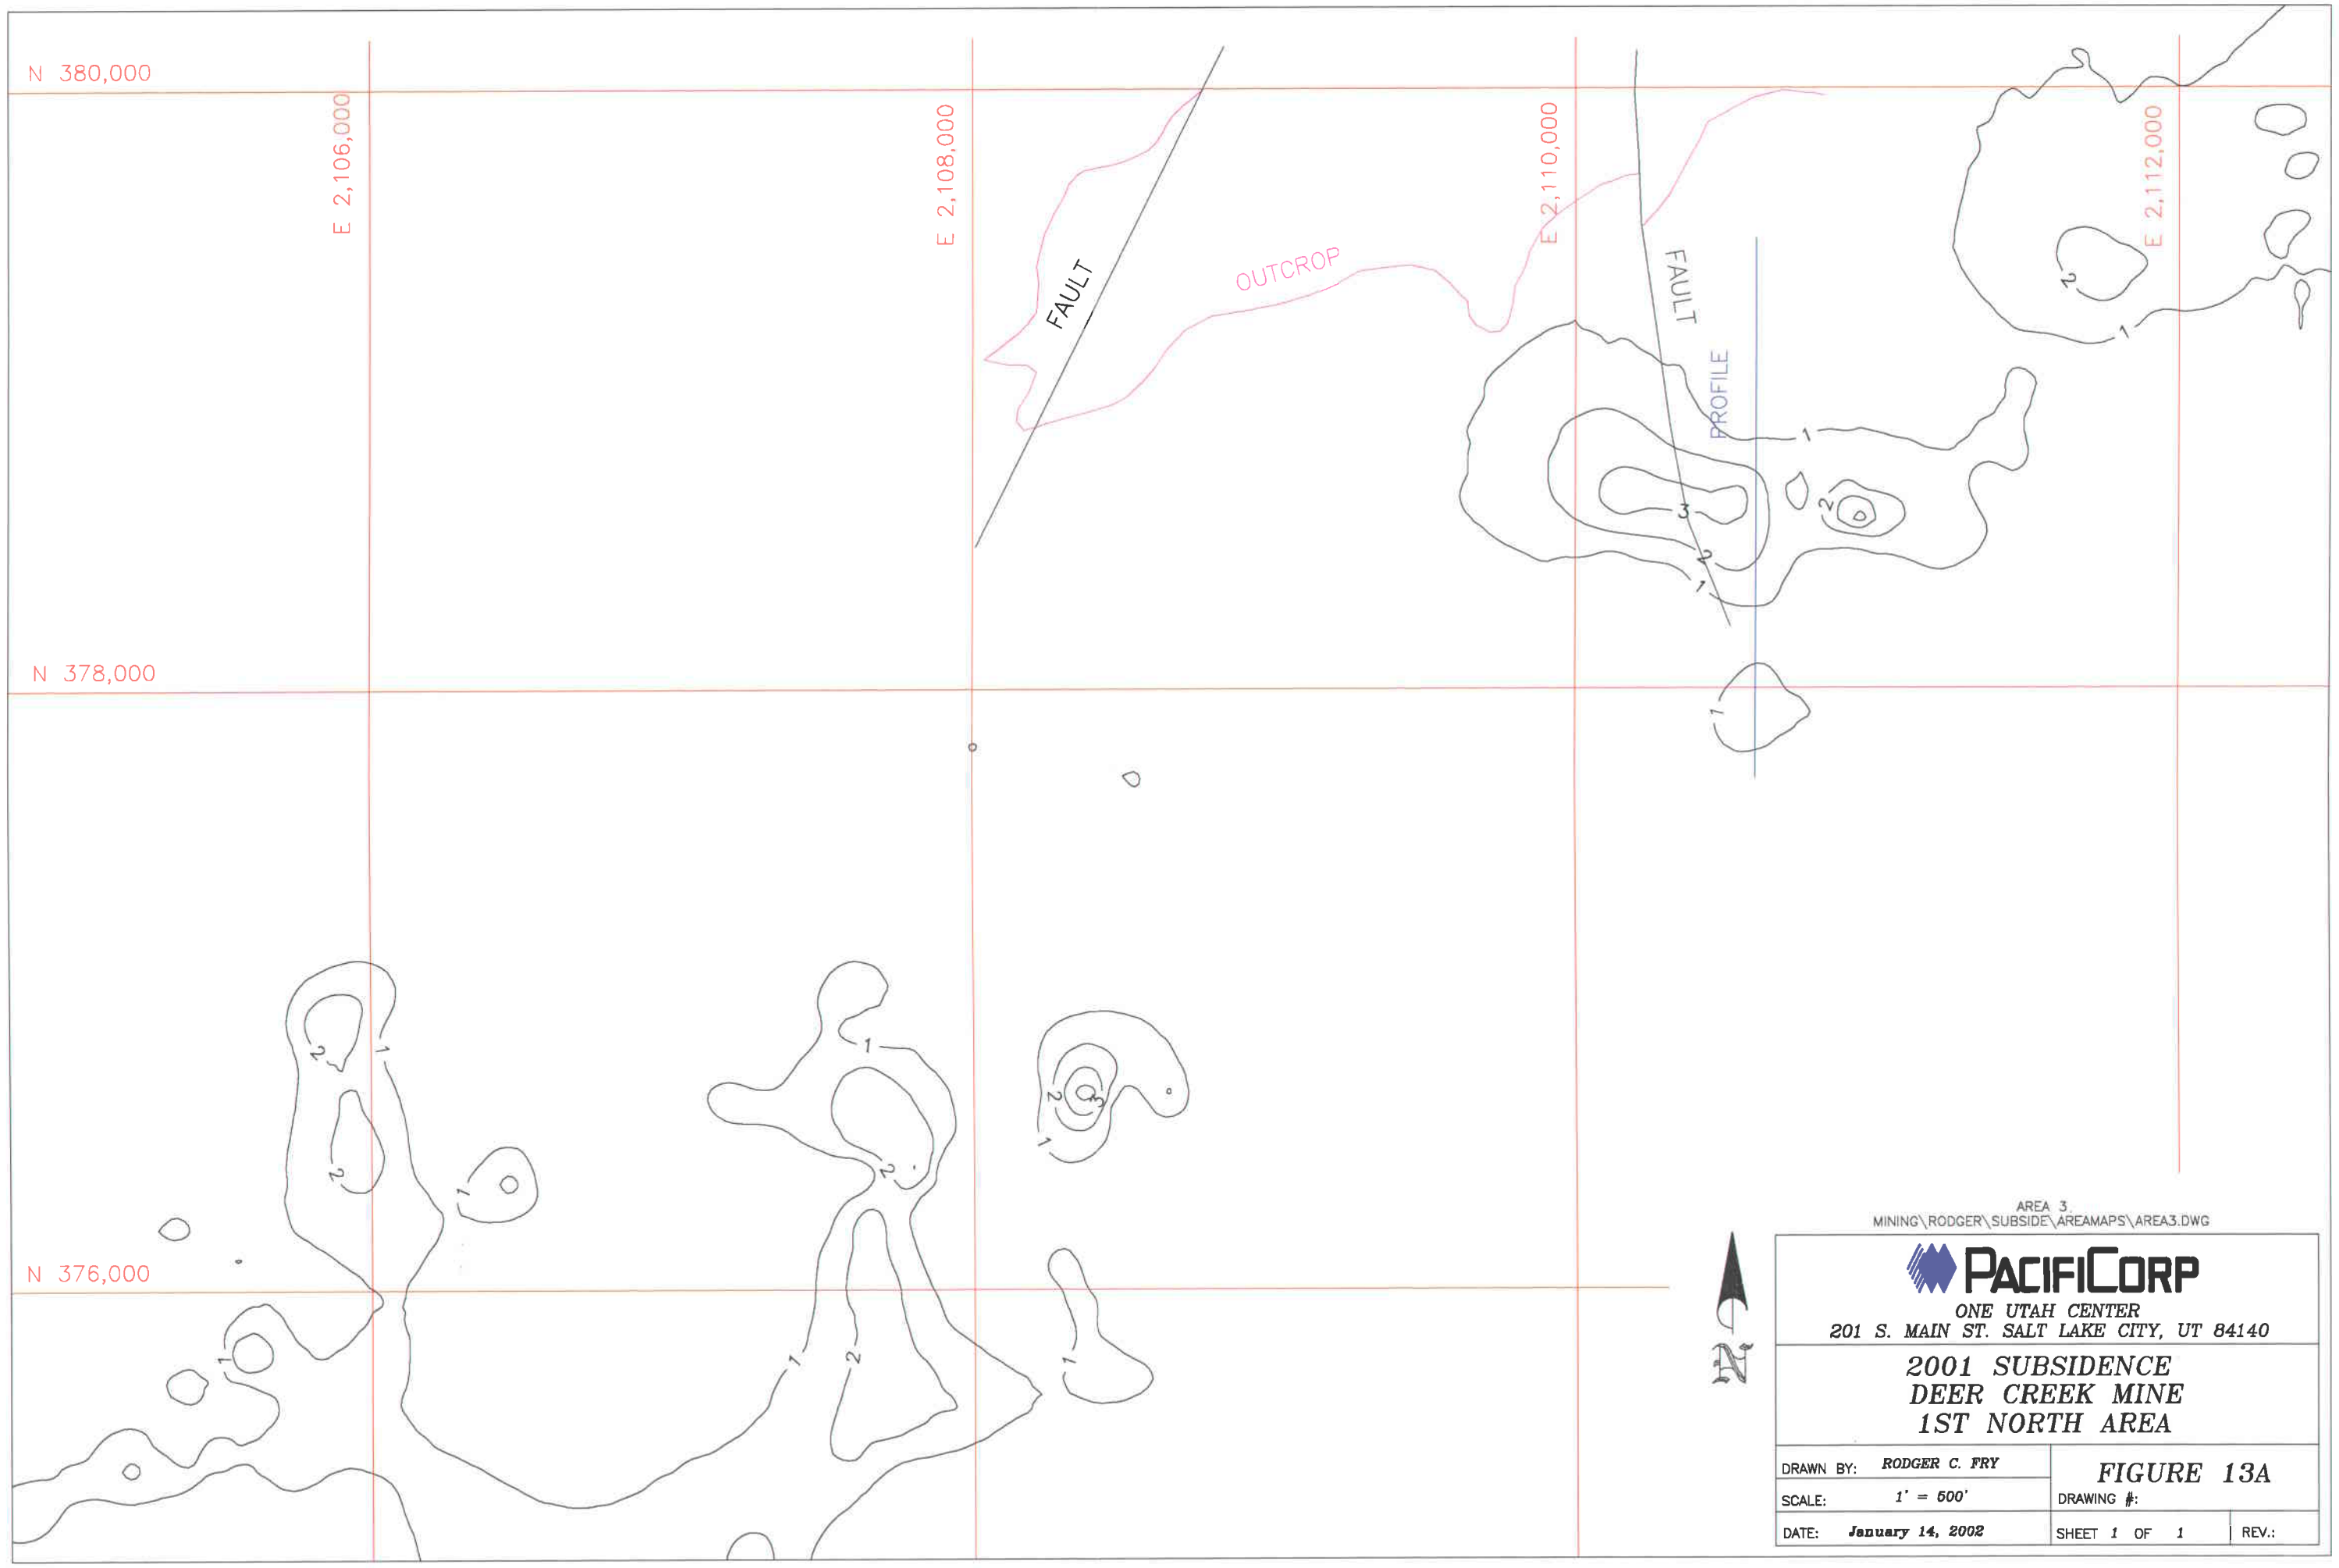
The subsidence above 1st North occurs on a narrow ridge capped by a highly fractured sandstone. The subsidence measured is depicted in Figure 13A. Figure 14 is a profile of total subsidence as it occurred along a line of points above the workings. The subsidence in area 3 has shown no significant change in the past 7 years.

A Helicopter survey in 2001 did not reveal any new surface cracks or new areas of cliff failure.
