C. MANGUM
STATE OF UTAH
CO-OP MINING CO.
MINE WATER SURVEY
SCALE: 1" = 500'
DRAWN BY: C. Reynolds
DATE: 01-01-95
BEAR CANYON
PLATE 7-10A

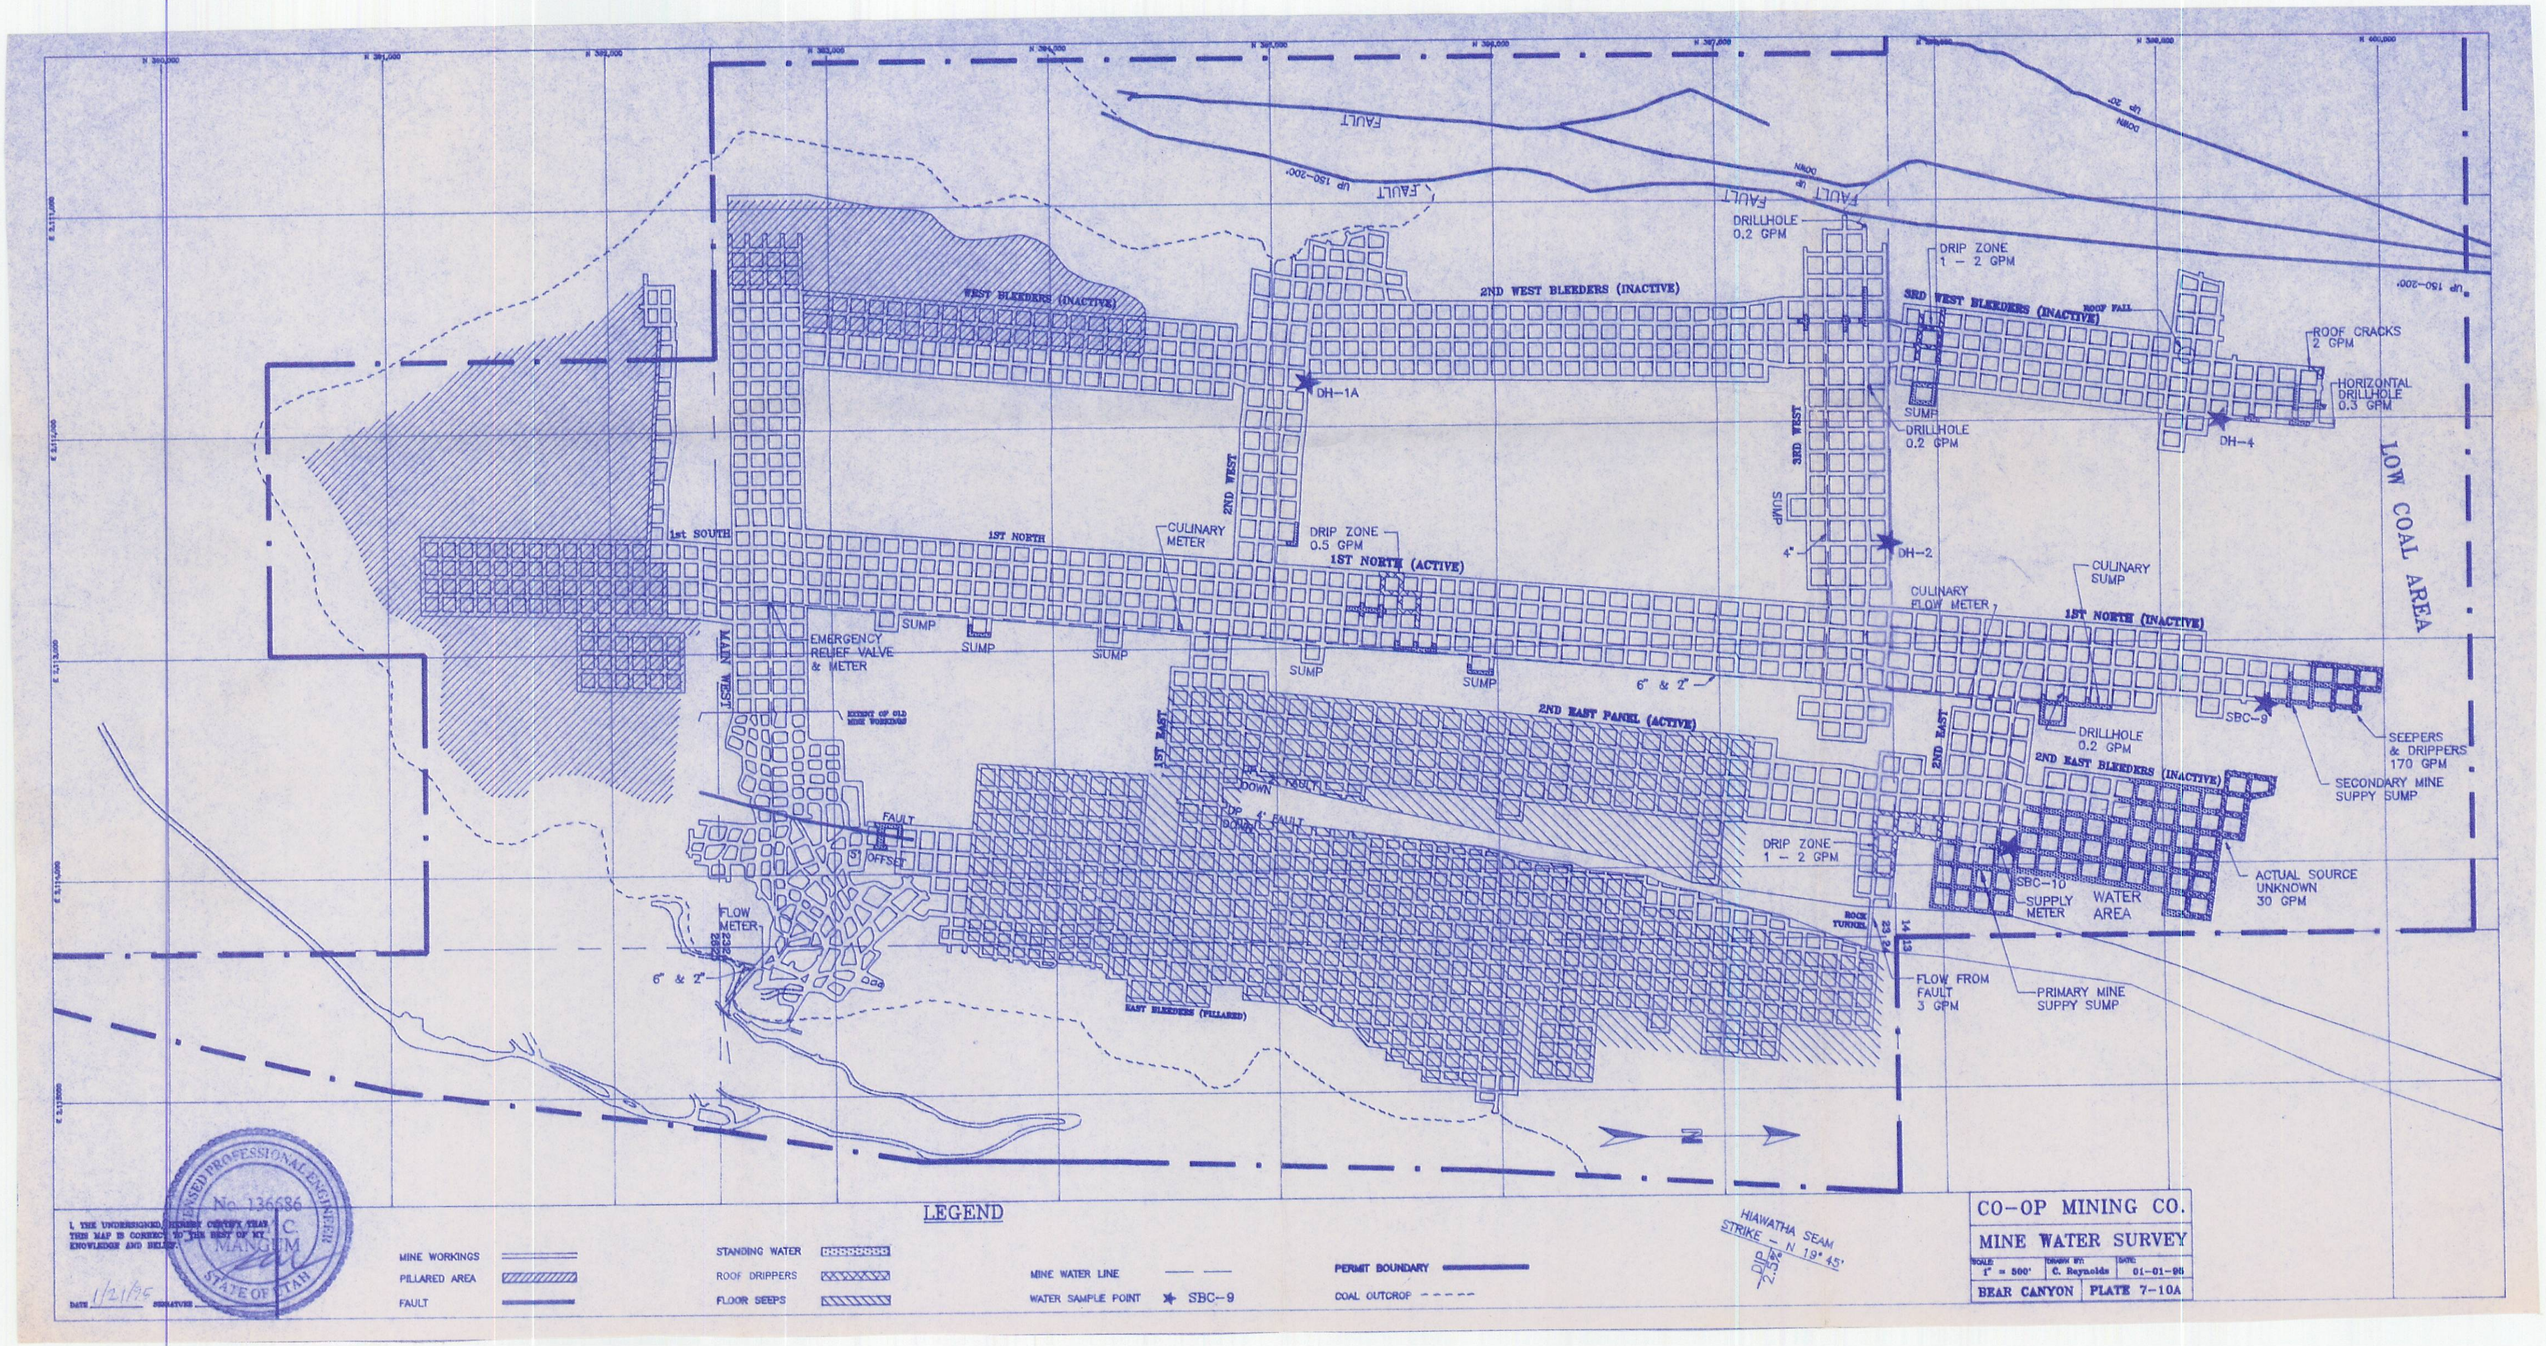
FAULT
UP 150-200'
DOWN
UP 20'
DRILLHOLE 0.2 GPM
DRIP ZONE 1 - 2 GPM
WEST BLEEDERS (INACTIVE)
2ND WEST BLEEDERS (INACTIVE)
3RD WEST BLEEDERS (INACTIVE)
ROOF FALL
ROOF CRACKS 2 GPM
HORIZONTAL DRILLHOLE 0.3 GPM
DH-1A
DH-4
SUMP
DRILLHOLE 0.2 GPM
3RD WEST
2ND WEST
LOW COAL AREA
1st SOUTH
1ST NORTH
CULINARY METER
DRIP ZONE 0.5 GPM
1ST NORTH (ACTIVE)
DH-2
4"
CULINARY SUMP
CULINARY FLOW METER
1ST NORTH (INACTIVE)
MAIN WEST
EMERGENCY RELIEF VALVE & METER
SUMP
6" & 2"
2ND EAST PANEL (ACTIVE)
SBC-9
SEEPERS & DRIPPERS 170 GPM
SECONDARY MINE SUPPY SUMP
DRILLHOLE 0.2 GPM
2ND EAST BLEEDERS (INACTIVE)
1ST EAST
2ND EAST
EXTENT OF OLD MINE WORKINGS
FAULT
5' OFFSET
DRIP ZONE 1 - 2 GPM
SBC-10
SUPPLY METER
WATER AREA
ACTUAL SOURCE UNKNOWN 30 GPM
FLOW METER
6" & 2"
ROCK TUNNEL
FLOW FROM FAULT 3 GPM
PRIMARY MINE SUPPY SUMP
EAST BLEEDERS (PILLARED)
N
LEGEND
MINE WORKINGS
PILLARED AREA
FAULT
STANDING WATER
ROOF DRIPPERS
FLOOR SEEPS
MINE WATER LINE
WATER SAMPLE POINT
SBC-9
PERMIT BOUNDARY
