C015/0025

Bear Cyn Mine 1/22/2003 5 Photos
NO3-46-2-2, 1 of 2
Exposed Outslope Reporting To Bear Creek
Note extensive acreage of untreated runoff.

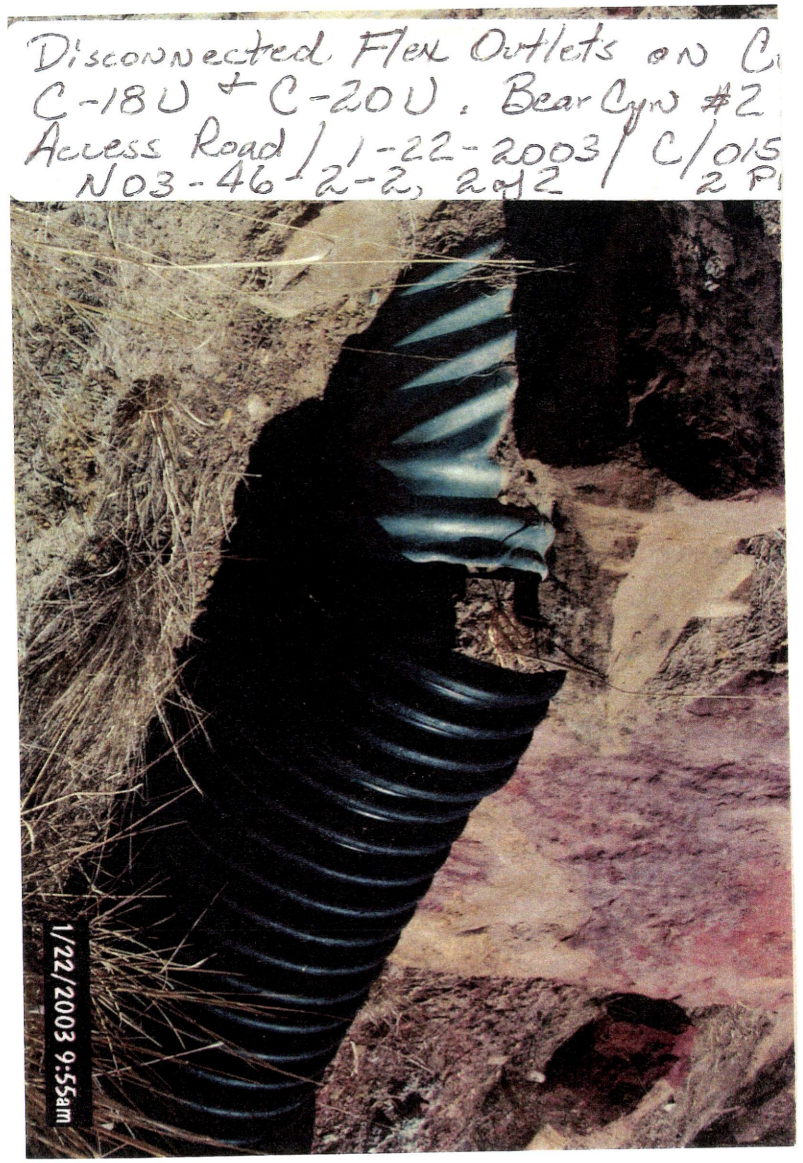
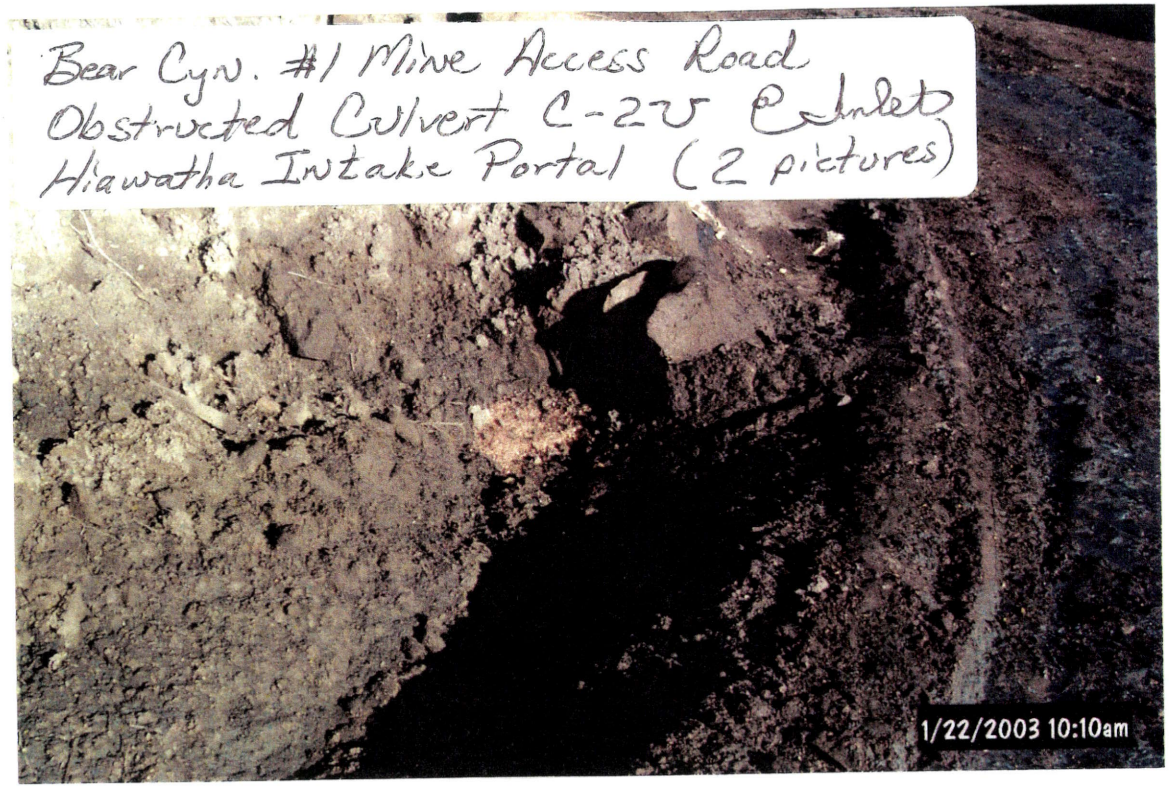
Bear Cyn. #1 Mine Access Road
Obstructed Culvert C-27 @ Inlet
Hiawatha Intake Portal (2 pictures)
1/22/2003 10:10am

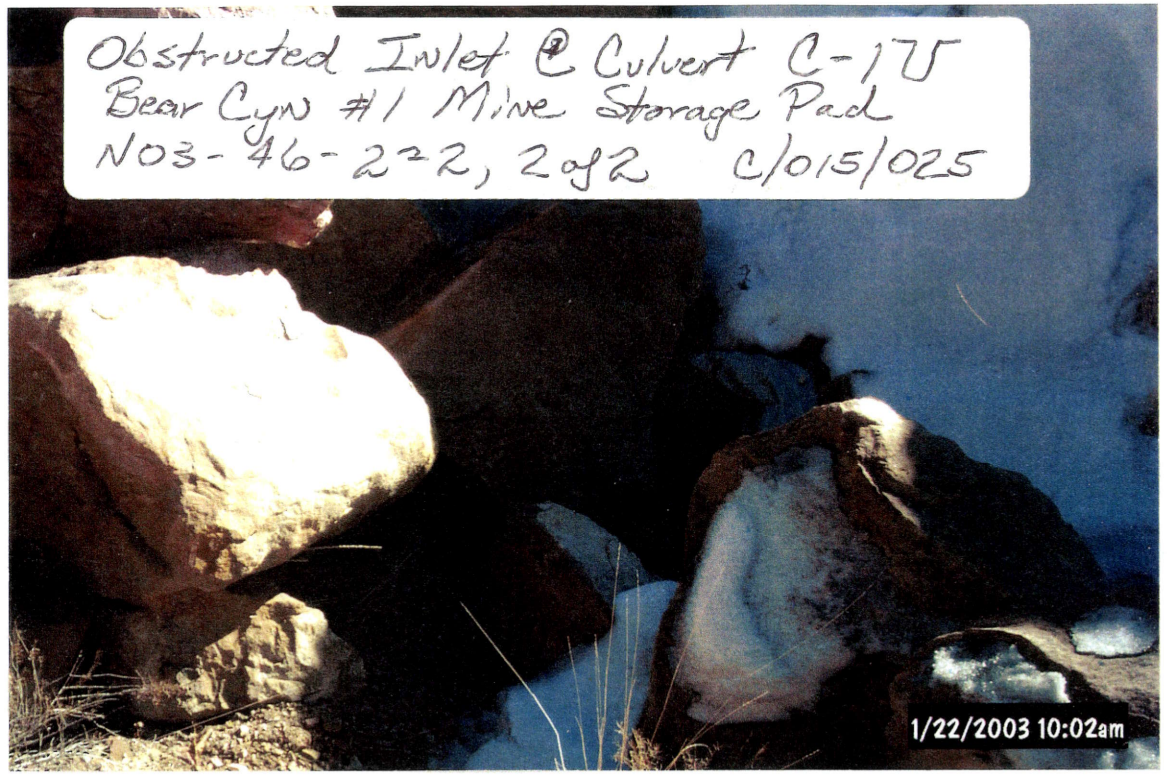
Obstructed Inlet @ Culvert C-17
Bear Cyn #1 Mine Storage Pad
N03-46-2-2, 2 of 2 C/015/025
1/22/2003 10:02am

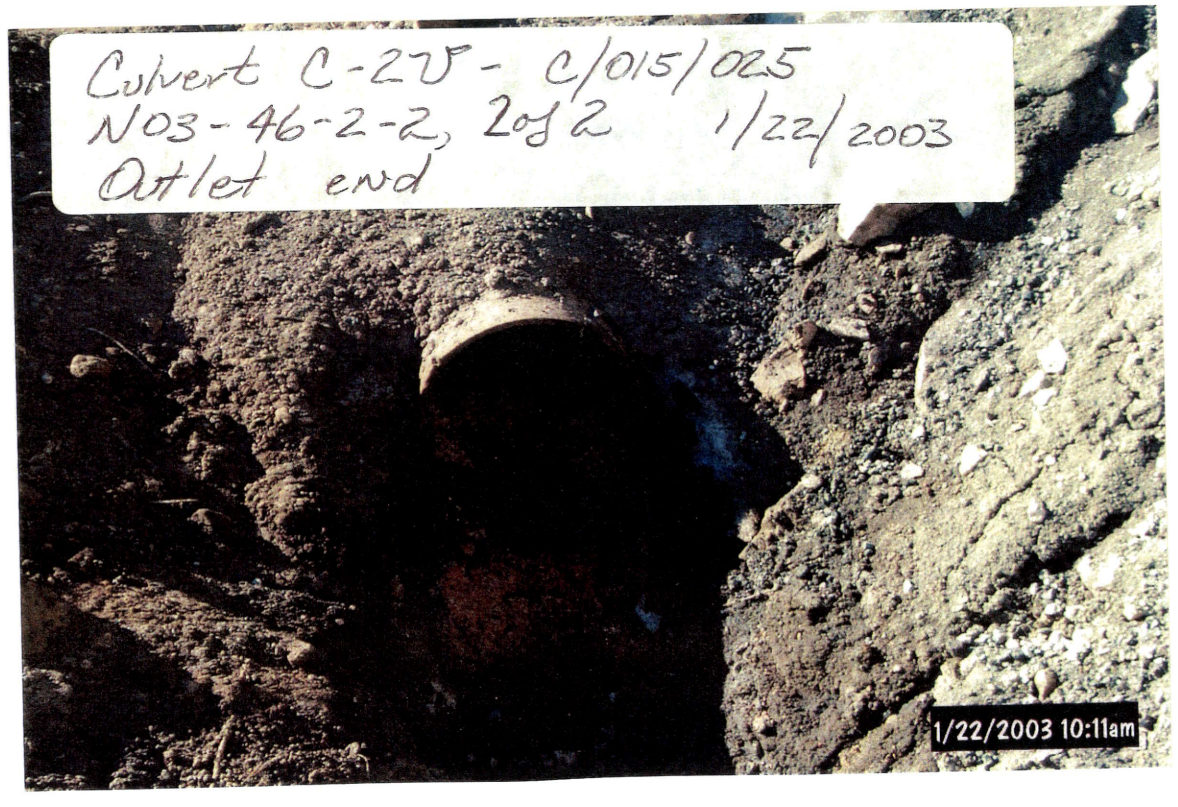
Culvert C-27 - C/015/025
N03-46-2-2, 2 of 2 1/22/2003
Outlet end
1/22/2003 10:11am
