Subject: 2012 Annual Report Submittal for Castle Va Mining LLC Bear Canyon Mine, C/015/0025

Annual Report

RHINO - CASTLE VALLEY MINING, LLC
October 2012 - Annual Subsidence Survey

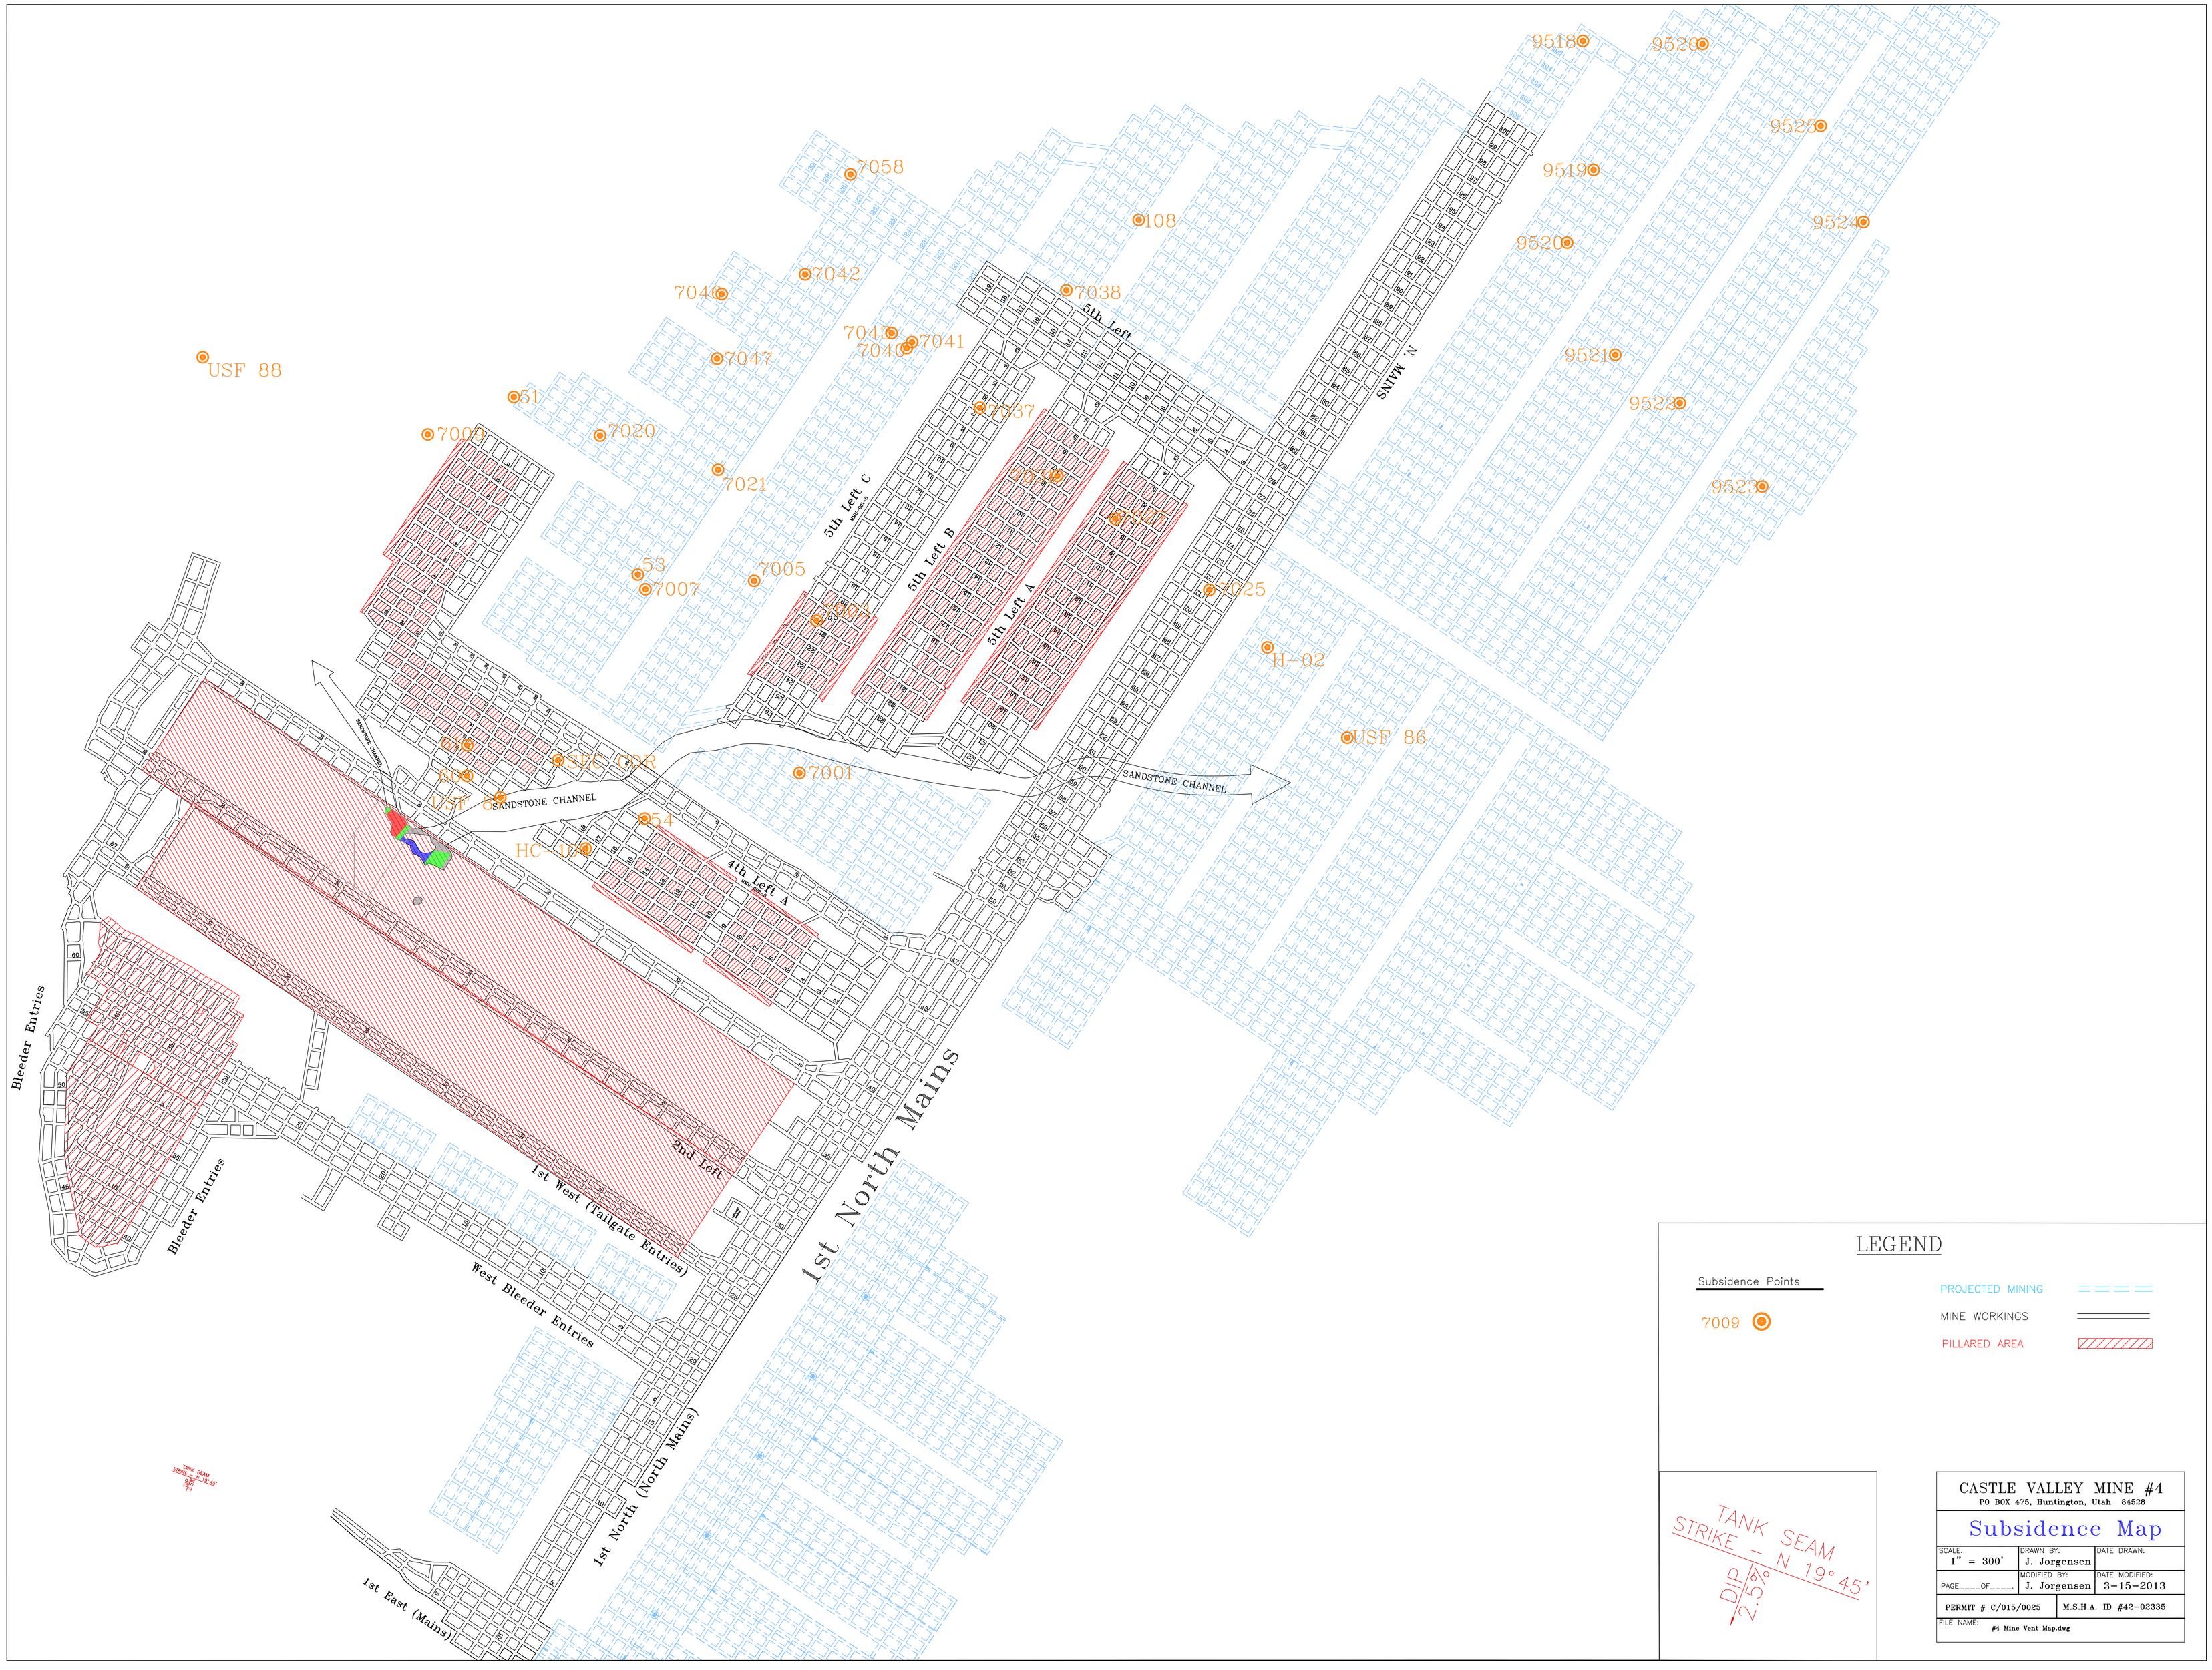
Subsidence Map & Data: This map shows all of the surveyed monitoring locations in relationship to the underground workings in PDF format. Survey monitored data is attached as well in PDF format.

A SUBSIDENCE MAP IN PDF FORMAT WILL BE ATTACHED. ALSO ATTACHED WILL BE THE MONITORING DATA

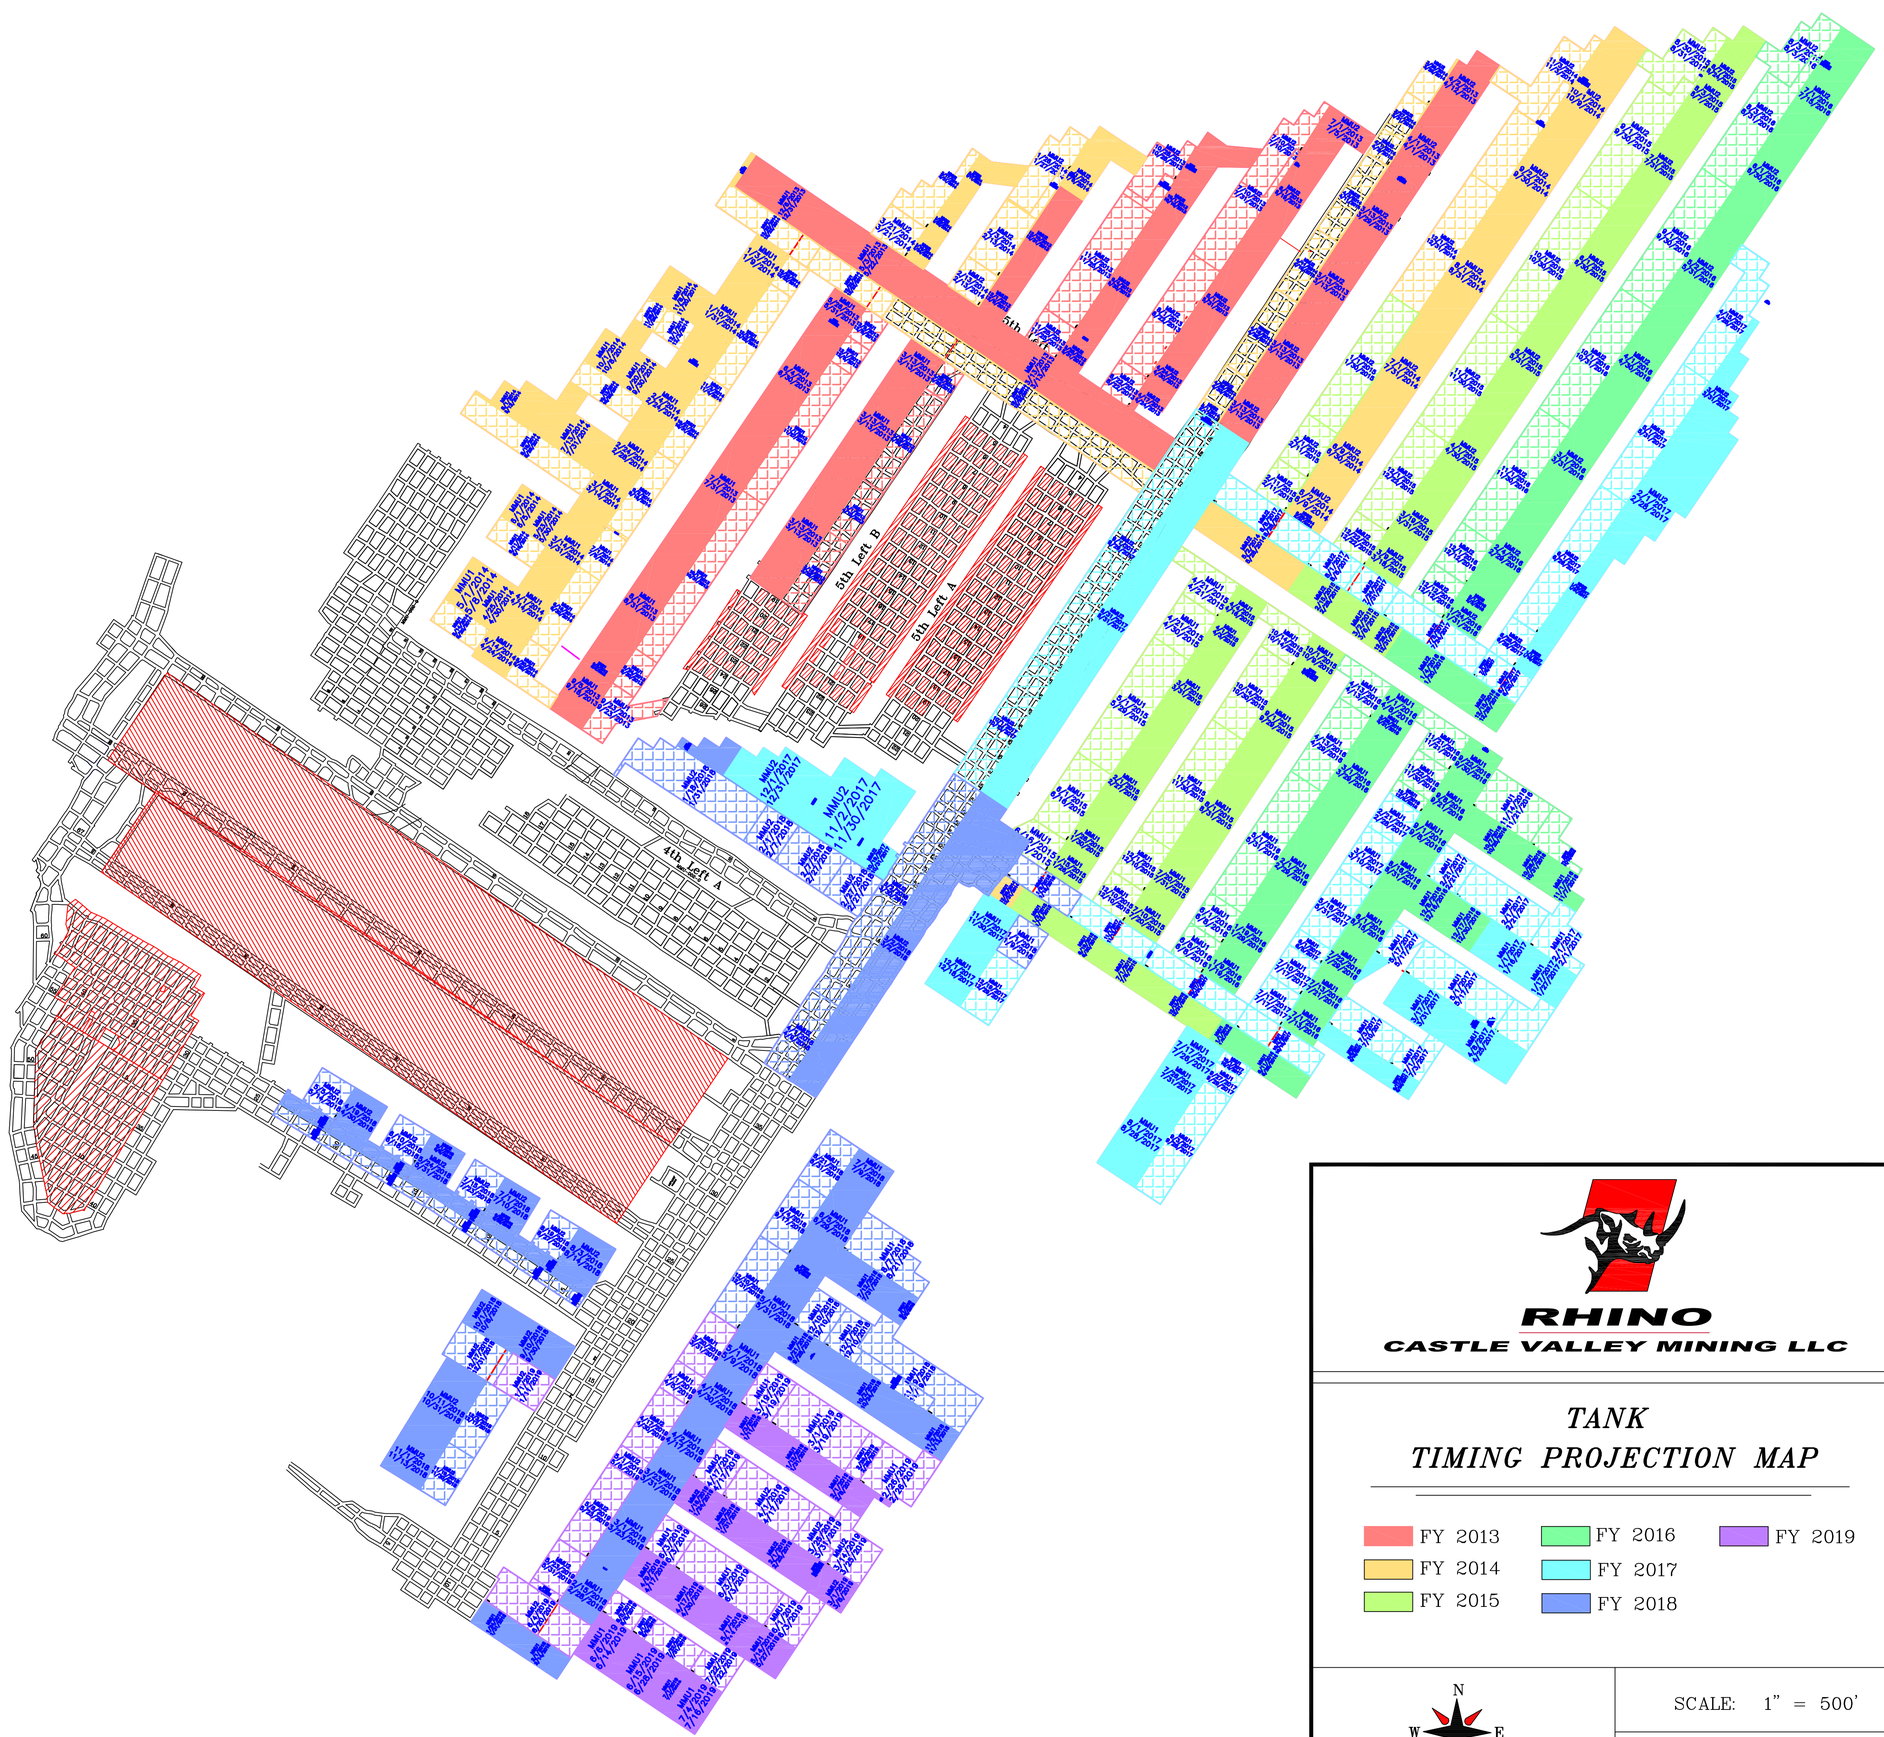
TANK
TIMING PROJECTION MAP

Projected Mining maps: This map shows more than five years of projected mining in PDF format. A PE certified map will be coming via ground mail to follow.
