OGMCOAL - Crandall pond cleaning-10046

UtahAmerican Energy, Inc.
2009 Crandall Canyon Mines
~~2008~~ Annual Pond Certification Report

SUPPLEMENTAL POND CERTIFICATION - POST CLEANING

POND: Sediment Pond LOCATION: Crandall Canyon Mines

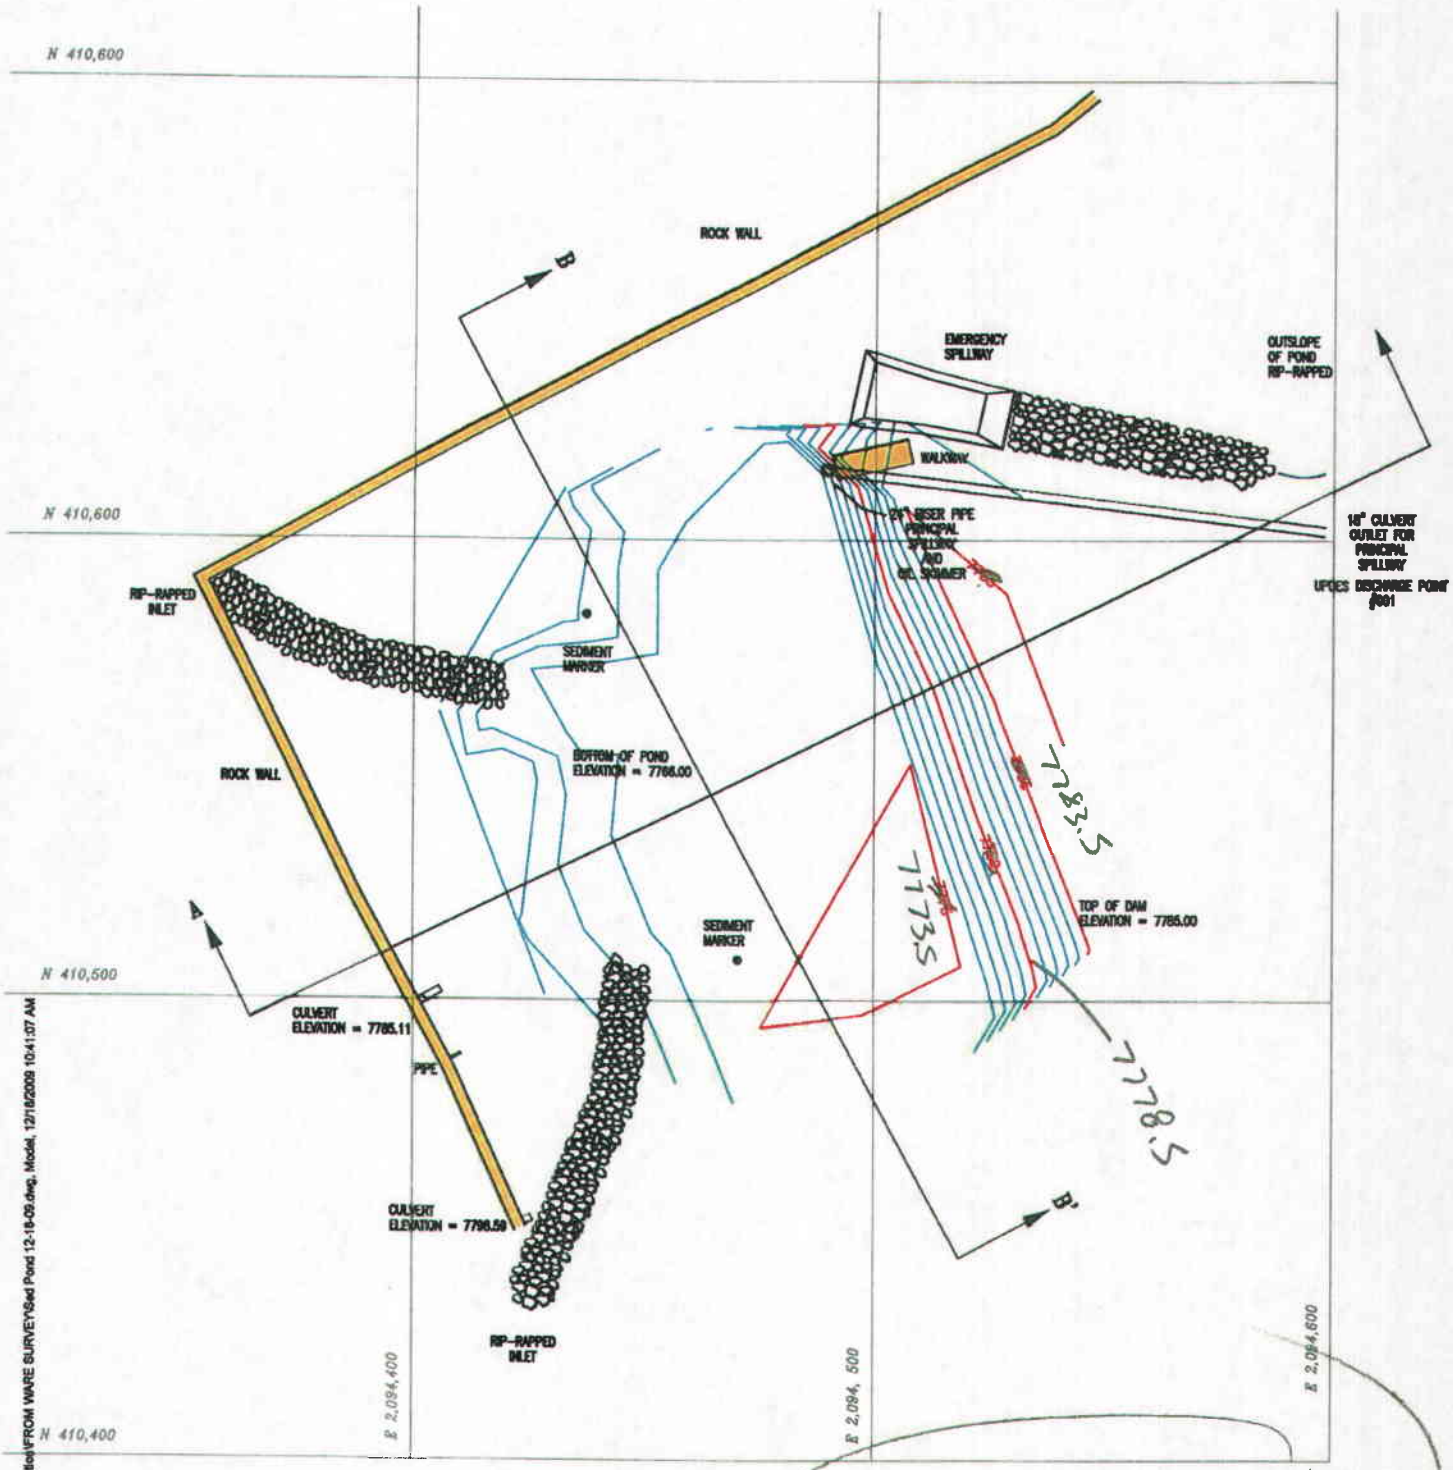
pre-clearing contours
July 2009

LOCATION:	ELEVATION:	VOLUME:
BOTTOM OF POND:	7766.00	0.000 AC. FT.
SEDIMENT CLEANOUT LEVEL:	7769.00	0.290 AC. FT.
MAXIMUM SEDIMENT LEVEL:	7770.00	0.437 AC. FT.
PRINCIPAL SPILLWAY:	7780.81	2.513 AC. FT.
EMERGENCY SPILLWAY:	7781.81	3.936 AC. FT.

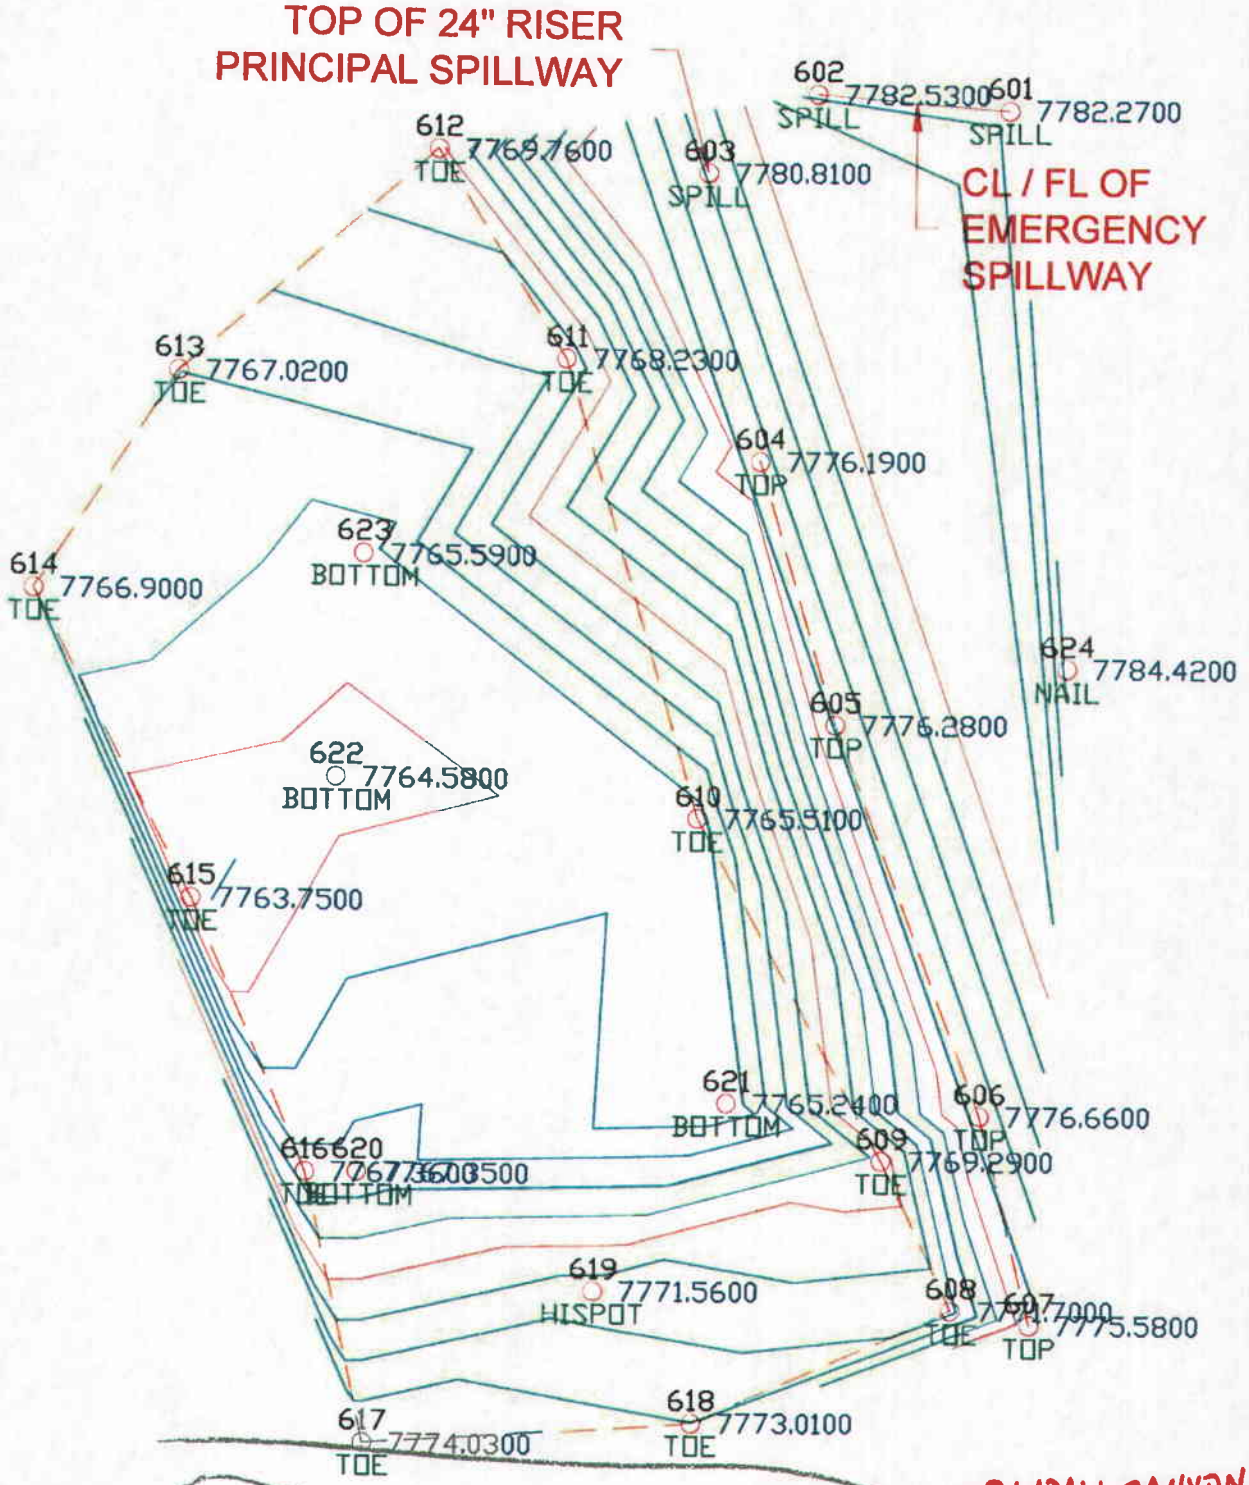
Post clearing contours
Dec 16, 2009

7763.75

CRANDALL CANYON
SEDIMENT POND SURVEY
DATE: 12/11/09
SCALE: 1":20'
