WATER QUALITY MEMORANDUM

Utah Coal Regulatory Program

December 26, 2019

RE: 2nd Quarter 2019 Water Monitoring, Genwal Resources, Inc., Crandall Canyon Mine, C/015/0032 Task ID #5941

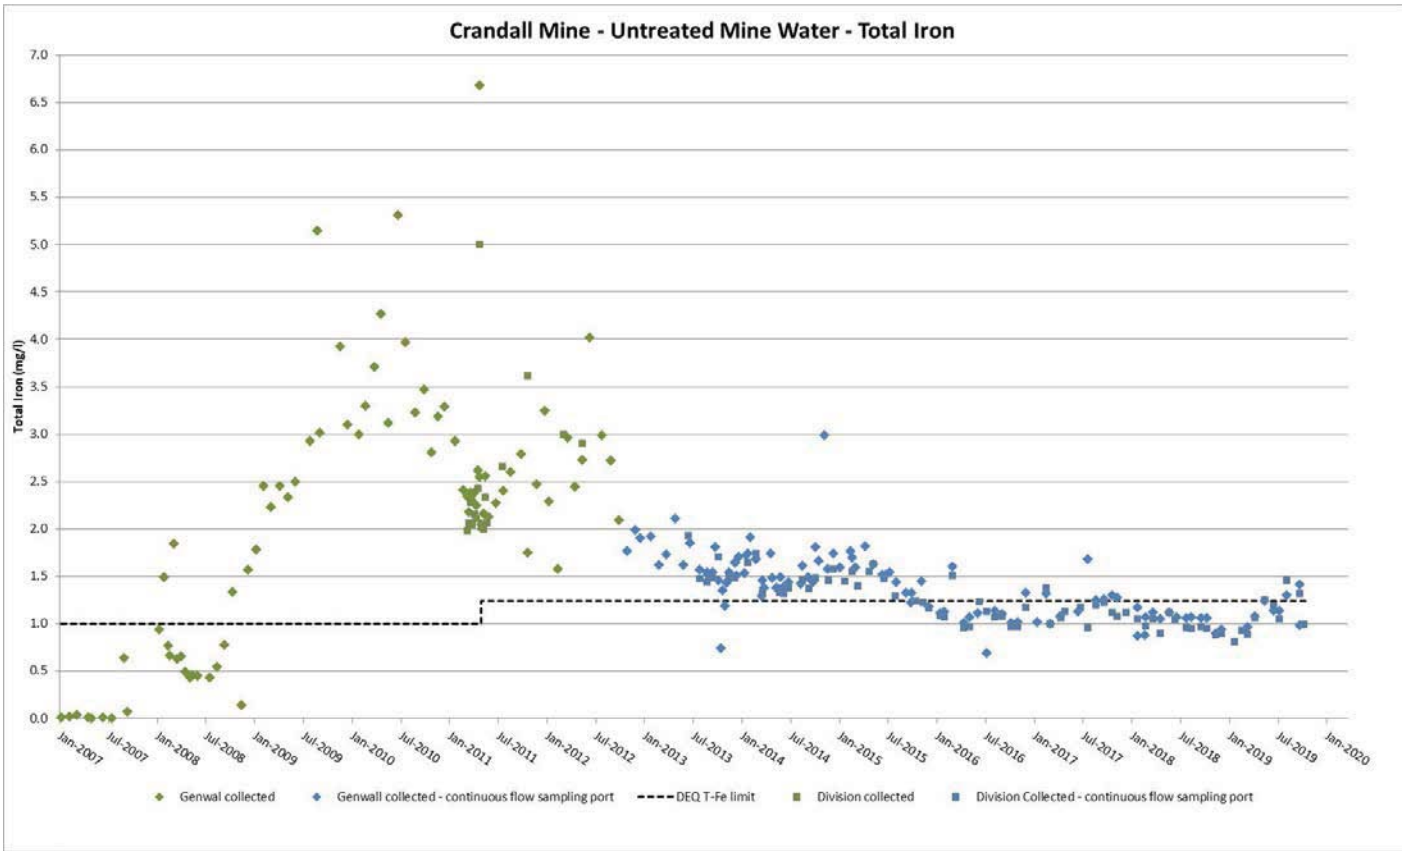
The total iron concentrations in the pre-treatment mine water for 2nd quarter 2019 were compliant to the 1.24 mg/L UPDES limit but were higher than levels than had been seen over the last 6 months. The three Genwal sampling events for this quarter in April, May, and June yielded total iron concentrations of 1.08, 1.24, and 1.14 mg/L, respectively. The graph provided below displays total iron trends.

Continued monitoring of the mine-water discharge is necessary to evaluate the need for any future treatment of the discharge. Therefore, it is critical to submit timely sampling results for pre-treatment (Pre-002) and Outfall 002 to DOGM, as required by Appendix 7-65.
