State of Utah
DEPARTMENT OF NATURAL RESOURCES

Division of Oil, Gas and Mining

Inspection Report

Permitee: **ALTON COAL DEVELOPMENT LLC**
Operator: **ALTON COAL DEVELOPMENT LLC**
Site: **COAL HOLLOW**
Address: **463 North 100 West, Suite 1, CEDAR CITY UT 84720**
County: **KANE**
Permit Type: **PERMANENT COAL PROGRAM**
Permit Status: **ACTIVE**

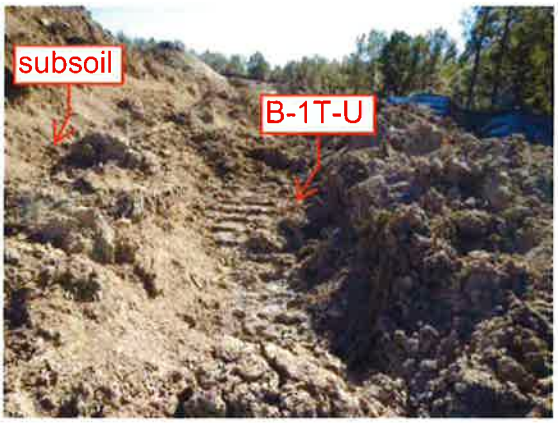
Looking N at topsoil piled along siltfence and subsoil pile berm and ditch B-1T-U
