Coastal States Energy Company

Re: Extension of Time to Comply
with Violation Abatements.
Notice Violation No. N 80-1-13-2
Violation Nos. 1 & 2

Re: Southern Utah Fuel Company
Convulsion Canyon Mine
ACT/041/002
Sevier County, Utah

SEDIMENTATION POND
AND APPURTENANCES

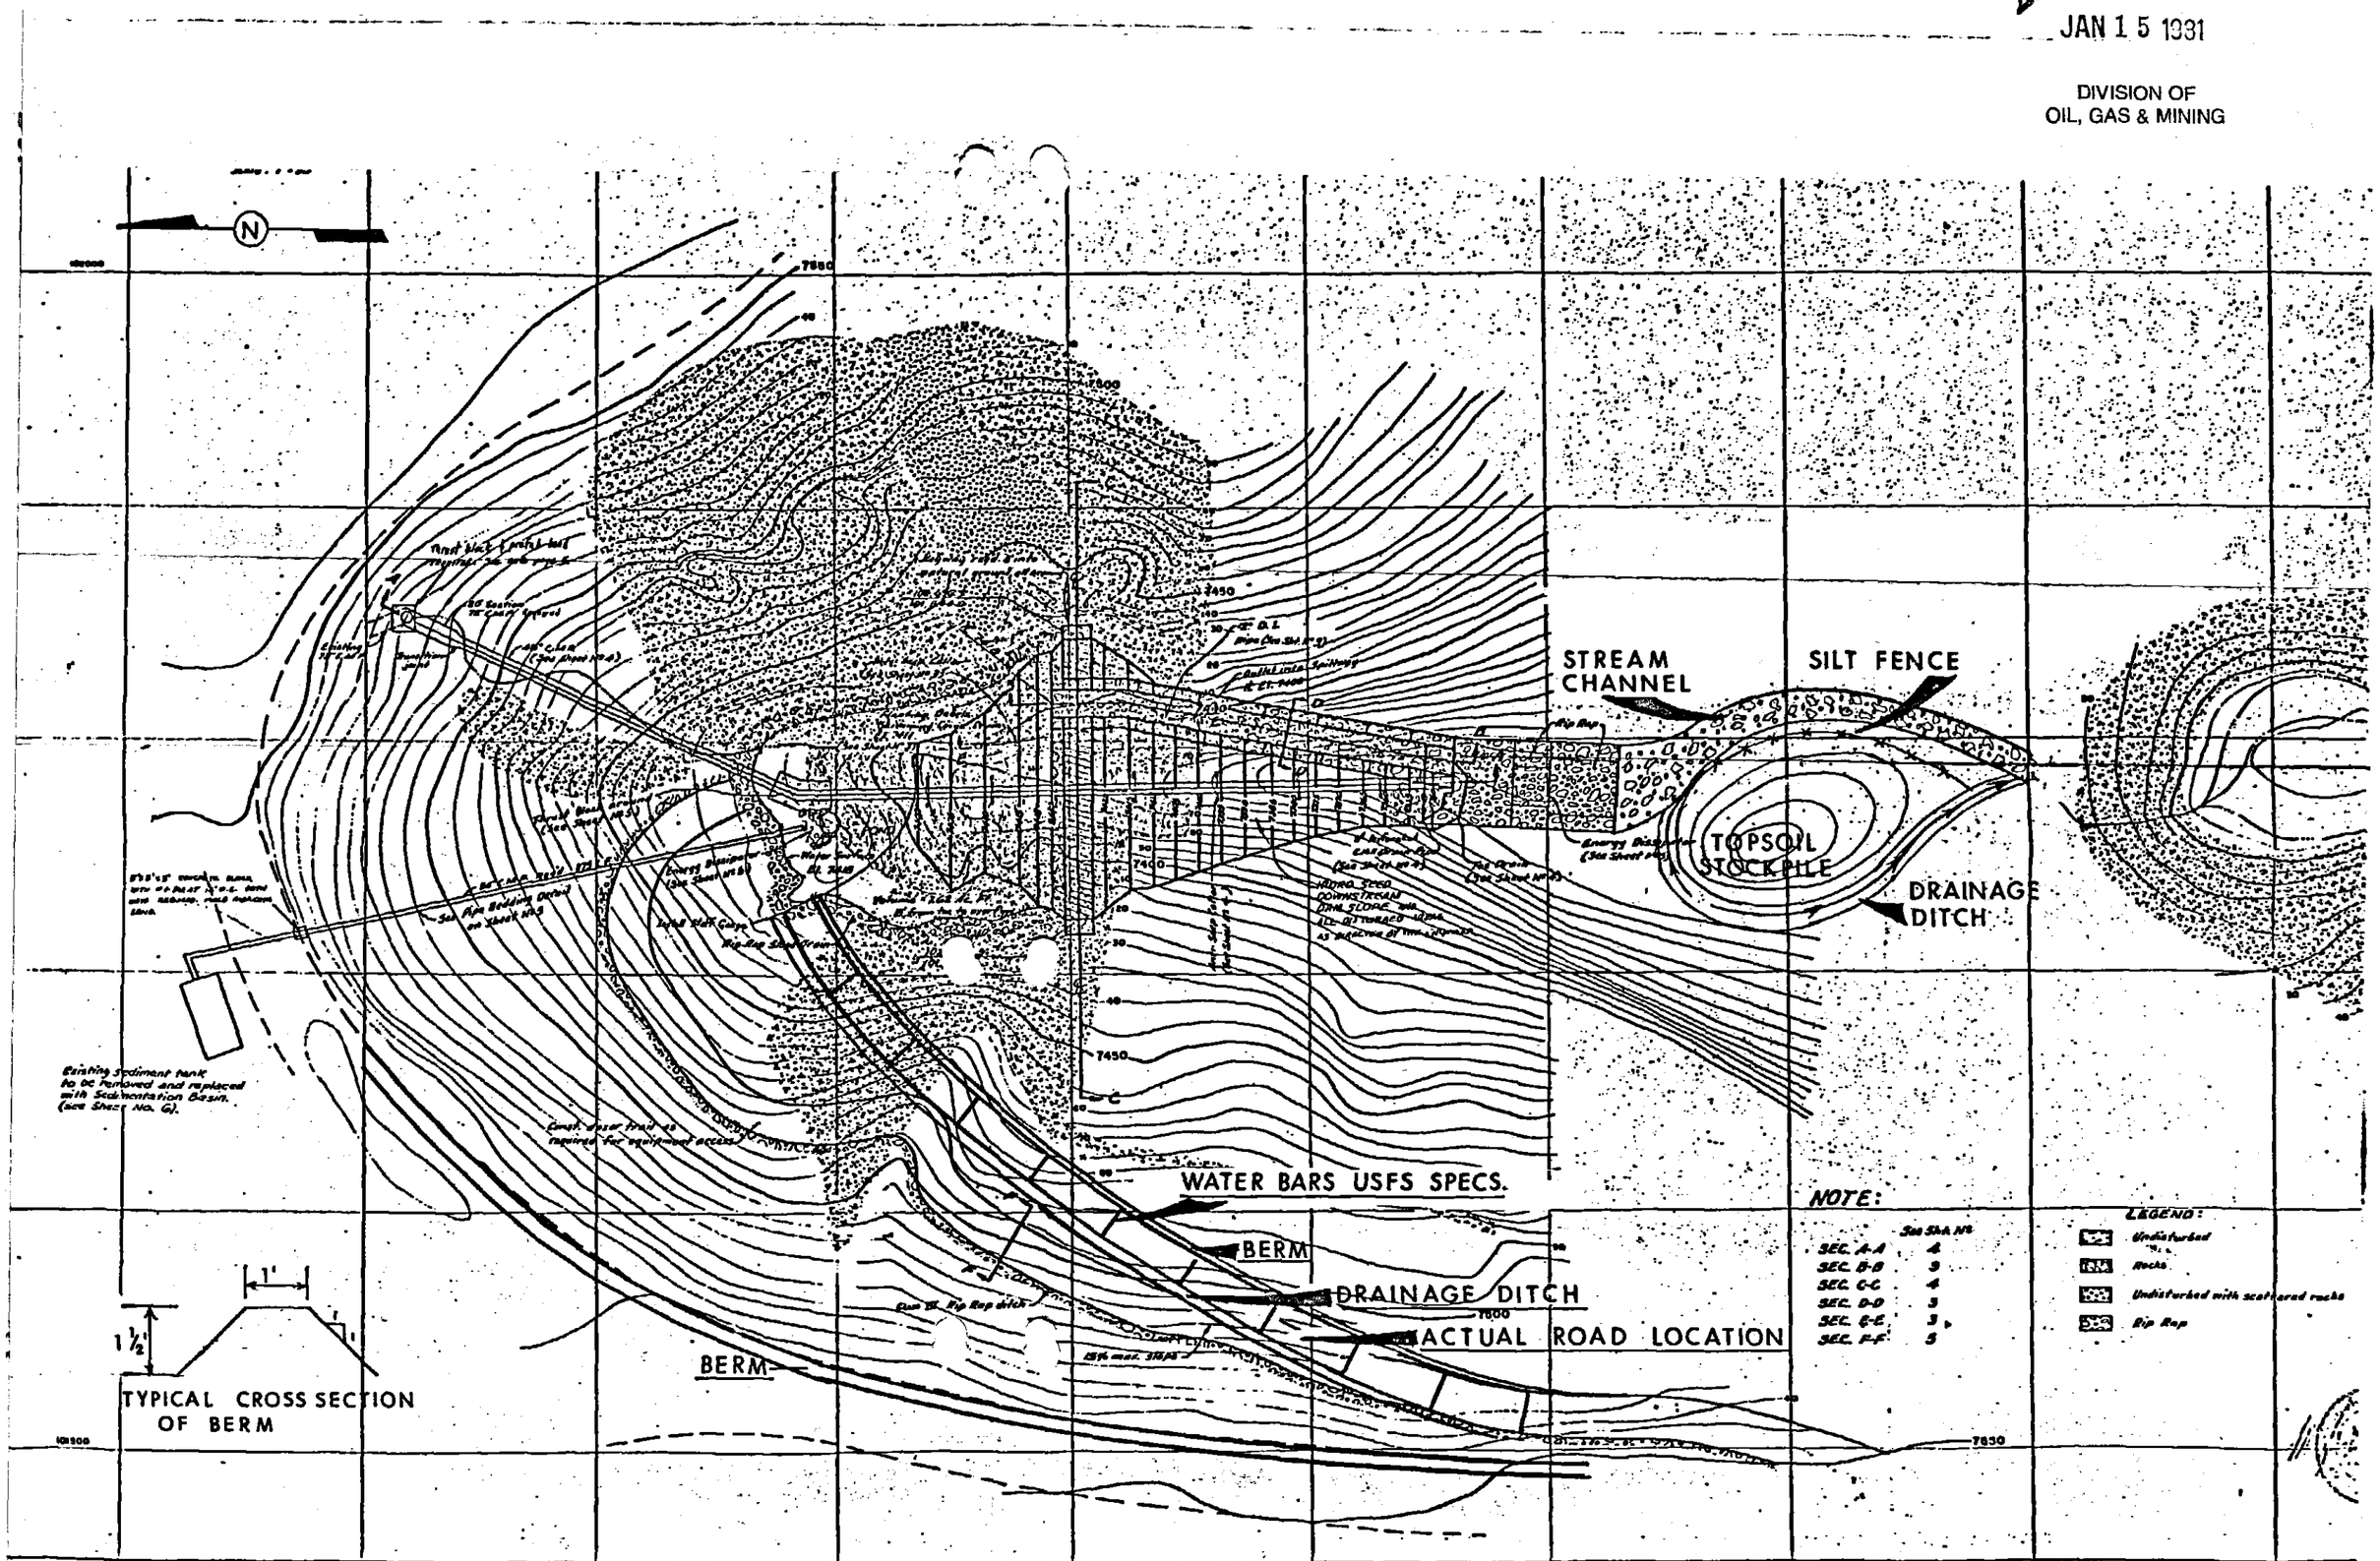
Failure to retain all earth, rock and other mineral non-waste materials on the solid portion of existing or new benches of road cuts, mine workings, or other benches.

Access road to sediment pond downslope areas.

5. Location of the road should be changed in order to avoid cutting into the loose fill material north of the sedimentation pond. Such a cut likely would have resulted in a very unstable situation on the face of the loose fill.

Failure to segregate stockpile and protect topsoil from wind, water erosion or contaminents in an approved manner.

1. In-place topsoil covered by construction of access road to sediment pond.

2. Topsoil stockpile location.

SUFCo is requesting a variance of Mc 717.14(a)(1) and c, Title 40-10-17c for the access road to the sedimentation pond. SUFCo is also requesting a modification of the road location as shown in Figure 1. The following summarizes the reasons for making these requests:

2. The road to the pond as shown in Figure 1 represents the only feasible access route.

1. Drainage will be established by use of ditches, berms and water bars as shown in Figure 1. Erosion and excessive wet conditions on the cuts and side cast slopes will be minimized.

2. A locked gate will be installed at the head of the road to limit access to the road.

3. Cut slopes, side cast material, and the road itself will be seeded and hydromulched.

1. Side cast material and downslope below access road have been reseeded and hydromulched.

2. Figure 1 shows the proposed topsoil stockpile location. The stockpile will be protected from runoff by establishing drainage ditches around the stockpile. The toe of the stockpile will be stabilized with a silt fence. The stockpile will be seeded. The stream will be channeled away from the stockpile area. A sign will be placed on the stockpile designating the material as topsoil.
