Canyon Fuel Company, LLC
A Subsidiary of Bowie Resource Partners, LLC

ANNUAL MINE SITE PRIMARY SEDIMENTATION POND CERTIFICATION -- 2018

Mine Site Primary Sediment Pond Annual Inspection Report

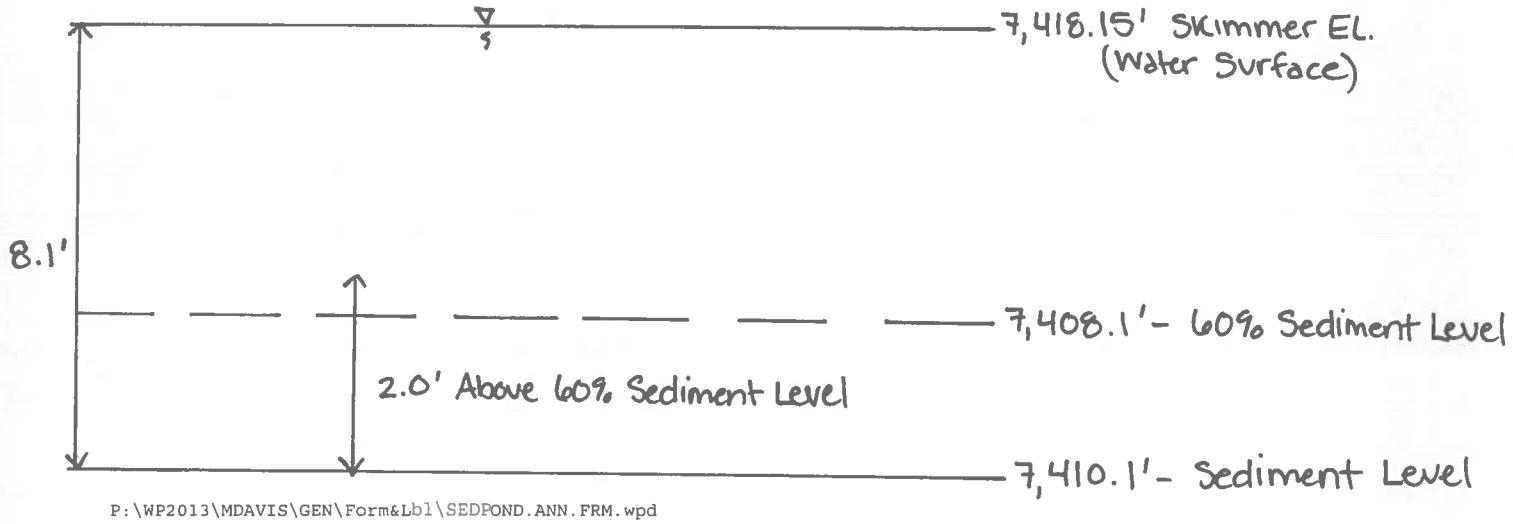
10. Drawing

The standpipe spillway in the pond is at an elevation of 7,418.15 feet. The water elevation is at 7,418.15 feet. Approximately an additional 0.29 acre-ft. of storage volume was available in the pond above the current standpipe spillway level. The sediment level in the pond just north of the decant structure was at 7,410.1 feet. This elevation is approximately 2.0 feet above the 60% sediment level.

Everything appears to be in normal operating condition. The primary pond will be cleaned in 2019.
