Subject: Completion of Reclamation and Removal from Inspectable Units List, Boyer Mine (C/043/0008) and Summit Minerals #1 Mine (C043/0001), Summit County, Utah

Inspection Report

Permit Number:	C0430001
Inspection Type:	COMPLETE
Inspection Date:	Tuesday, June 26, 2018
Start Date/Time:	6/26/2018 9:30:00 AM
End Date/Time:	6/26/2018 10:15:00 AM
Last Inspection:	Tuesday, June 27, 2017

Permit Number:	**C0430008**
Inspection Type:	COMPLETE
Inspection Date:	Tuesday, June 26, 2018
Start Date/Time:	6/26/2018 8:15:00 AM
End Date/Time:	6/26/2018 9:25:00 AM
Last Inspection:	Tuesday, June 20, 2017

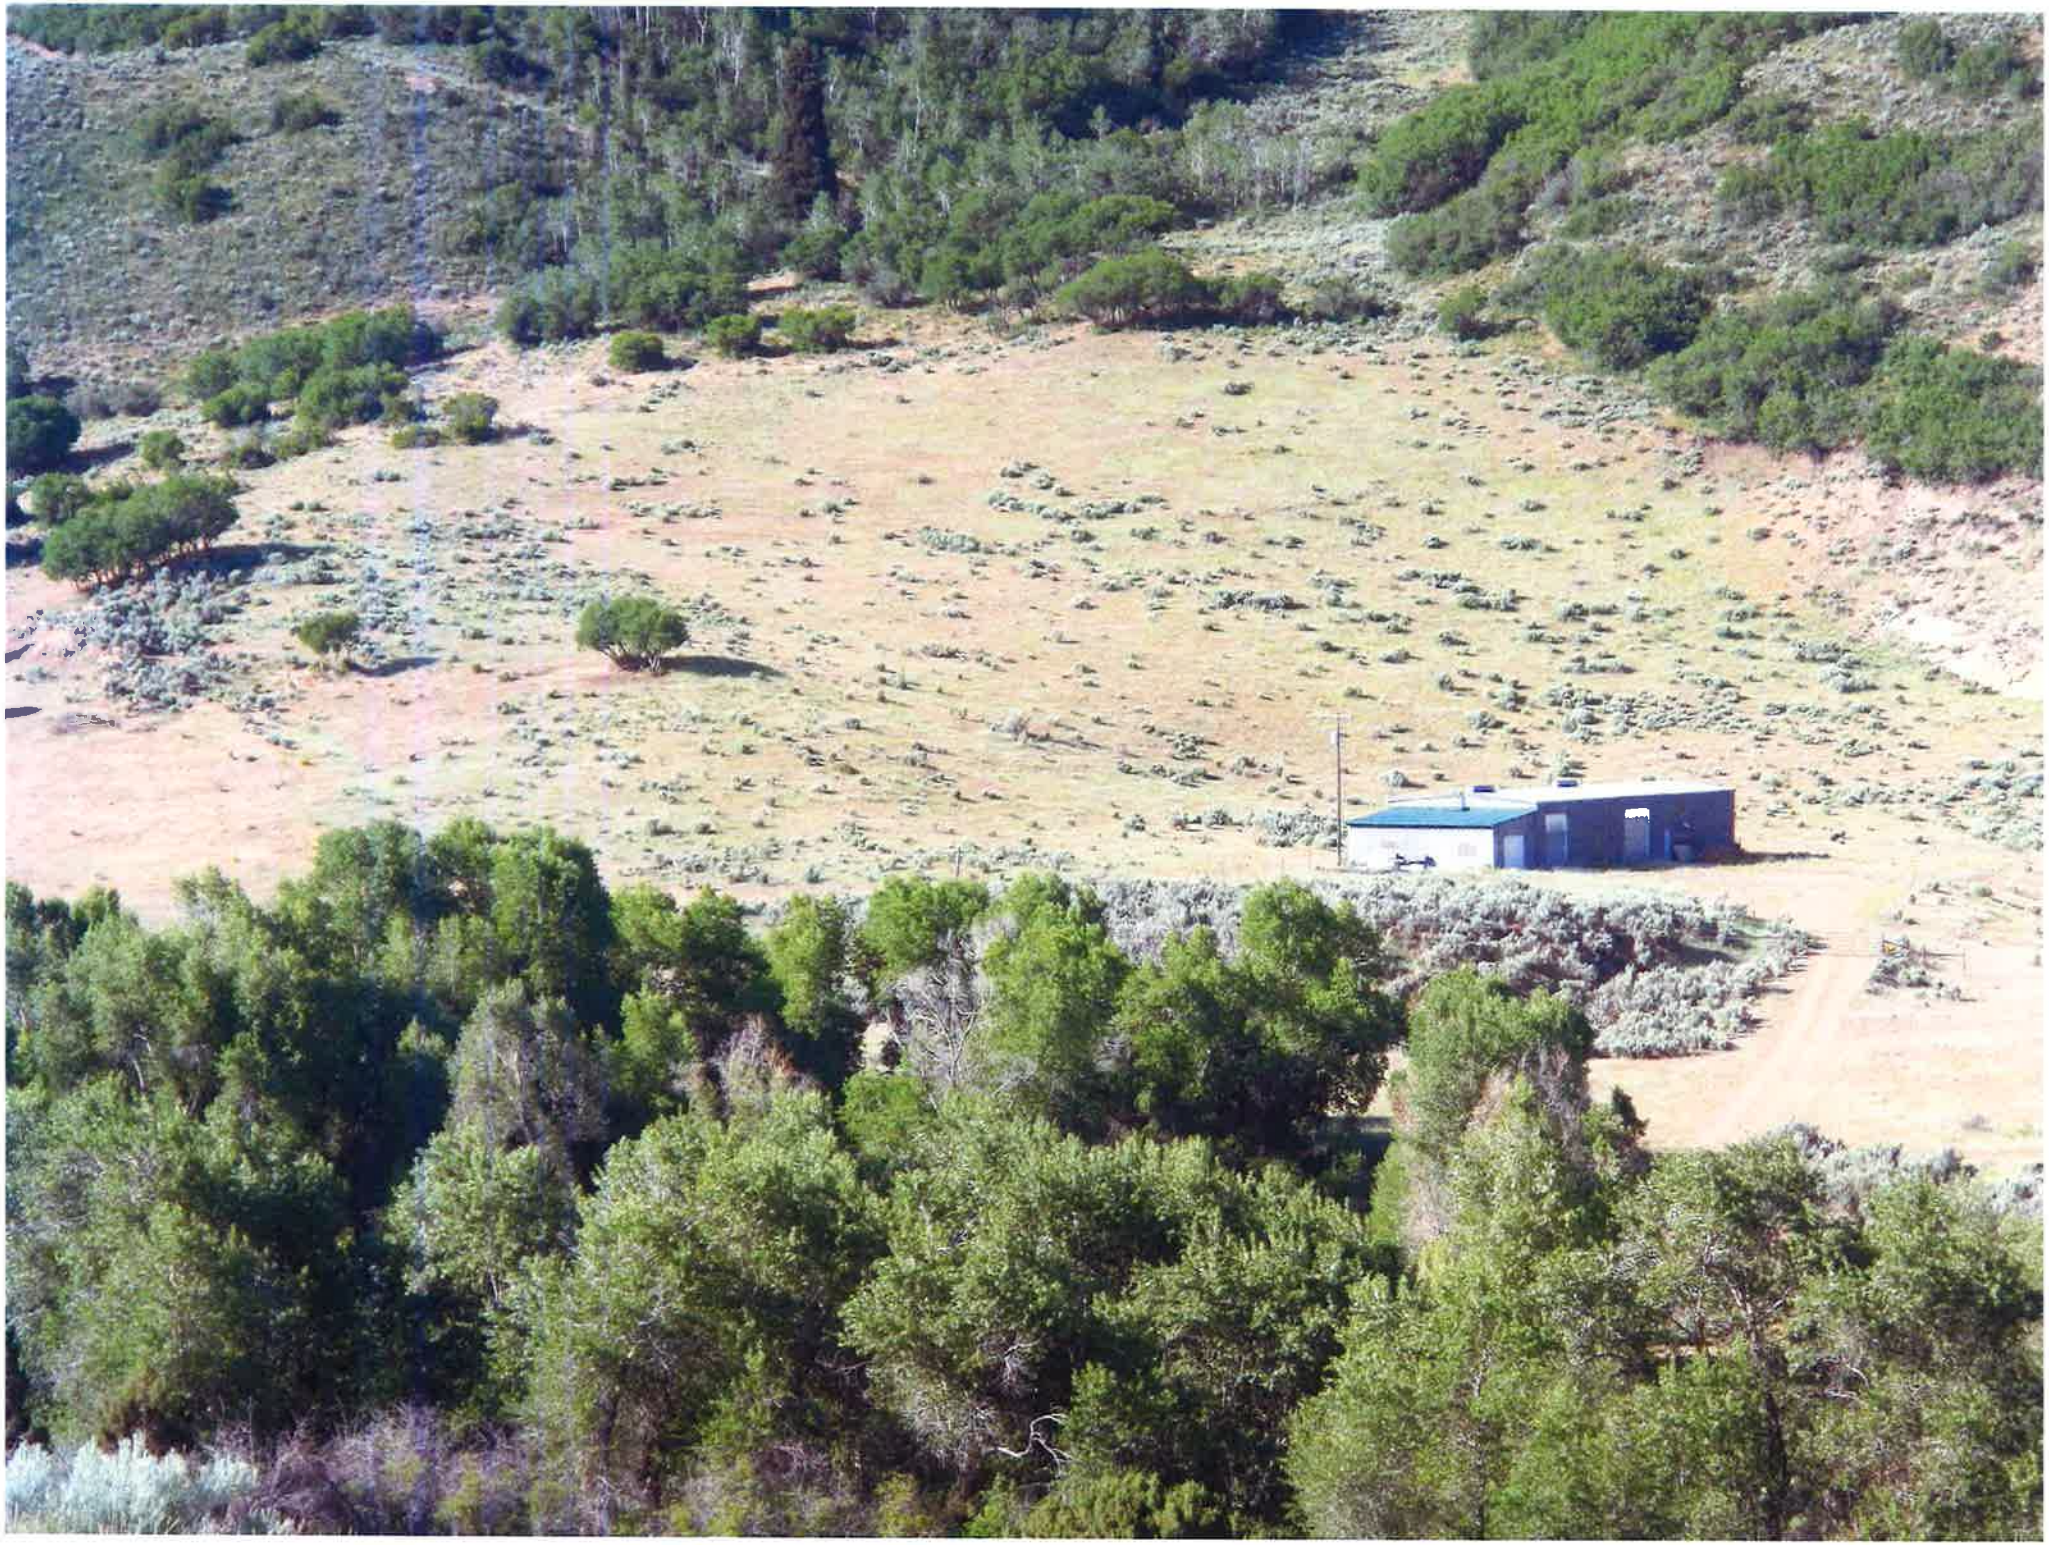
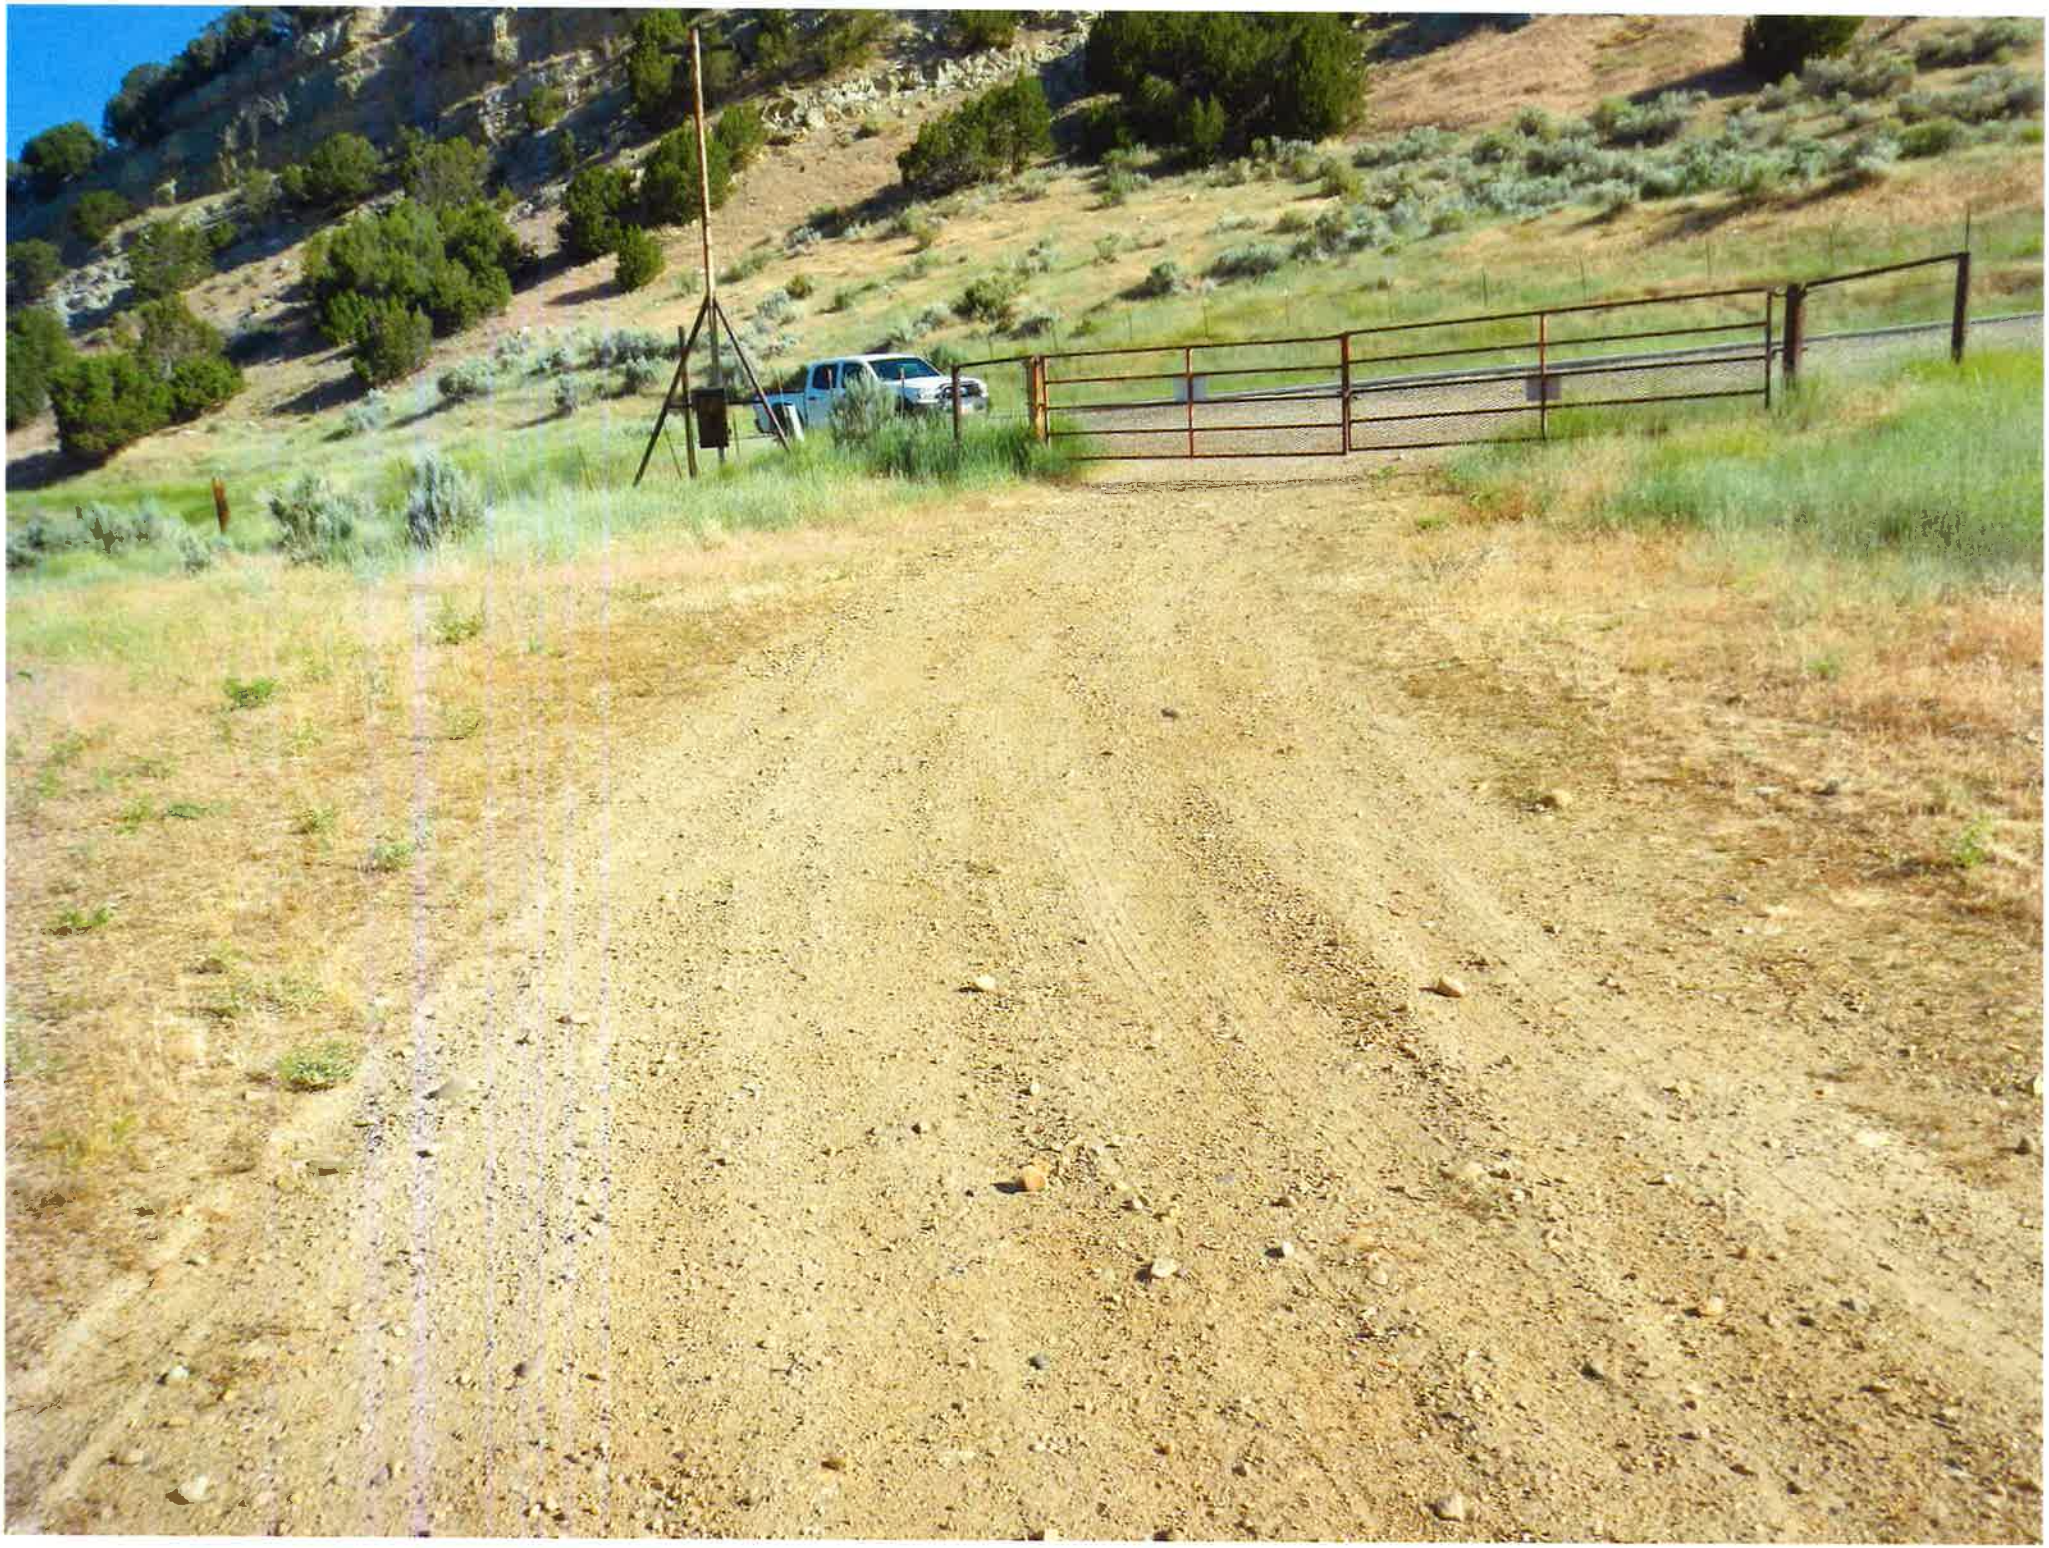
The access road to the mine site is the only remaining road. The condition of the access road and side slopes observed during inspection were stable. The side slopes of the road remain vegetated with no evidence of erosion or rills. The bridge crossing was stable with no evidence of scouring or undercutting observed at the time of the inspection. The embankments on both sides of the bridge were also stable.

The pad and shop remain in good condition. These items were also left in place during reclamation at the request of the land owner as noted in the summary statement.

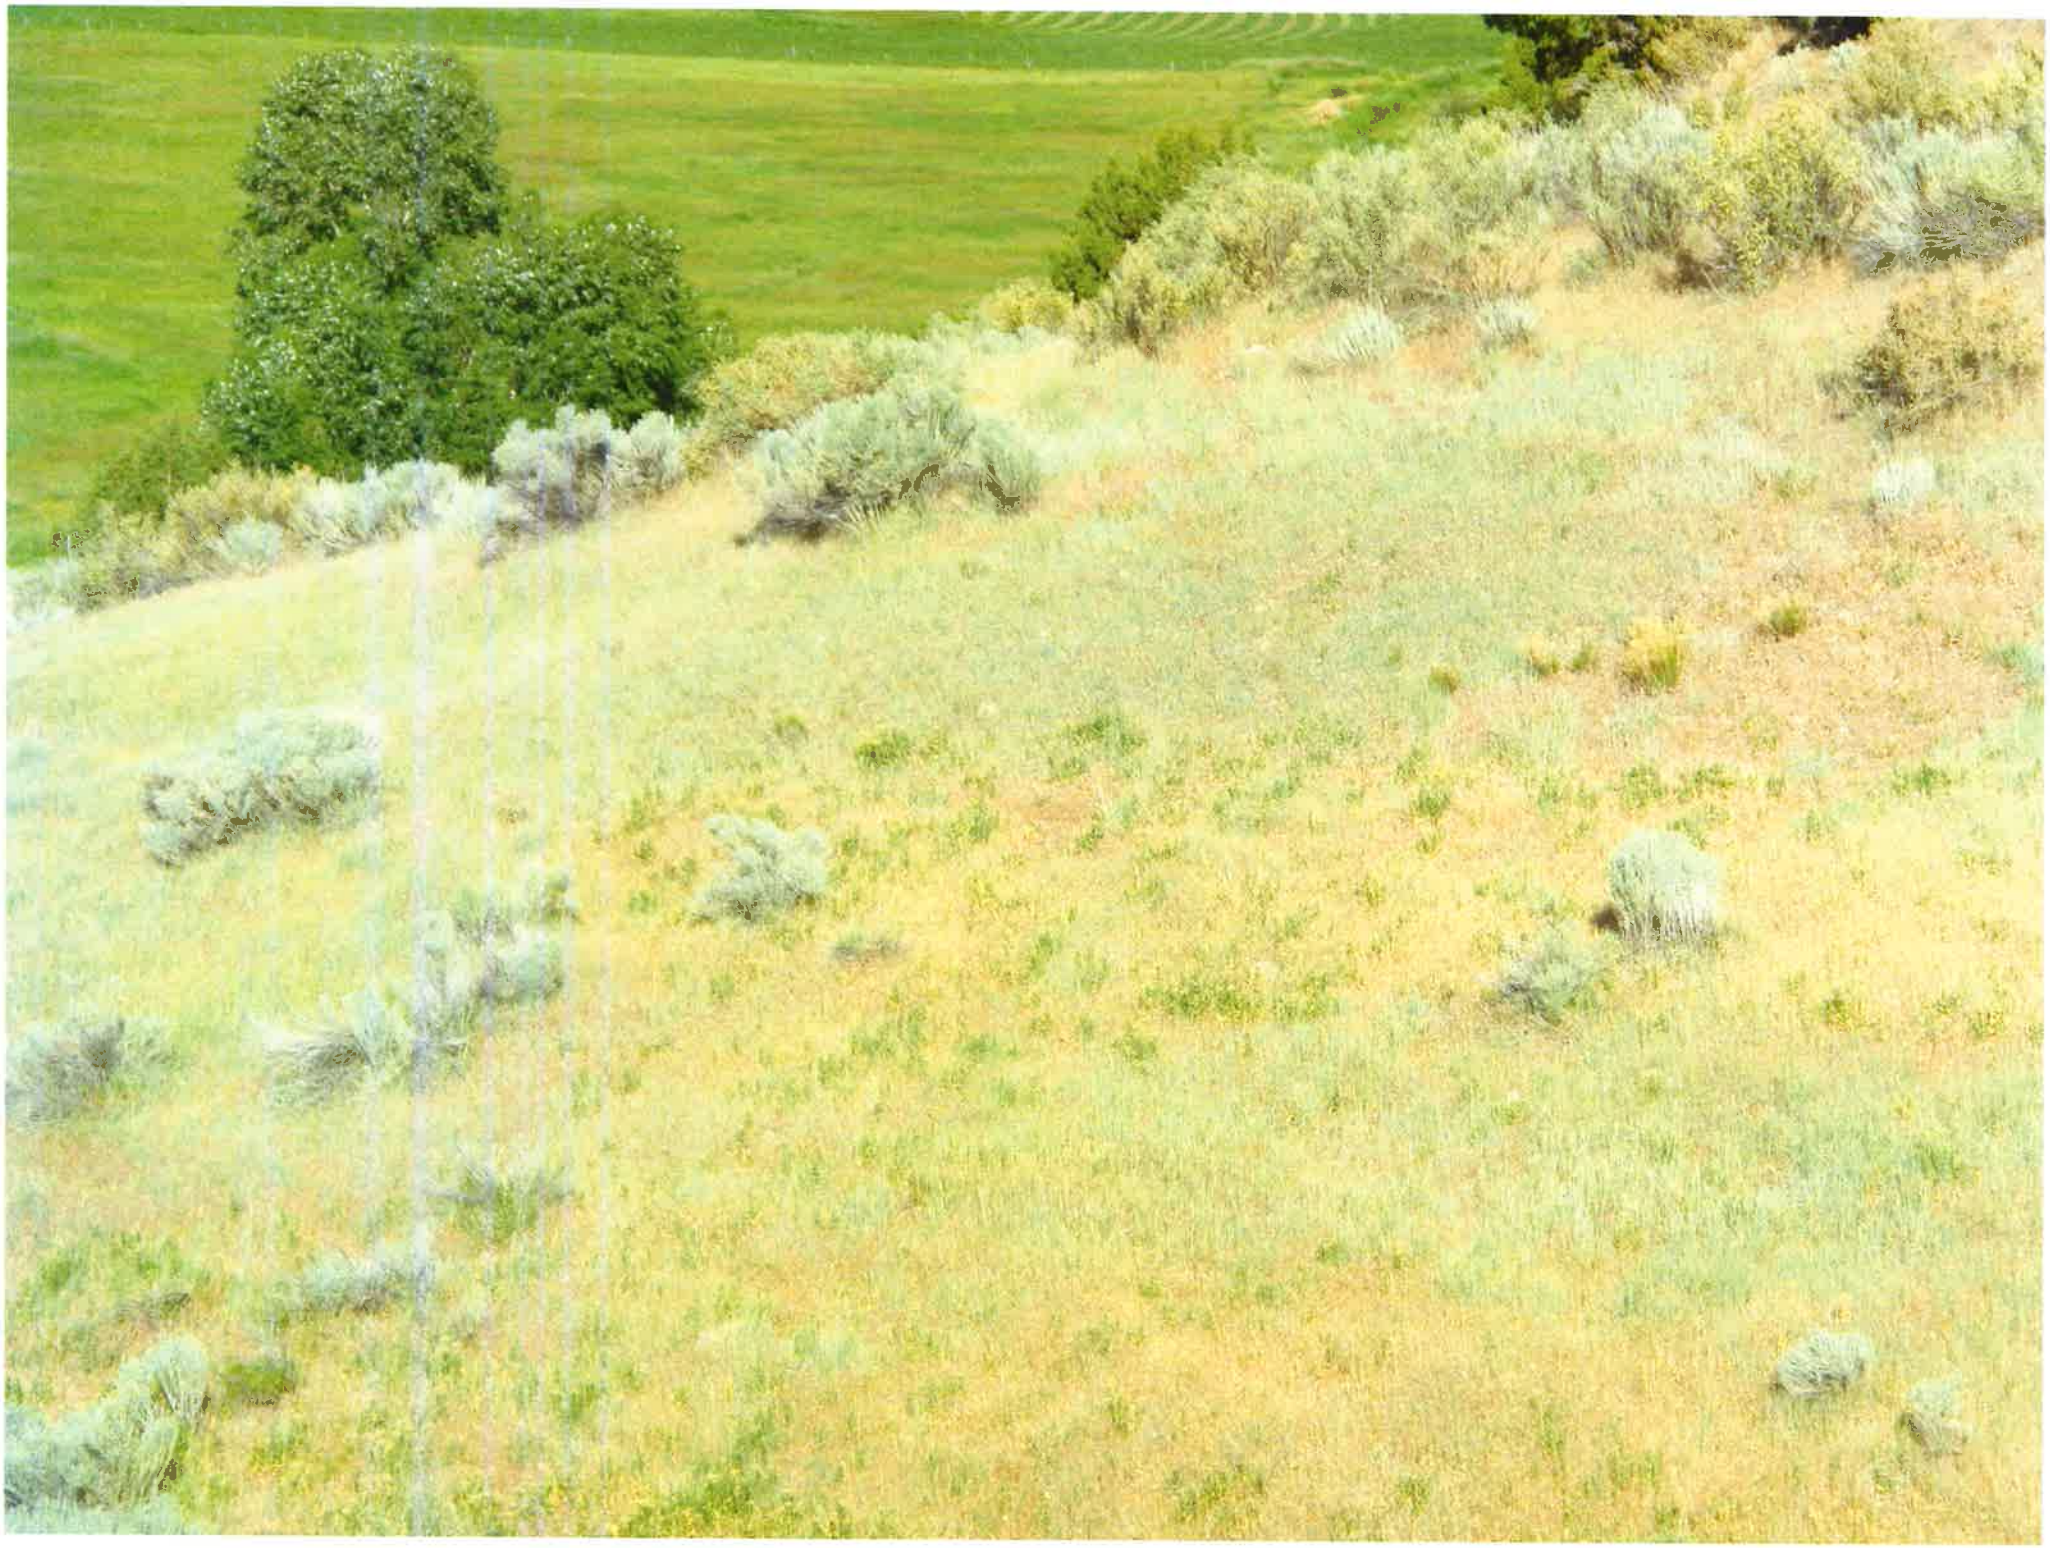
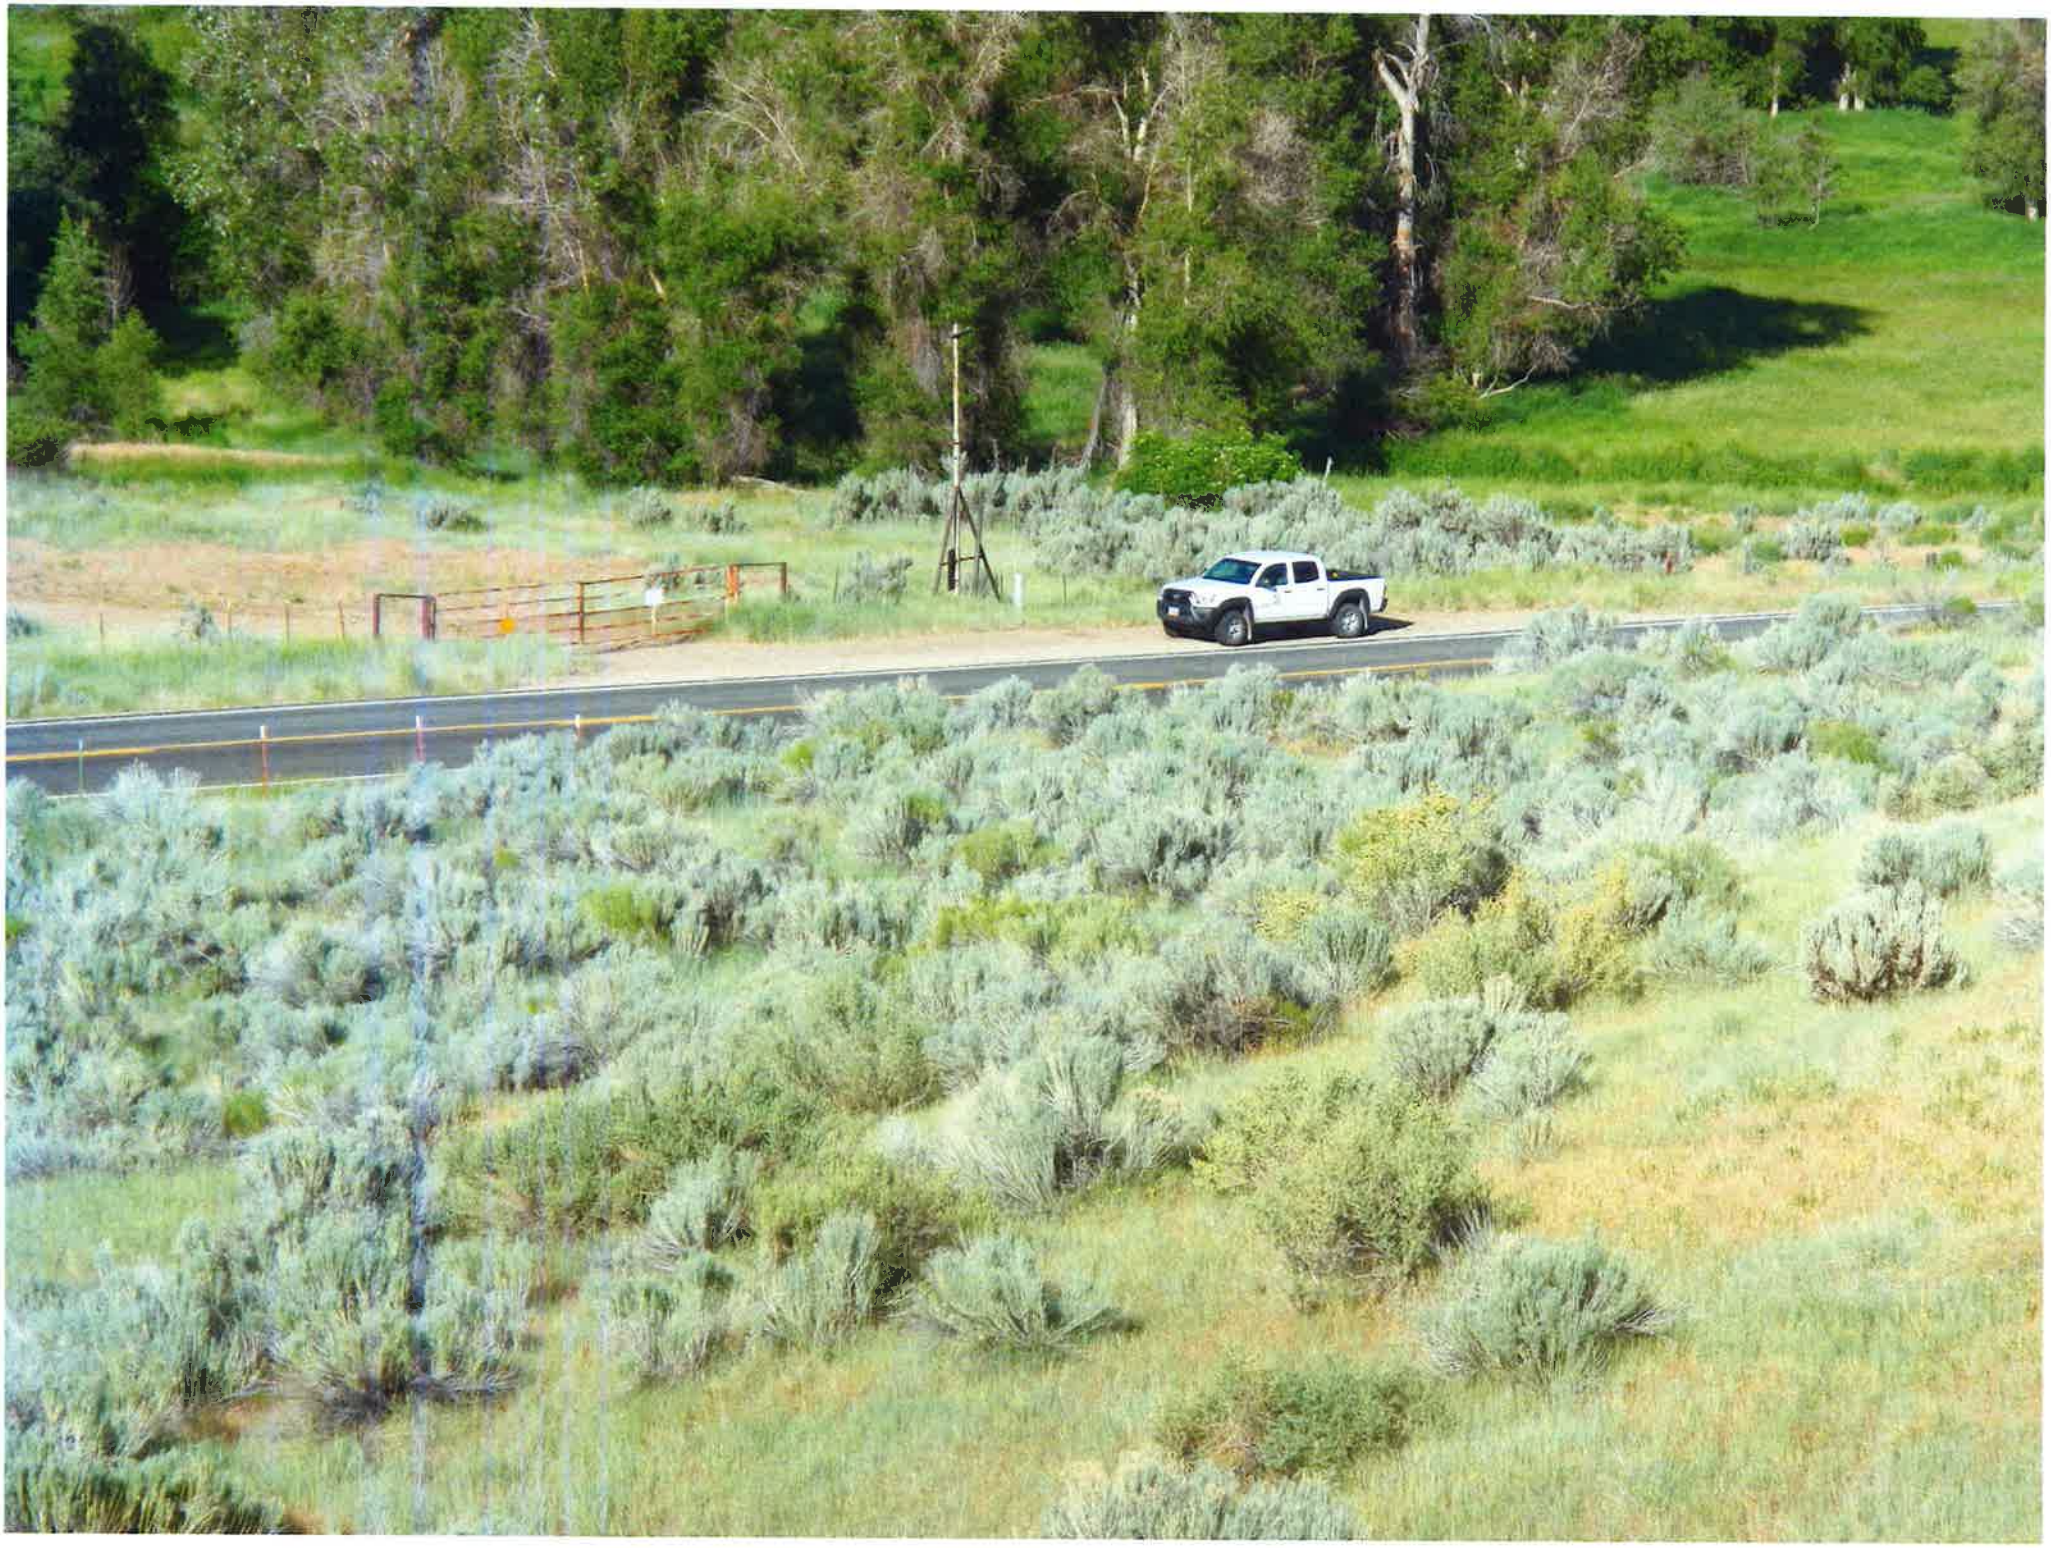
The vegetation on the site looks good and is adequate to control erosion as evidenced by previous inspections. The grasses and forbs in the main channel and along the edges of the channel are well established. There appears to be better vegetation on the reclaimed site than on the adjacent areas that are comprised mainly of Pinyon / Juniper, Sage brush and Scrub oak. The noxious weed Whitetop is prevelant throughout the site. This noxious weed species probably germinated when the soil was disturbed during the backfilling and grading of the site. Although prevelant the whitetop does not seem to be out competing the other grasses and forbs on the reclaimed site. DOGM biologist (Joe Helfrich) met with Cade Willoughby (Summit County Weed Enforcement Officer) on June 20th 2017. Portions of the sight were sprayed with Weedmaster on June 20th, 2017. Additional spraying was completed on June 28th. A final spraying is scheduled for July 11th, 2018.
