UNITED STATES
DEPARTMENT OF THE INTERIOR
BUREAU OF LAND MANAGEMENT

10/17/90

~15:15 VIPONT MINE SITE D/003/007

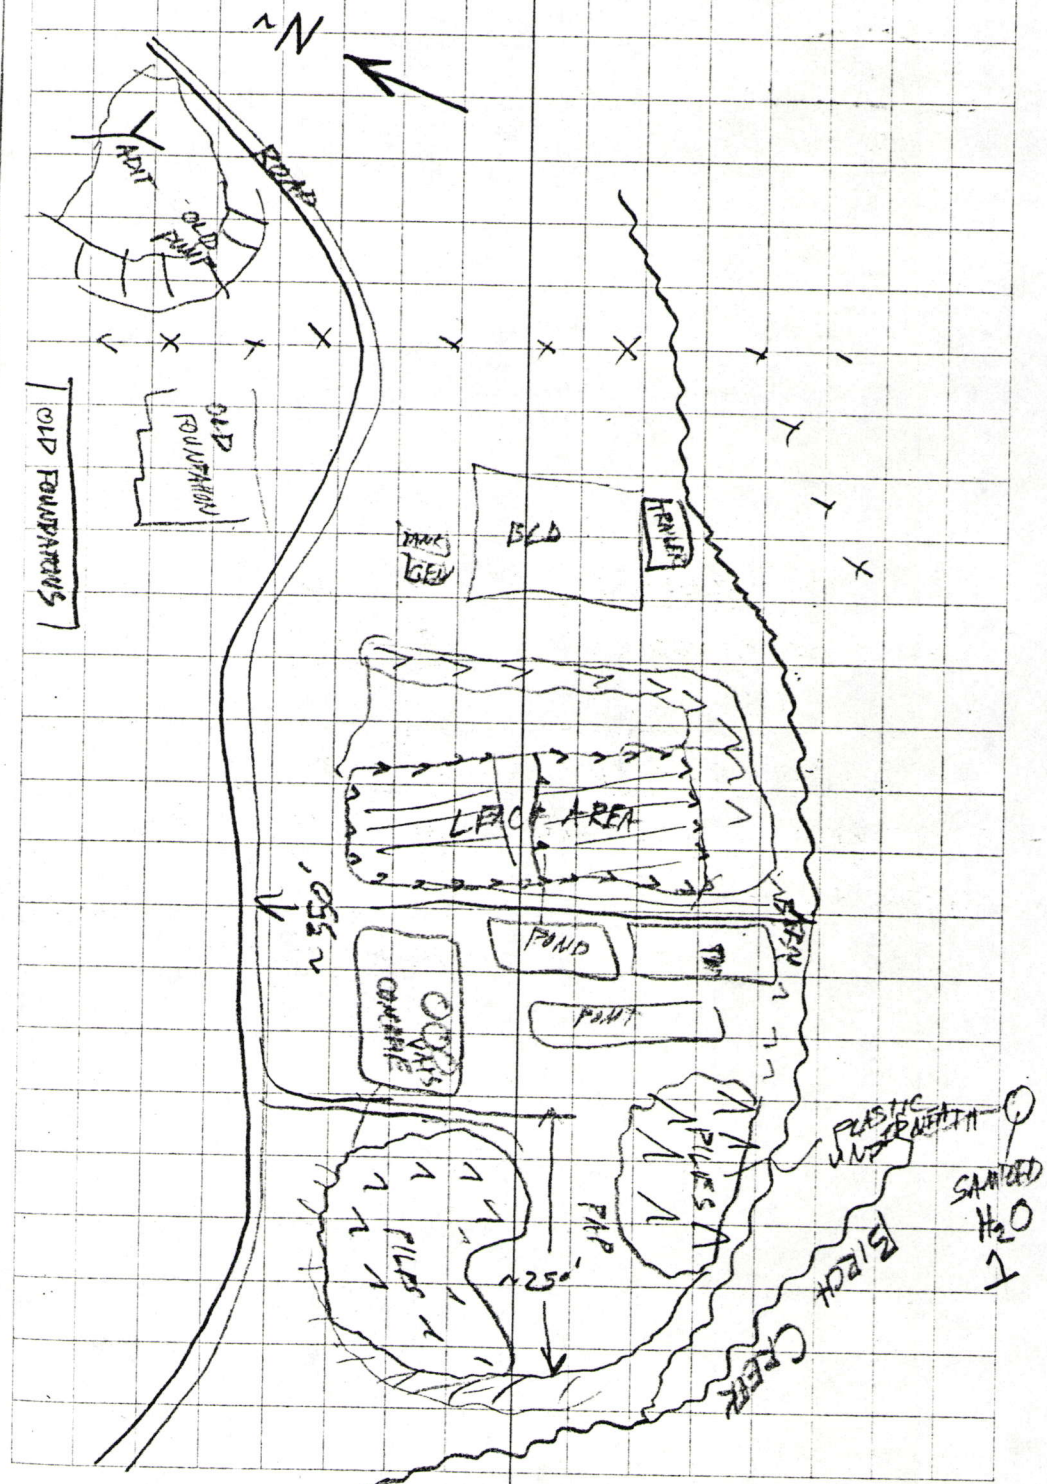
CONCRETE PAD

- LEACHED MIL FAIRLY SOLID
- ASPHALT GUTTER @ W END OF HEAPS
- 3 VATS/TANKS EMPTY
- PONDS WERE LINED W/PLASTIC ONLY
- PLASTIC DRUM OF CAUSTIC SODA 50% LIQUID PURIFIED

VAN WATERS & ROGERS - HAD SEVERAL LABELS UNDERNEATH

- METAL DRUMS - CAUSTIC SODA 50% LIQUID
- FULL PLASTIC DRUM
- WATER DRAINING FROM PIPELINE NEAR TRAILER
- CYANOBRIK (SMALL BLACK DRUMS) FROM DuPONT
- FISH IN BIRCH CREEK BELOW BEAVER DAM BELOW VIPONT
- NO FISH SEEN IN STREAM NEAR OLD TAILINGS POND
