Inspection Report
Minerals Regulatory Program
August 13, 2008

Mine Name: Eagle Canyon
Operator Name: Georgia Pacific

Permit number: M0150050
Inspection Date: July 1 and July 29, 2008
Times: 11:30 AM to 1:00 PM on July 1; 10:30-11:40 AM on July 29

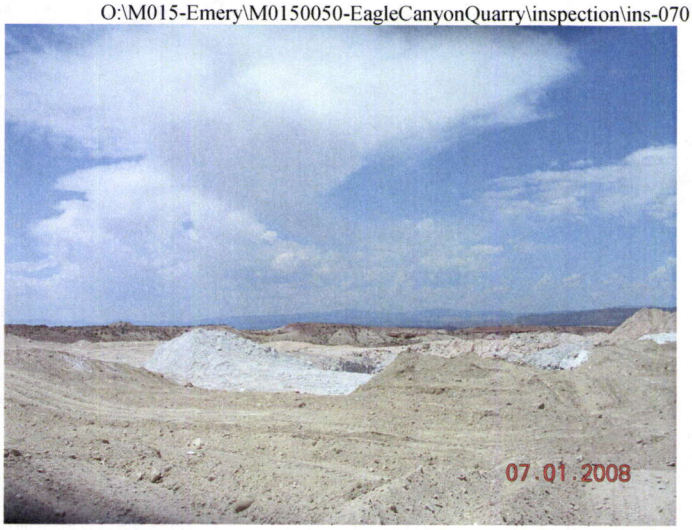
To the left of center in Photo 1 is a gypsum stockpile which by the inspection on July 29 had been almost completely buried. Other areas that were basically regraded are shown in Photos 2 and 3.

Photo 1. Just to the left of center in this photo is a gypsum stockpile that has now been mostly buried.

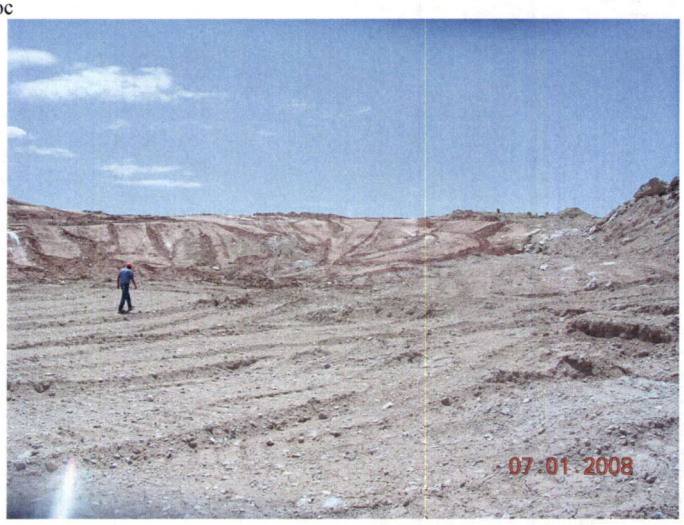
Photo 2. This photo and photo 3 show areas that have been mostly or completely regraded.
