5/015/074
CLARK #1

92 EM 1
~~AMR/045/003~~ FROM FILE AMR/015/902
Cowboy Mine
Mesa Butte Quad

COWBOY CONSOL MINE

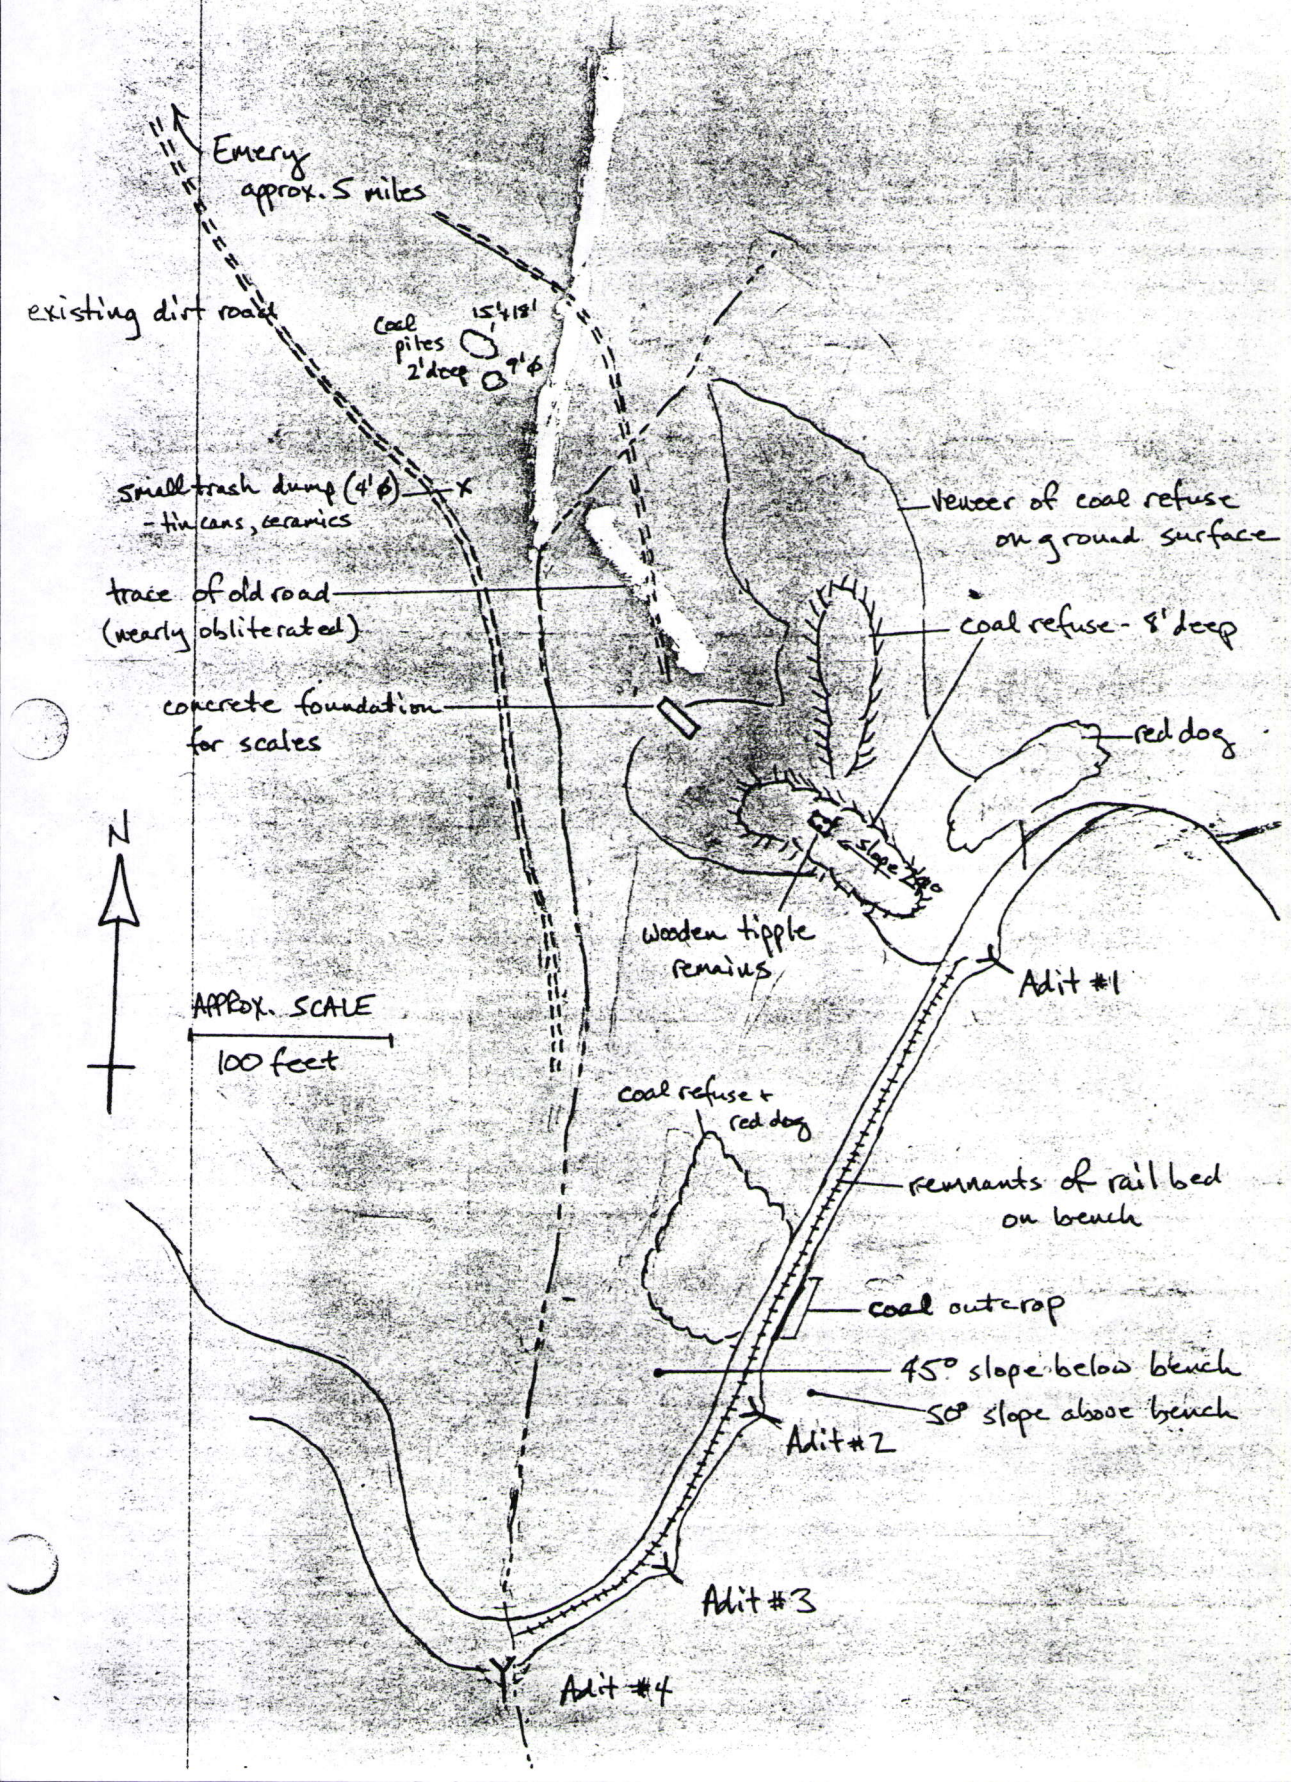
S/015/074
CLARK #1

Adit #1: 15' high face-up area cut back 25' into west-facing slope. Sloughing of rock debris from above has closed opening to 1' h x 4' w. Before sloughing opening was approx. 5'-6' high. 12'-15' layered sandstone caprock.

Adit #2: Configuration similar to Adit #1. Opening 4' h x 10' w narrowing to 4' h x 9' w inside. Timber and steel sets. 4' massive sandstone caprock.

Adit #3: Configuration similar to Adit #1. Opening 4' h x 12' w; partial caving at 6'. Timber sets, 2" x 8" lumber caps. Porcelain insulator on one timber. 3'-4' massive sandstone caprock with another 10' of layered sandstone.

Adit #4: Opening 5' h x 12' w, closes to 3' h x 10' w about 10' inside. Timber sets, 2" x 8" lumber caps. Face-up is a vertical to overhanging cliff in the middle of a drainage gulley; sandstone and exfoliating carb shale.
