D603031 P

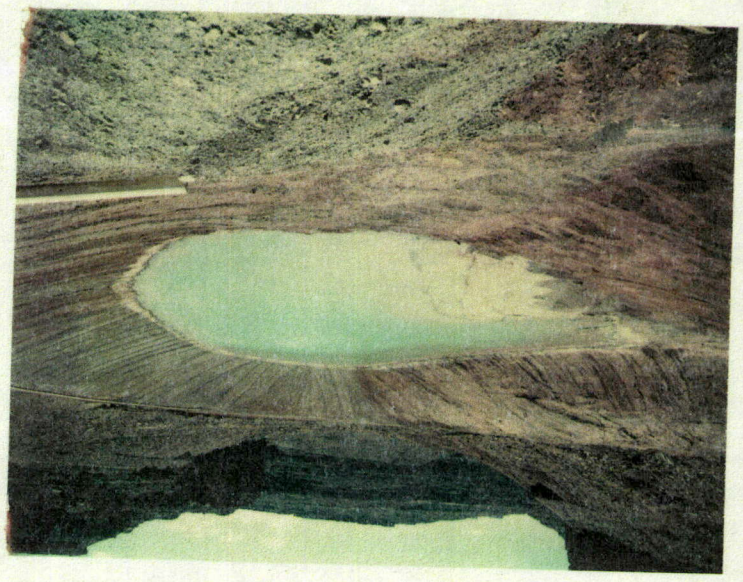
8/18/76

View down Shitemaring Canyon over the tailings dam. Evidence of bentonite (rolled) in bottom & scattered bent. on dam. Dam does not appear adequately sealed.

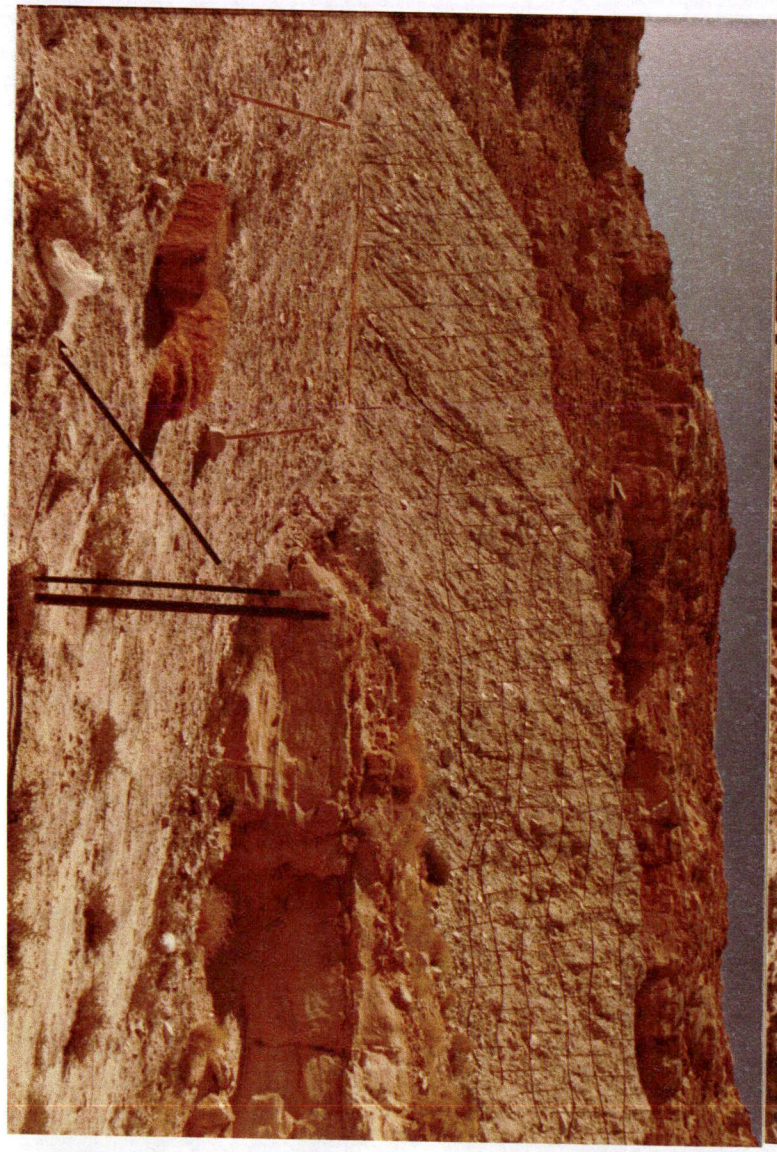
8/18/76

Drainage into tailings pond. View to the east over dam at water notch in cliff. All drainage over this notch appears to drain into tailings pond.
