State of Utah
DEPARTMENT OF NATURAL RESOURCES
DIVISION OF OIL, GAS AND MINING

RE: Site Inspection, Plateau Resources, Inc. Tony M/Lucky Strike & Frank M Mines, M/017/001 & S/017/017, Garfield County, Utah

Date of Inspection: November 19, 2003
Time of Inspection: 9:30 AM to 12:30 PM
Conditions: Clear, Sunny, 50's
Participants: Fred Craft – U.S. Energy Corp, Jim Butt – Contractor; Tom Munson & Wayne Hedberg, DOGM

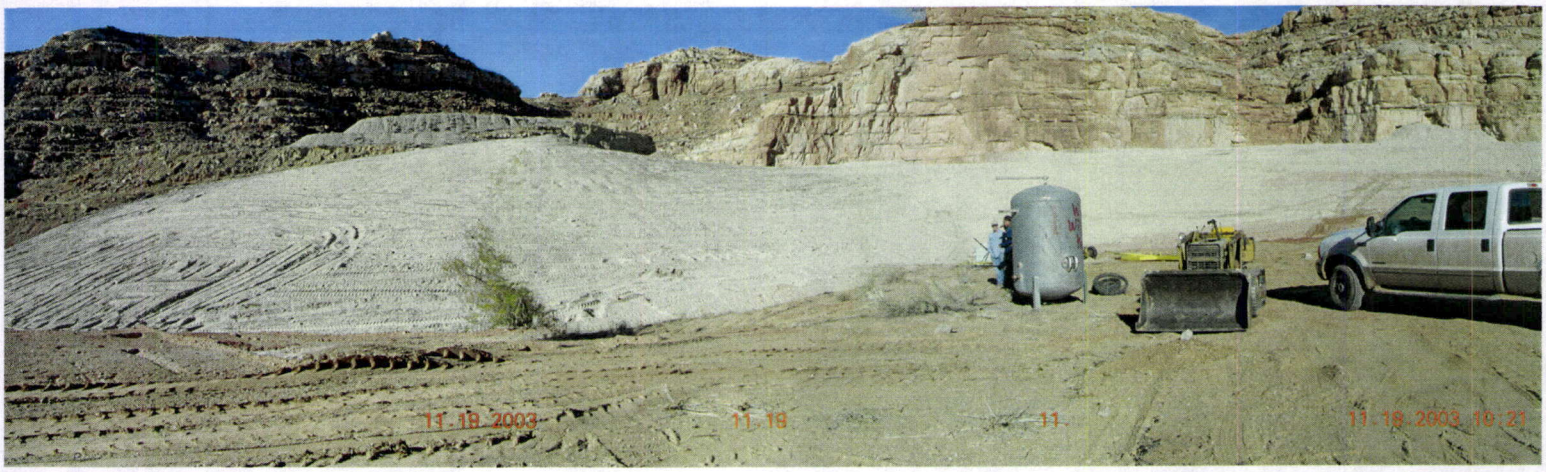
Pano 1

Tony M Mine & processing facilities area - contoured

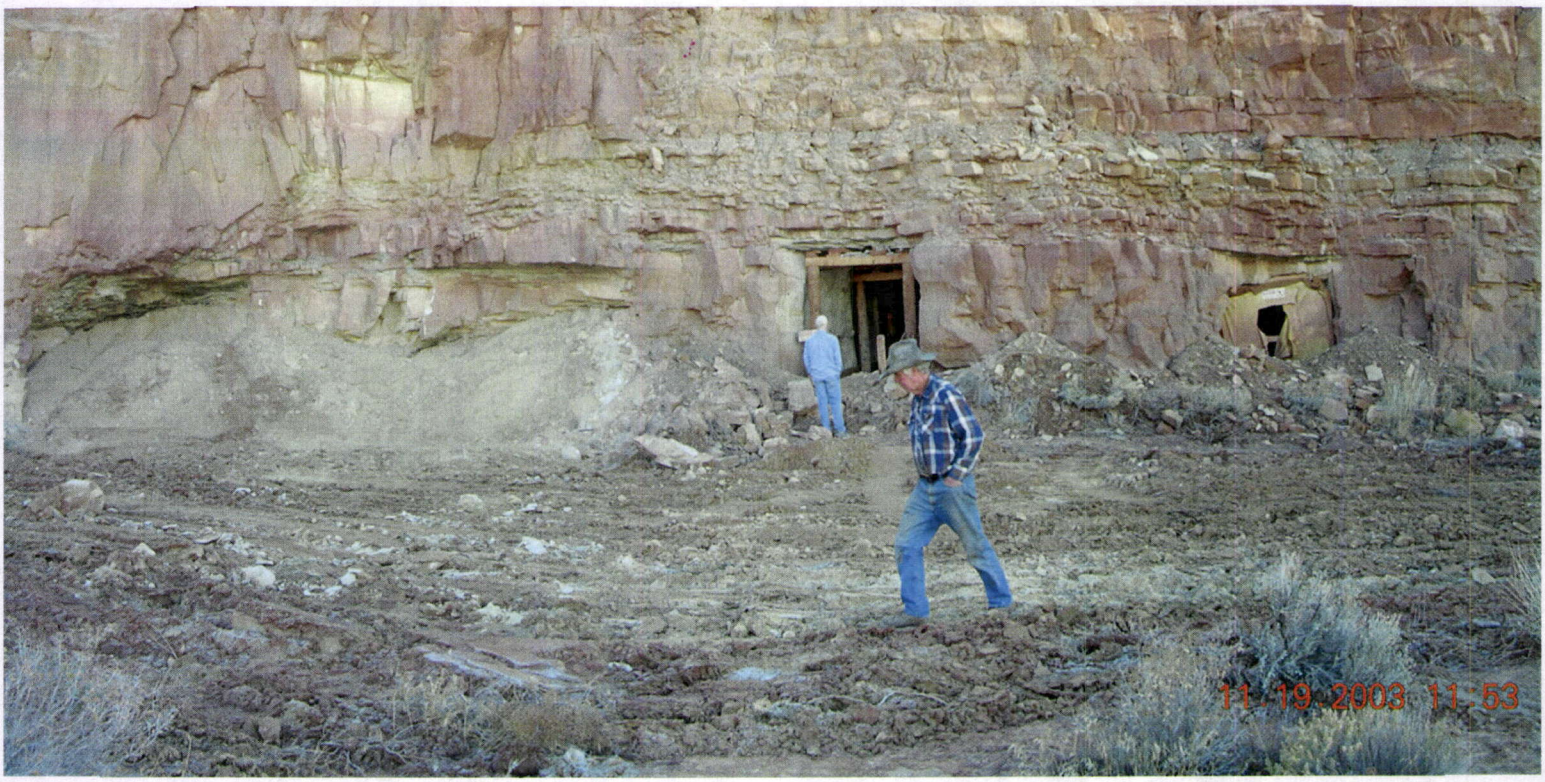
Pan 08

Lucky Strike Mine area portals

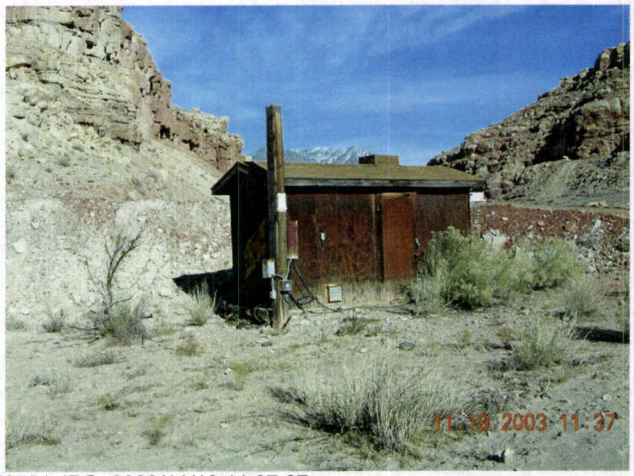
Tony M (water well & pump house)

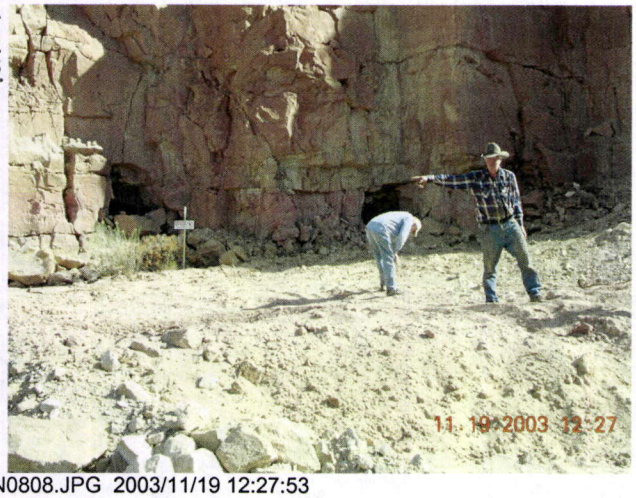
Lucky Strike (South - open portals pre-law?)

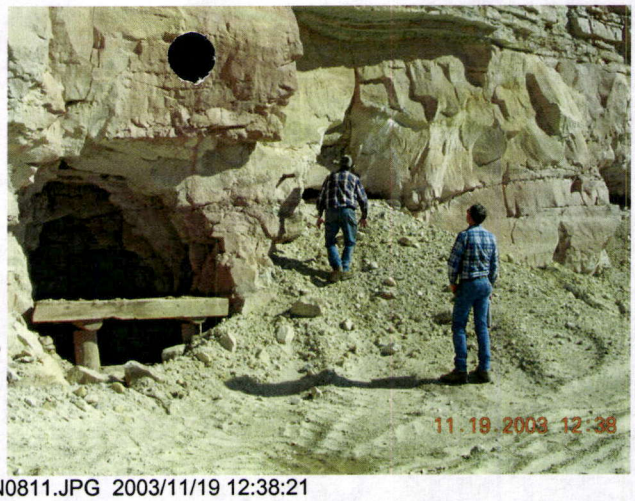
Open & backfilled portals Lucky Strike south

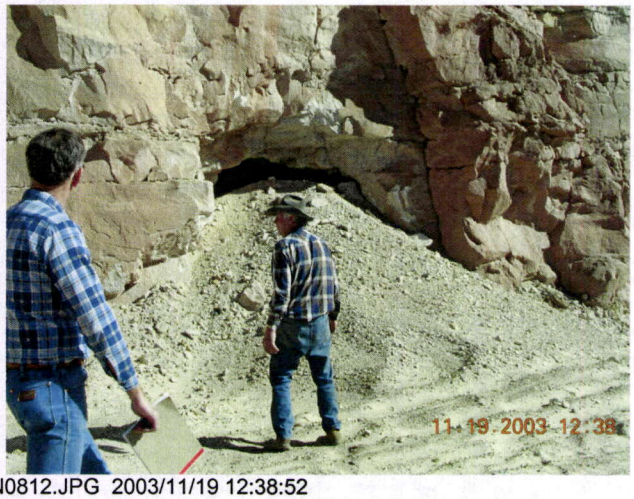
Backfilled portal – Lucky Strike south
