Inspection Report
Minerals Regulatory Program
Report Date November 9, 2005

Mine Name: Crescent Creek/May Day Mill
Operator Name: Martinique Mining

Permit number: S/017/043
Inspection Date: September 13, 2005
Time: 5:10-5:30 PM

ATTACHMENT
Photographs
S/017/043, Crescent Creek Mine/May Day Mill, Martinique Mining
Inspection Dated: September 13, 2005; Report Dated: November 9, 2005

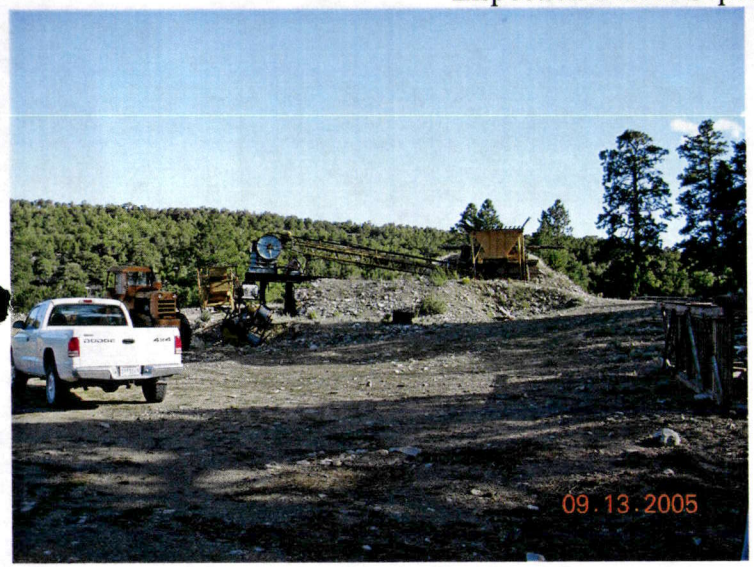
2. Public Safety (shafts, adits, trash, signs, highwalls)
The site contains some processing equipment (Photos 1 and 8), but there are also several other items that may be useable but look more like scrap or trash (Photos 2, 3, and 4).

Rule R647-3-107.1.12 requires the disposal of trash, scrap metal and wood, and extraneous debris. Many of the items being stored on site appear to fit the category of "trash, scrap metal and wood, and extraneous debris" and need to be cleaned up.

Photo 1. Some of the processing equipment.

Photo 3. There is a fair amount of what appears to be scrap or trash.

Photo 2.

Photo 4.
