State of Utah
DEPARTMENT OF NATURAL RESOURCES
DIVISION OF OIL, GAS AND MINING

RE: Site Inspection, Hecla Mining Company, Escalante Silver Mine, M/021/004, Iron County, Utah

Date of Inspection: October 16, 2002
Time of Inspection: 6:45 p.m.
Conditions: Warm, Breezy
Participants: Doug Jensen, DOGM

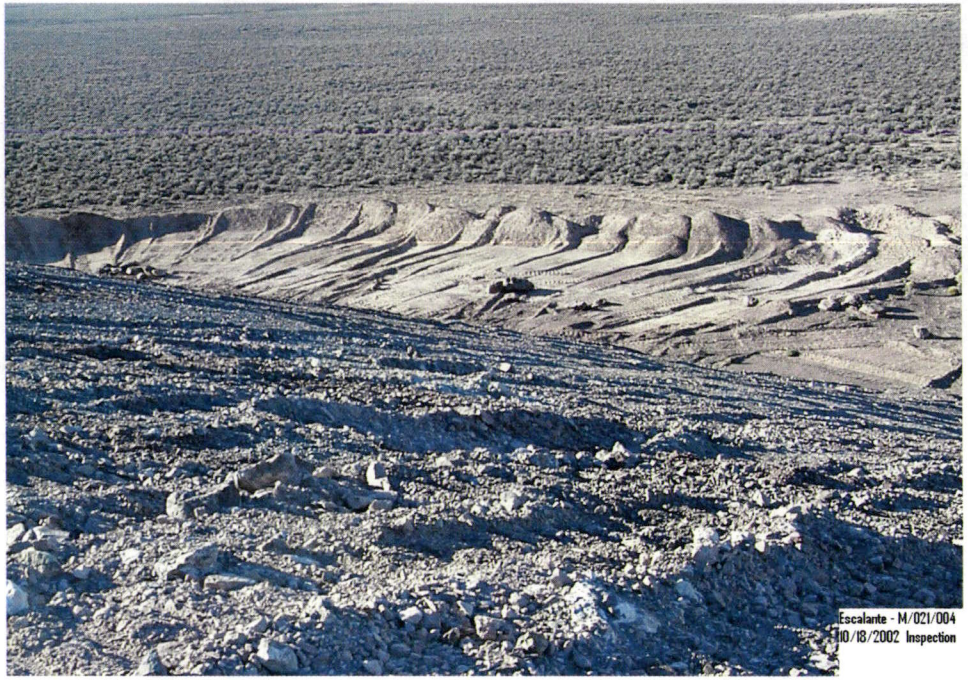
Escalante - M/021/0C
10/18/2002 Inspectio

The material pile had been recontoured recently and it appears that prior to the recontouring effort some growth medium had been harvested from the area to be covered by the pile resloping. The soil harvest was not as extensive as Alan Wilson (Hecla Rep) had indicated during a previous meeting with the Division. To date, no attempt has been made to place growth medium on the reworked surface.

Because the slot was not created before resloping, it is now probable that a small borrow pit will have to be created to make up for any shortfall of growth medium.

It is the recommendation of the inspector that the growth material that is to be placed on the recontoured pile be hauled to the top of the pile and spread down the slopes. This method of material application will allow for the maximum utilization and uniform application of the growth material being placed on the final slopes.
