Inspection Report
Minerals Regulatory Program
Date: January 13, 2010

Mine Name: Barneys Canyon	**Permit Number**: M/035/0009
Operator Name: Kennecott Utah Copper	**Inspection Date**: December 2, 2009
Inspector(s): L Heppler, E. Berry	**Time**: 8:00 am
Other Participants: G. Eurick, Z. Kenyon & others- Kennecott	**Mine Status**: Active

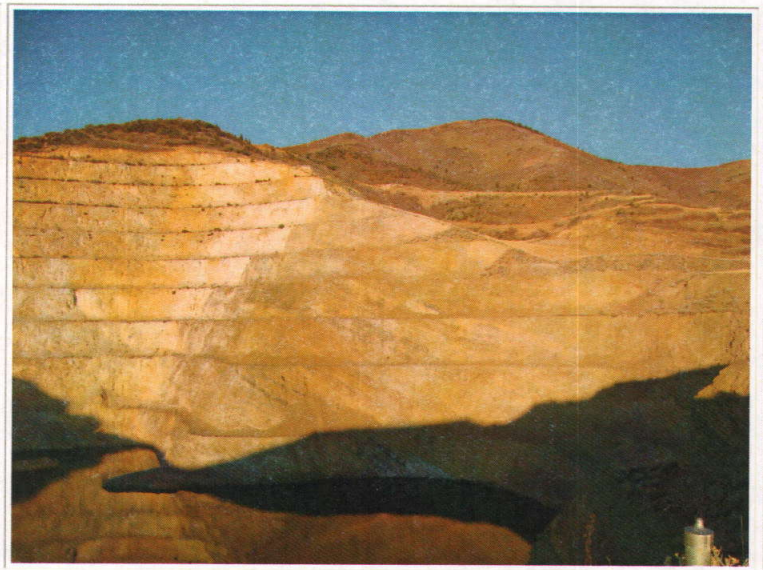
Barneys Canyon Highwall – Note reclamation on benches

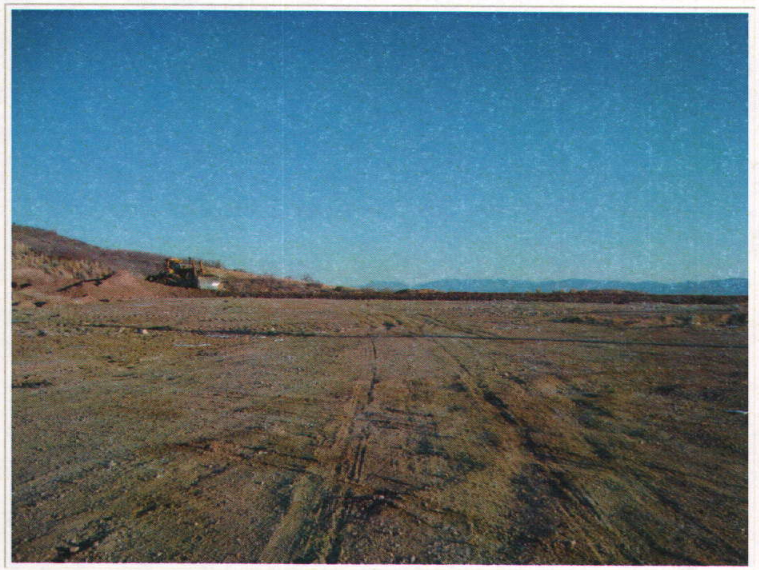
Reclaimed Melco Haul road
