# State of Utah
DEPARTMENT OF NATURAL RESOURCES
DIVISION OF OIL, GAS AND MINING

SUBJECT: Site Inspections; UMETCO; Calliham, Wilson/Silverbell, and Deremo/Peterson Mines; M/037/023, M/037/027, and M/037/025; San Juan County, Utah

**Photographs**
**M/037/023, M/037/027, and M/037/025; Calliham, Wilson-Silver Bell, and Deremo-Peterson Mines; UMETCO**
Inspection Dated: August 8, 2003; Report Dated: October 21, 2003

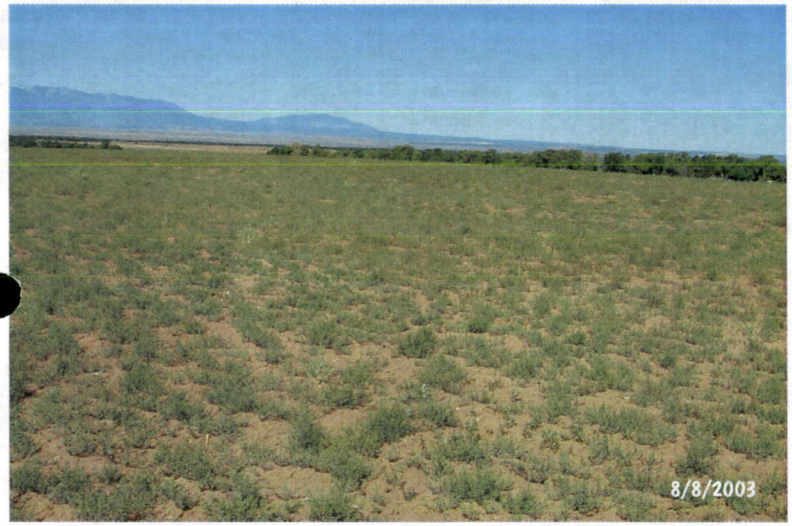
There has been some erosion on the waste pile and in a few other areas, and the operator installed erosion control matting in an attempt to control this erosion (Photos 3 and 4). There were erosion rills a few inches deep in other areas.

**Photo 1. The waste pile at Calliham. Note the ATV tracks on the left side of the photo.**

**Photo 3. One of the erosion control blankets at Calliham.**

**Photo 2. Typical vegetation at Calliham.**

**Photo 4. Another erosion control blanket at Calliham.**

Vegetation at the Calliham Mine did not meet revegetation success standards, but I was rushing to complete the sampling and did not feel the measurements were necessarily accurate. I need to go back when possible and take more measurements, particularly in the undisturbed area.

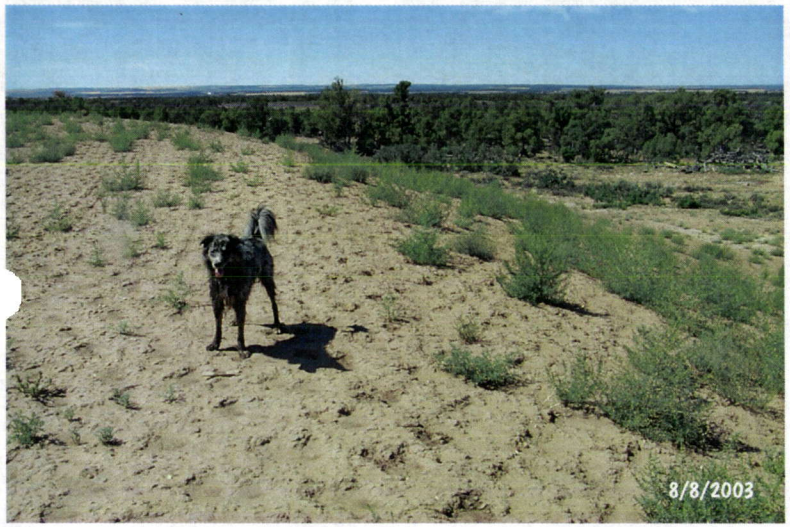
At the Wilson/Silverbell Mine, there was some Russian knapweed that the operator has been attempting to control with an herbicide called Curtail (Photo 8). The herbicide appears to have been effective in some areas, but the knapweed had hardly been affected in others. Herbicide applications on Russian knapweed tend to be most effective later in the summer, so there was still time to spray to try to control this persistent weed.

Part of the Wilson Mine was reseeded last year, and the vegetation has not done well. I believe there is less desirable vegetation than there was a year ago (Photo 5). Vegetation seems to be doing well at the Silverbell Mine.

**Photo 5. Waste pile at the Wilson Mine.**

**Photo 6. Waste pile at the Silverbell Mine.**

**Photo 7. A closer view of vegetation on the Silverbell waste pile.**

**Photo 8. Sprayed Russian knapweed at, I believe, Wilson.**

The operator needs to continue to try to control the Russian knapweed. I also suggest that portions of the Wilson and Deremo-Peterson Mines be seeded once again. I believe the reason for having so little vegetation is simply the dry weather the area has experienced the last few years.
