Denison Mines (USA) Corp.
1050 17th Street, Suite 950
Denver, CO 80265
USA

February 1, 2012

Re: Vent Hole Questions for the La Sal Mines

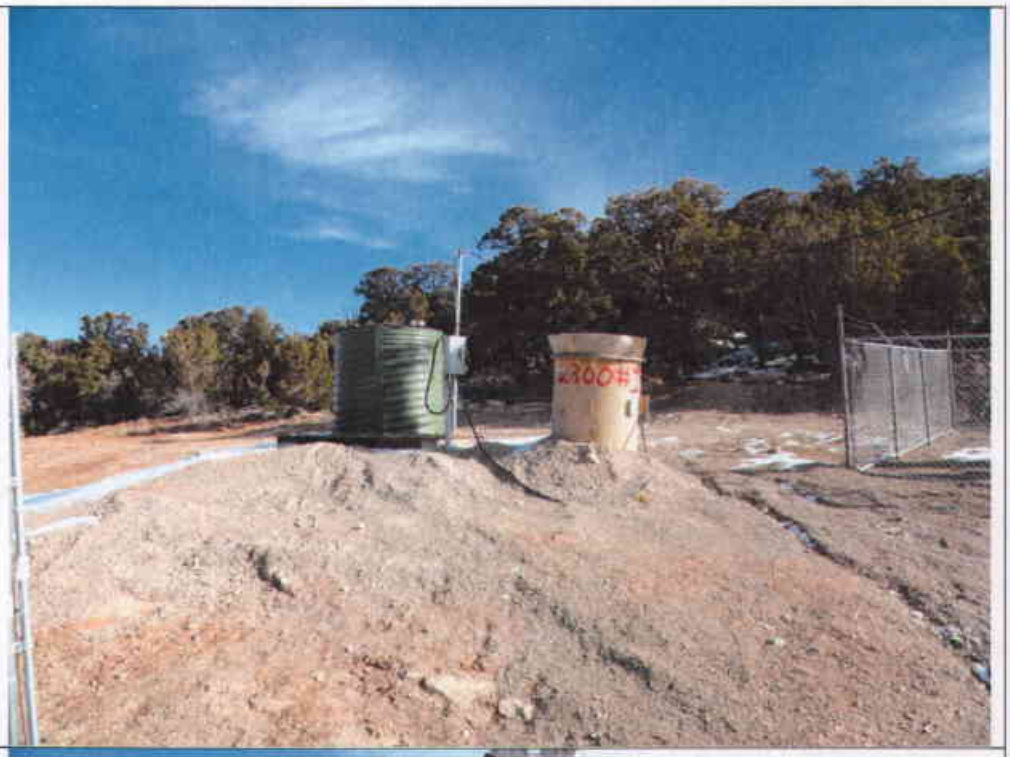
Vent 2300 #1

- Denison performed maintenance activities on the 2300 #1 and 2300 #2 vents in the late summer and fall of 2011. These vents were naturally plugged and were re-drilled adjacent to their existing locations. The photographs you forwarded where taken while these activities were ongoing. The former holes have since been reclaimed and updated photographs are provided with this letter.

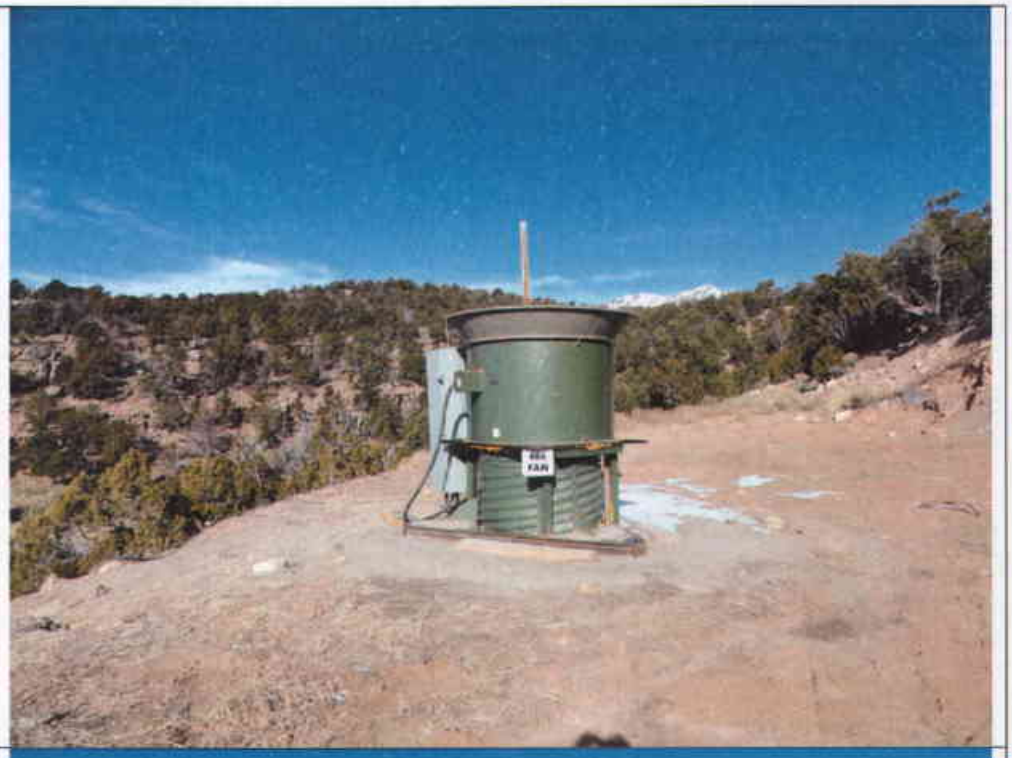
Vent 900

- The 900 vent was also a re-drilled hole and the former site has been reclaimed. Additional concerns included the electrical lines for this vent. Denison was at the site with the BLM in December and the electrical wiring for this vent and the 1050 vent were inspected. Denison followed up with a licensed electrician in Utah and is enclosing the specifications for the wiring at the site. In addition, MSHA has inspected these lines and indicated that armored cable is OK to be left on the ground. Photographs from the BLM inspection are also included.
