November 2, 1988

RE: Site Inspection, Kennecott, Utah Copper Division, Pine Canyon Reclamation Project, M/045/004, Tooele County, Utah

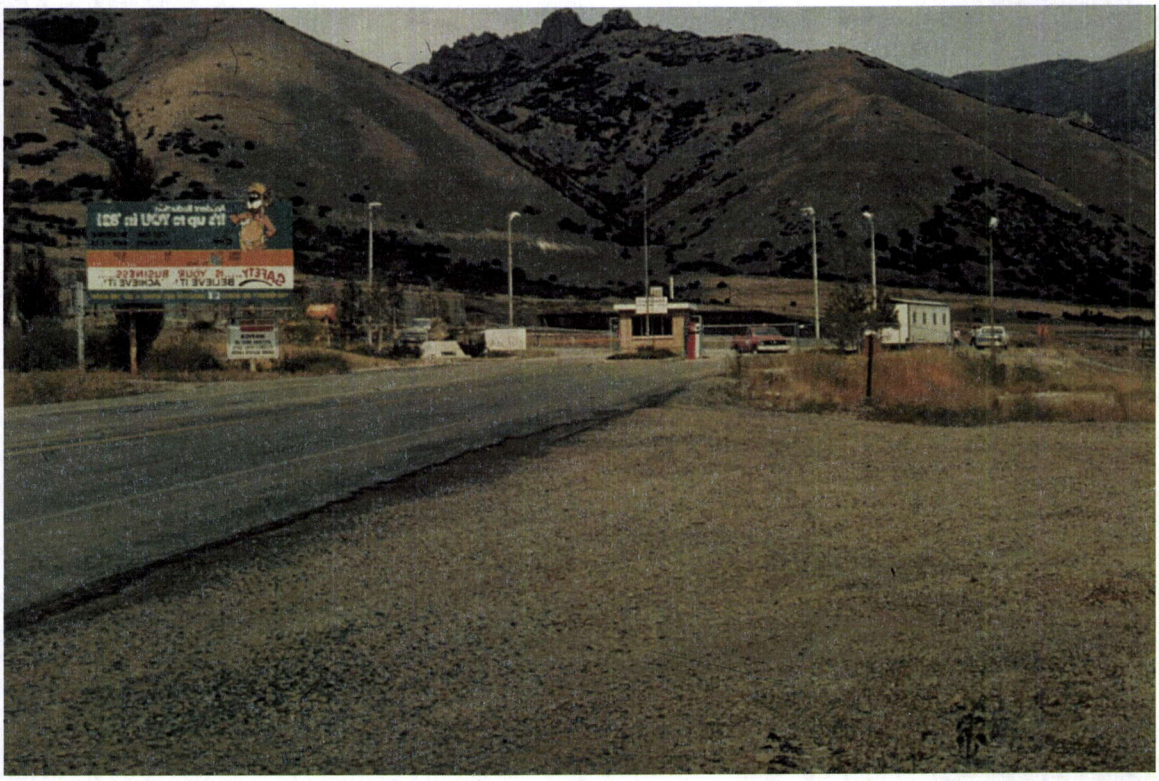
M/045/004 Kennecott - Pine Cyn. Reclam. Project
(11/1/88)
Upper Canyon regrading work
+ Channel reconstruction (above upper-most pad.)
* View to the west side of canyon

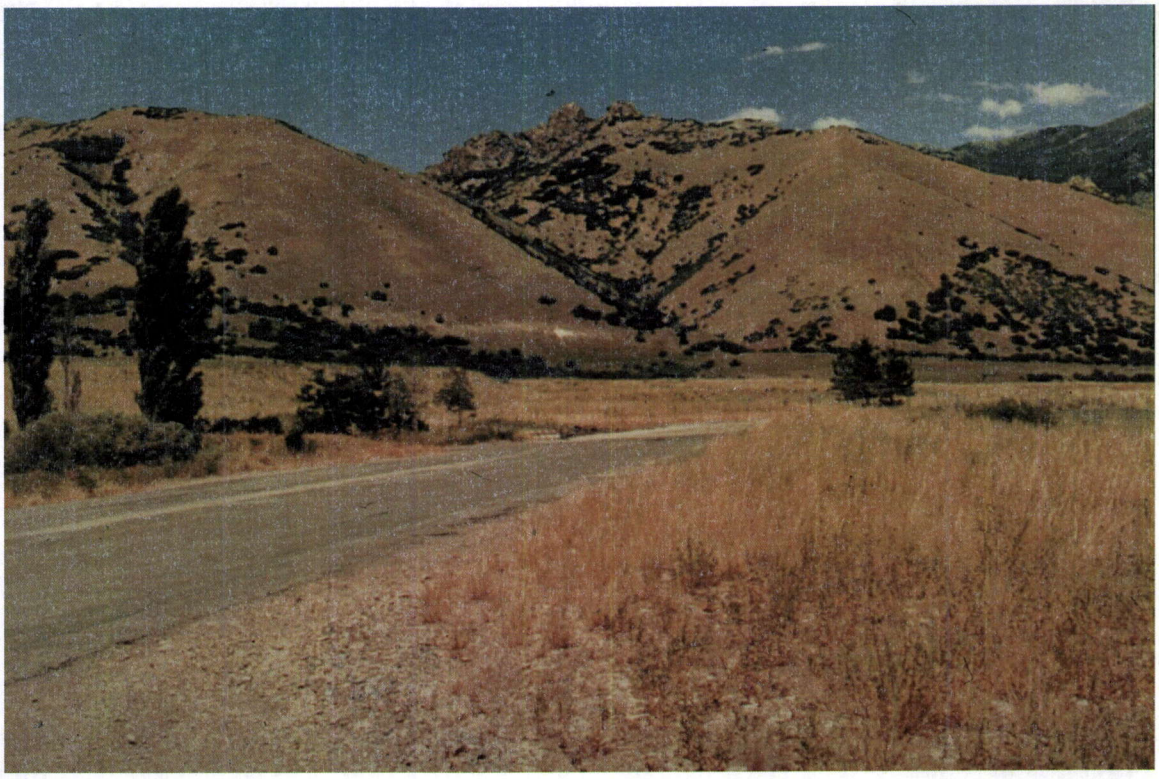
Channel reconstruction above upper most pad.

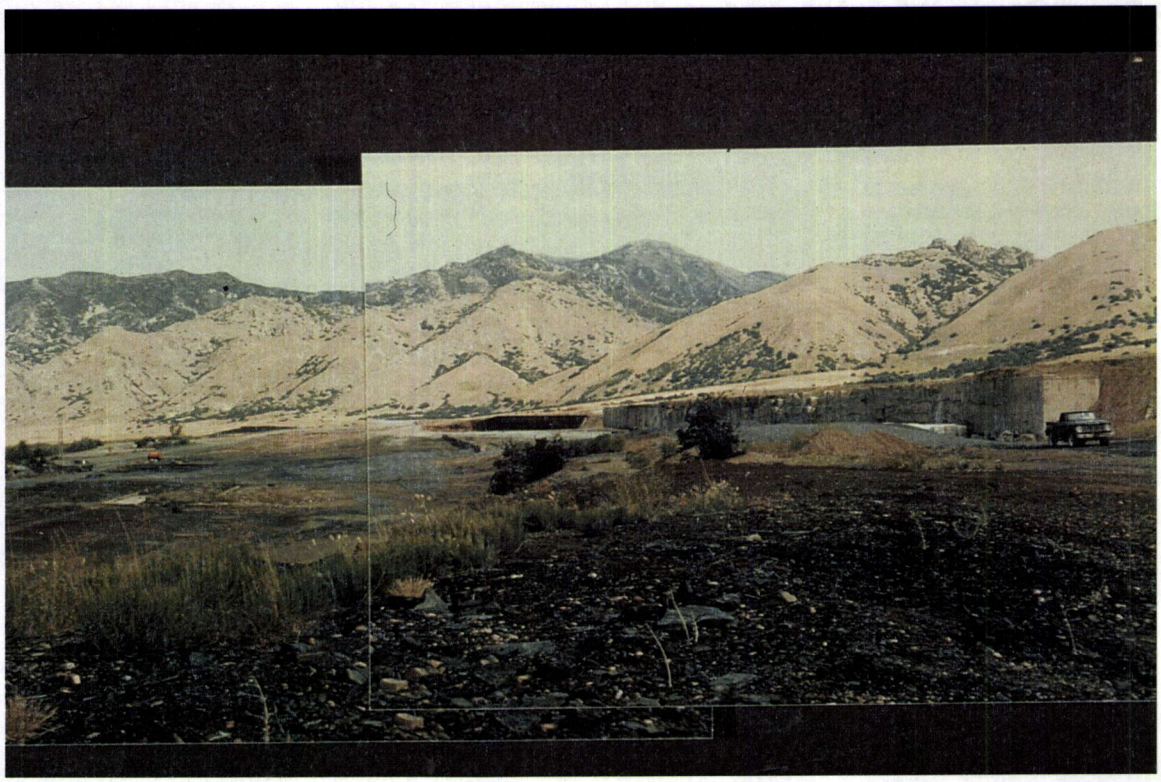
M/045/004 Kennecott – Pine Cyn. Reclam.
Regrading & foundation burial work.
(11-1-88)

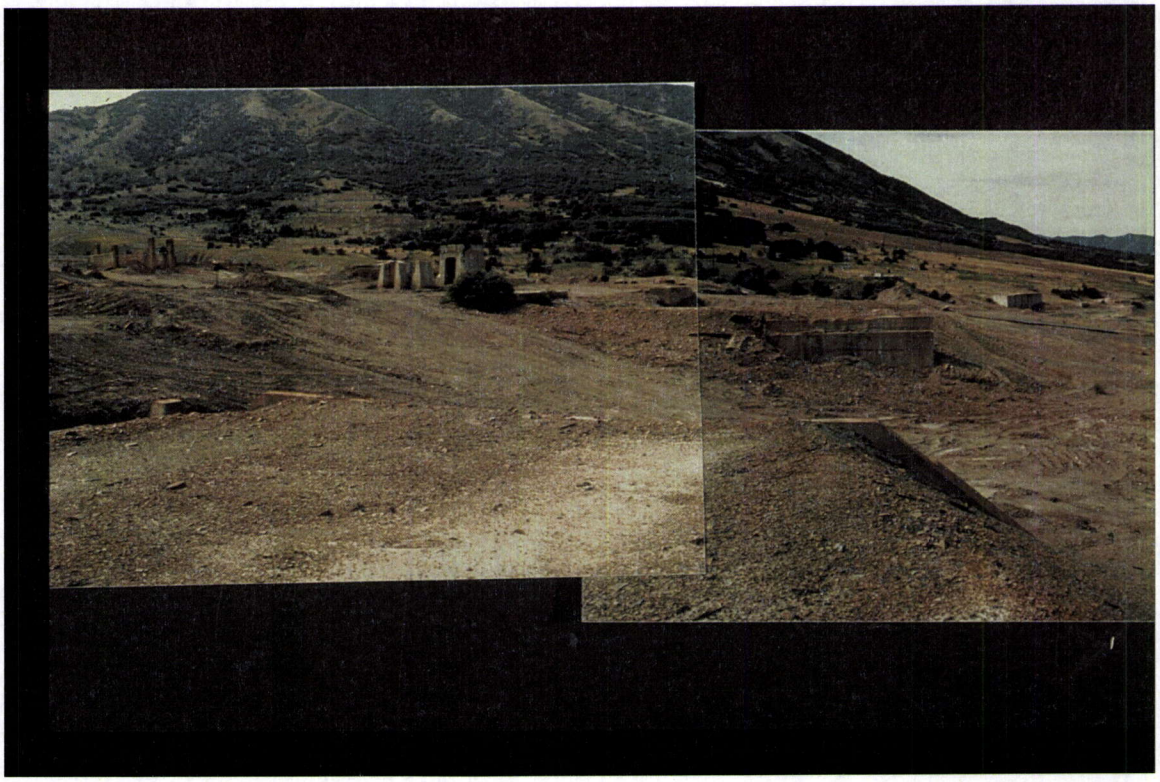
M/045/004 Kennecott – Pine Cyn. Reclam.
(11/1/88)
Upper Pad regrading + North Fork Channel reconstruction
* Note Pine Canyon Tunnel Closure lower left corner of picture.

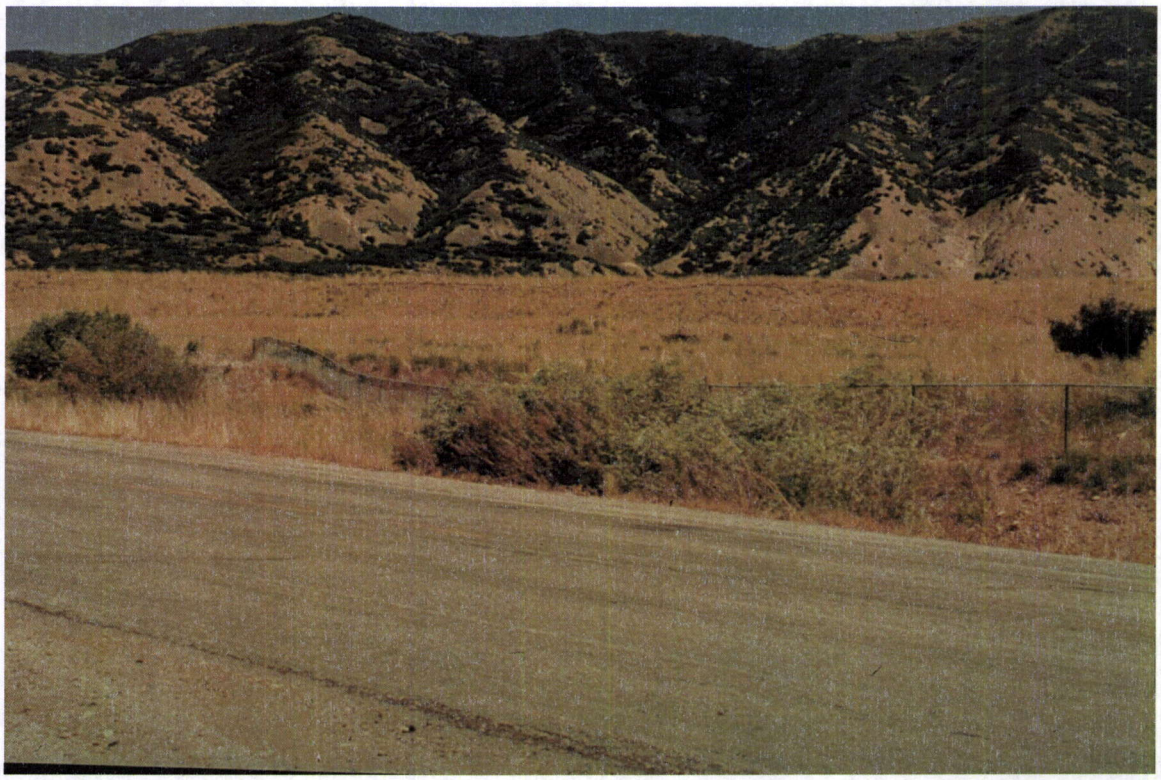
Some stream channel realignment modification may be required in the area where old stockpiled ore reserves have been removed. Currently, there is a large depression which is well below the proposed grade for the realigned stream channel. A series of drop structures were discussed as a possible solution to lowering the stream channel down to this grade. This would be a change in the previous design approval for this section of the channel. Another option would be to haul in a substantial amount of fill material to bring the depression area back up to grade.

D
M/045/004
11/1/88
Salvaged stockpiled ore area. Area is now below grade of proposed stream channel. Will require minor changes to engineering designs for channel section due to lack of fill.

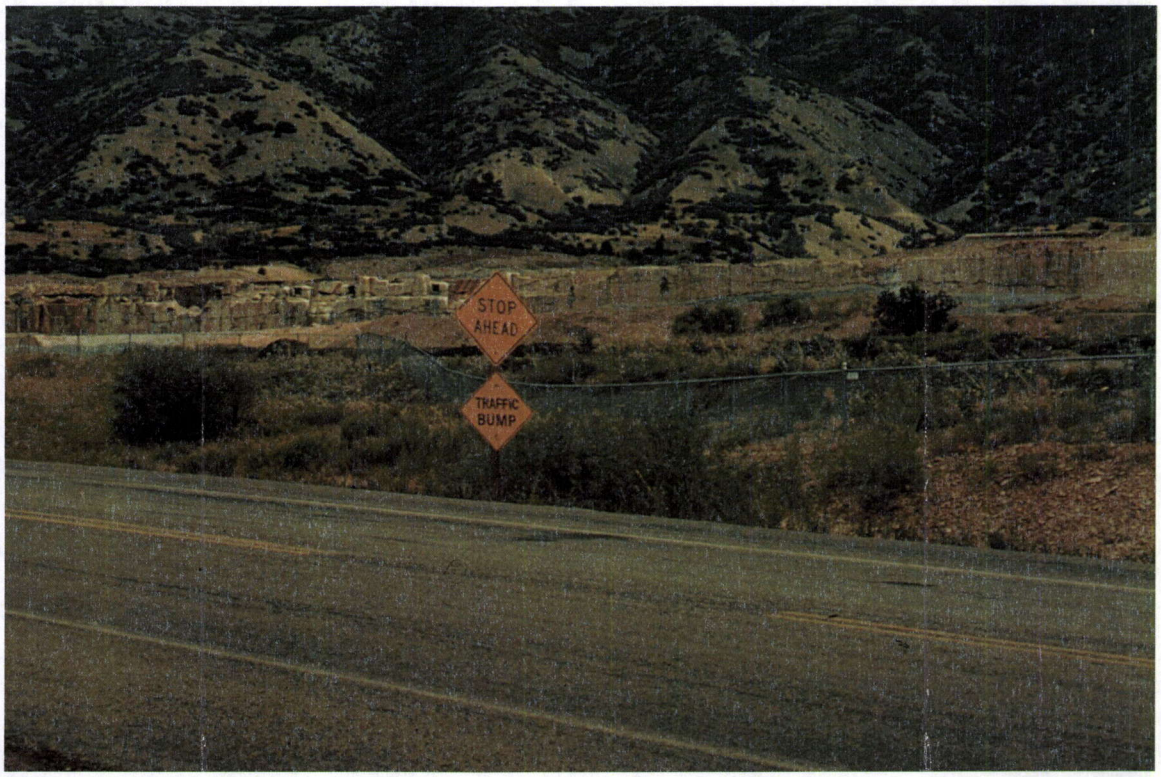
M/045/004 Kennecott – Pine Canyon Reclam.
(11-1-88)
Channel realignment construction.
* Area is adjacent (just west) of upper most pad.

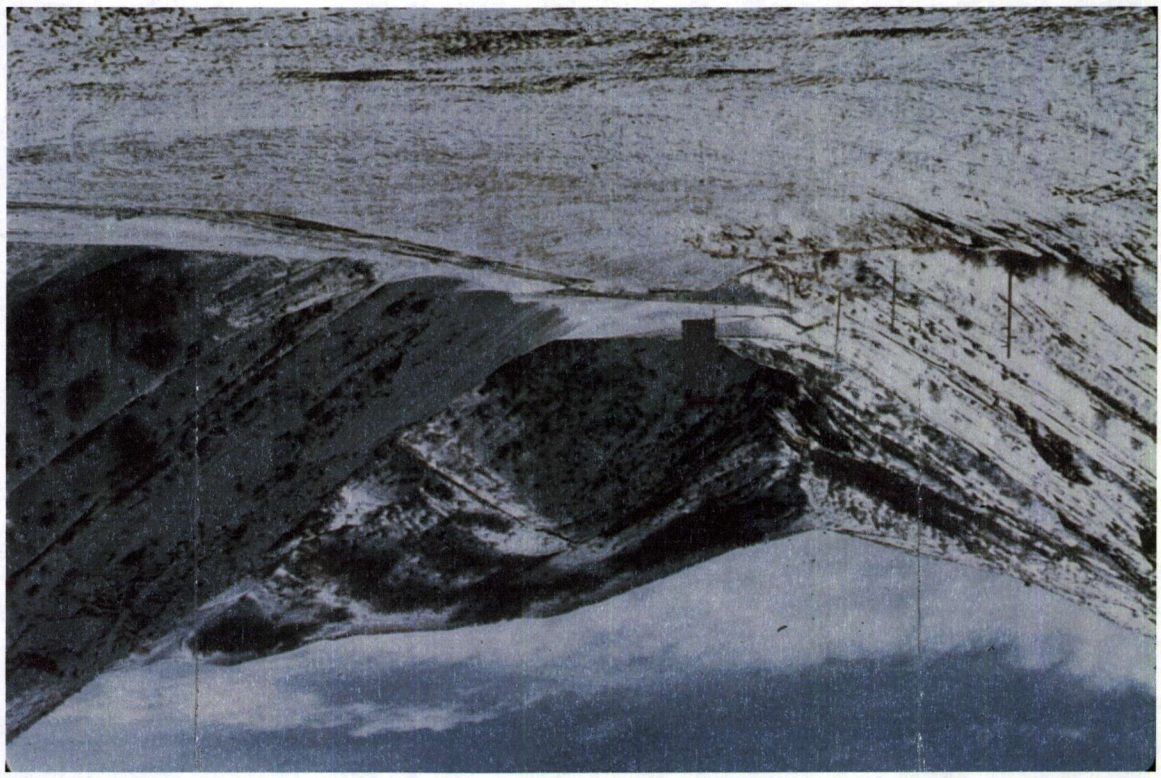
M/045/004 Pine Cyn. Reclamation
Area of old thickners, steel has been salvaged, hole to be plugged + then area regraded & revegetated
11/1/88
