S/047/0085

SITE INSPECTION
ML 47278

Date: May 31, 2006
Time: 5:30 to 6:30 PM
Persons Present: William Stokes, SITLA
Lease #: O,G & H, ML 47278
DOGM #: S/047/085
DOGM Reclamation Bond: $18,600.00
Lands Inspected: Access within Section 36, T4S, R20E, SLB&M, Uintah County

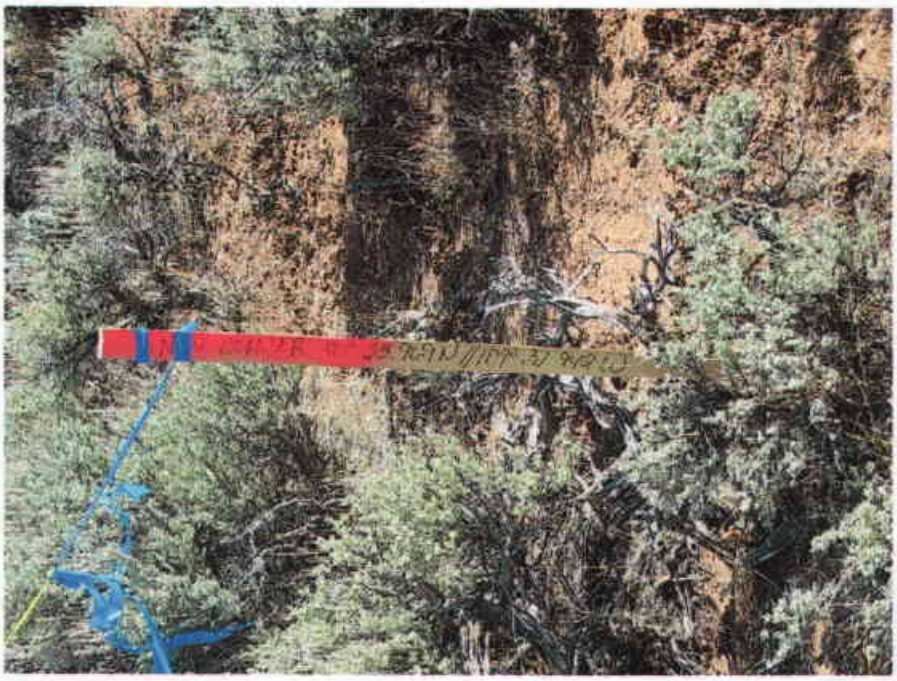
ML 47278 – 5-31-06 Survey marker believed to be the establishment on of the northwest corner of Section 36. The marker is identified as the NW corner, 40*25.969N, 109*37.942W. There is evidence in the field that the original NW section corner is nearby at a different location.

ML 47278 – 5-31-06 The Notice of Intent identified a five acre parcel at the northwest corner of Section 36 as the proposed mine site. Note the painted arrow on the ground at the turn off to this location. There is not development at this site.

ML 47278 – 5-32-06 Looking south onto the 5 acre mine site as proposed in the Notice of Intent.

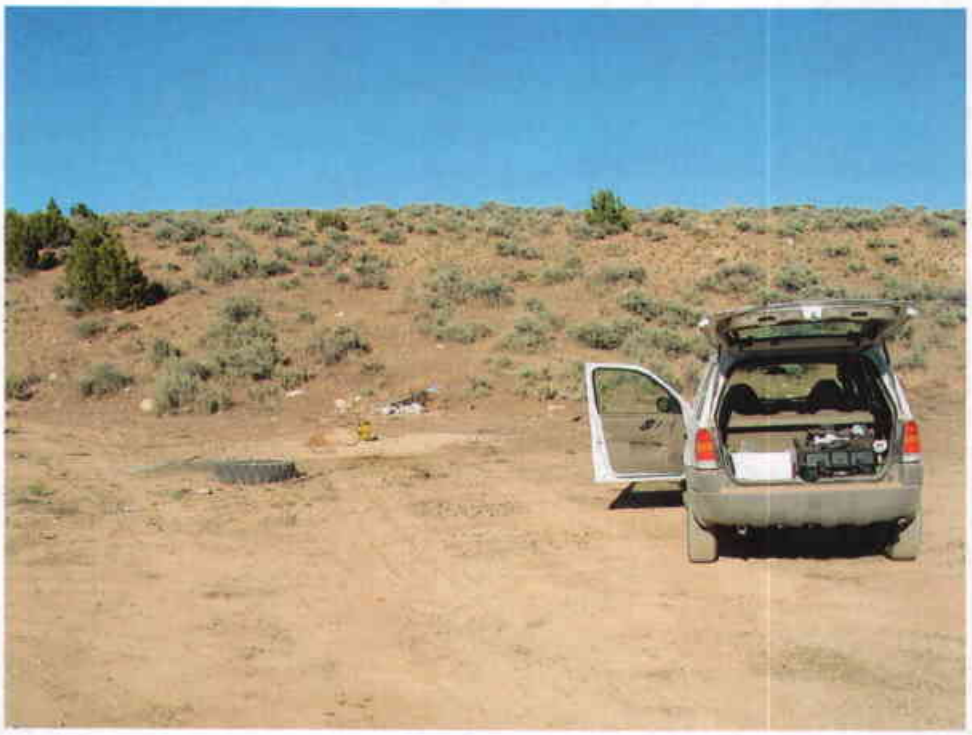
ML 47278, 5-31-06 The GPS unit, at the drill hole, is located at UTM coordinate N 4476227.60, E 616147.72. The drill hole is located along a road that accesses to north central portion of Section 36.

ML 47278, 5-31-06 Looking south onto a drill hole, next to the rock, that is covered with a piece of plywood. This drill hole is approximately 4 feet deep. Note that there are few cuttings around the drill hole. The UTM coordinates are N 4476415.22, E 616204.50.

ML 47278, 5-31-06. Looking east from a drill hole that is located just off the access road near the center of the N½ Section 36. The UTM coordinates for this drill hole are: N 4476448.52, E 617208.03.
