Minerals Inspection Report

Mine Name: Harrison	Permit Number:	S/47/0100	Mine Status:	Reclaimed
Operator Name: Zeigler Chemical	Inspection Date:	5/6/2015	Permit Fees:	Paid
Inspector(s): A. Abate	Inspection Time:	12:30 PM	Bond Amount:	$7,300
Attendee(s): Chip Zeigler, Zeigler Chemical	Weather:	Cloudy 60F	Bond Escalation:	12/15/2012
Inspection Purpose: Determine if the site has been reclaimed			Prior Inspection:	None

Harrison Permit S/47/0100

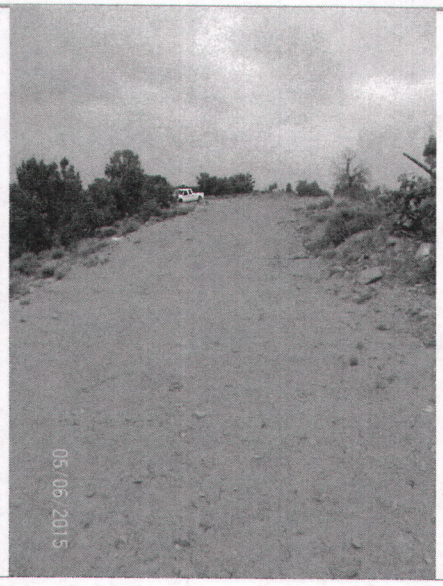
2.	*Public Safety (shafts, adits, trash, signs, highwalls)*	☒	☐
	There is an exposed gilsonite vein adjacent to the west. However, that is on another company's claim and not under the responsibility of Zeigler Chemical.

3.	*Protection of Drainages/Erosion Control*	☐	☐
4.	*Deleterious Material*	☐	☐
5.	*Roads (maintenance, surfacing, dust control, safety)*	☐	☐
6.	*Reclamation*	☒	☐
	All major structures have been removed from the site. Site is graded and is looking good.

Road to Harrison work area.

Reclaimed Harrison pad.

Wash located below the Harrison pad.

Exposed gilsonite vein at the adjacent claim.

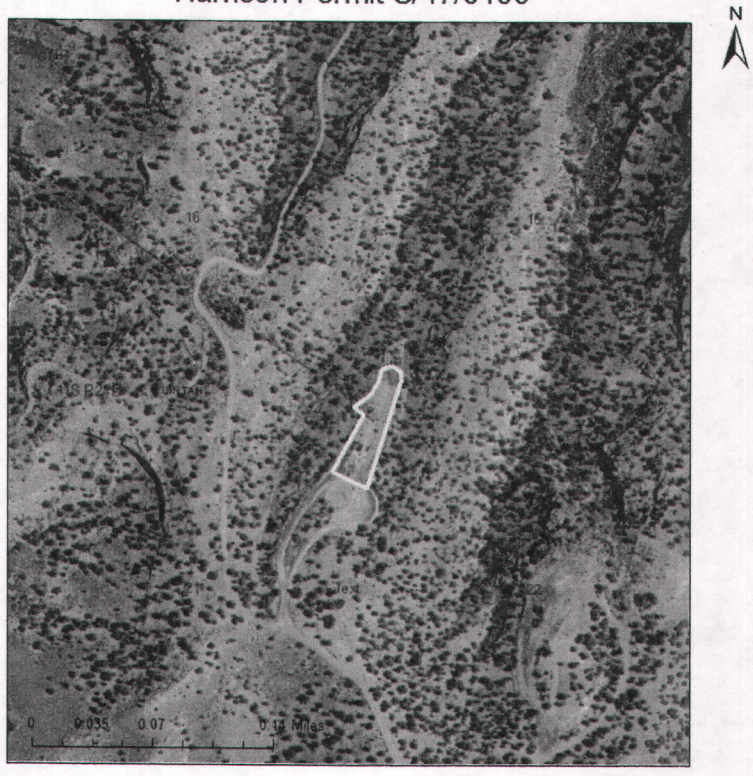
Note: Yellow boundary is the permit area 0.75 acres.
