Canyon Fuel Company, LLC
SUFCO Mine

SUBSIDENCE CAVING PROFILE
ELUSIVE PEACOCK SHELTER

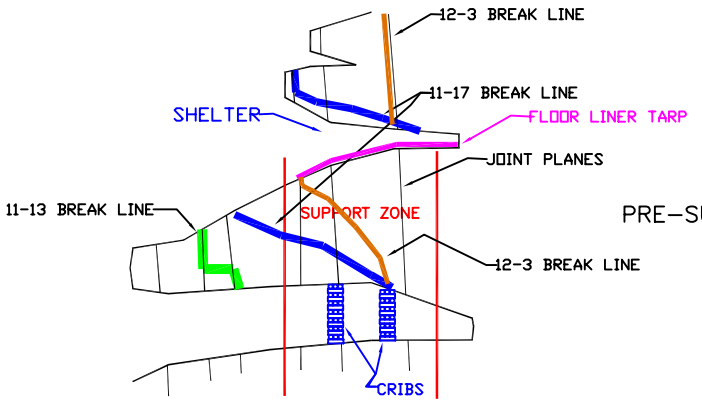
A

PRE-SUBSIDENCE

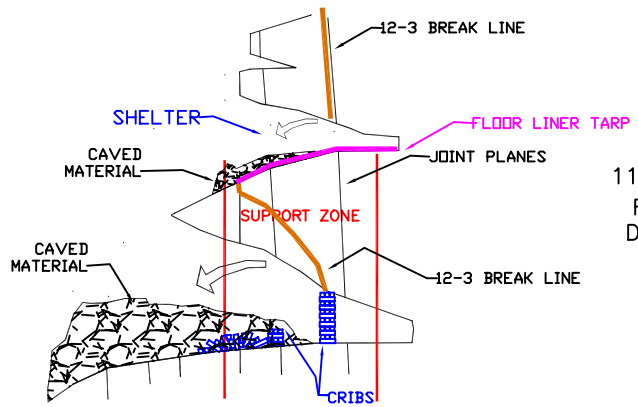
C

11–17–03, 12:00PM
ROOF SHEARS INTO DOME SHAPE UNDER COMPRESSION

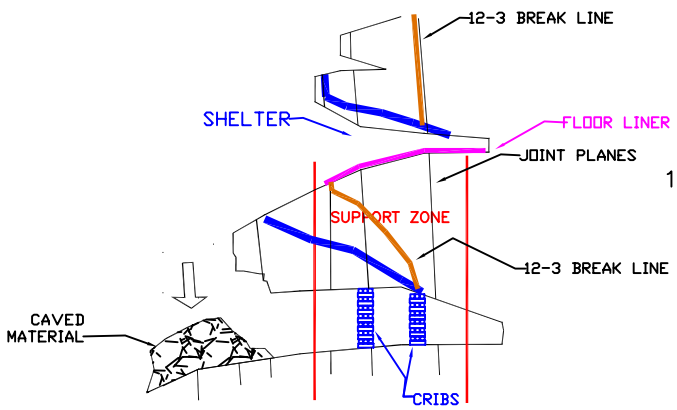
B

11–13–03, 12:00PM
ROOF FAILS ALONG JOINT PLANES UNDER TENSION

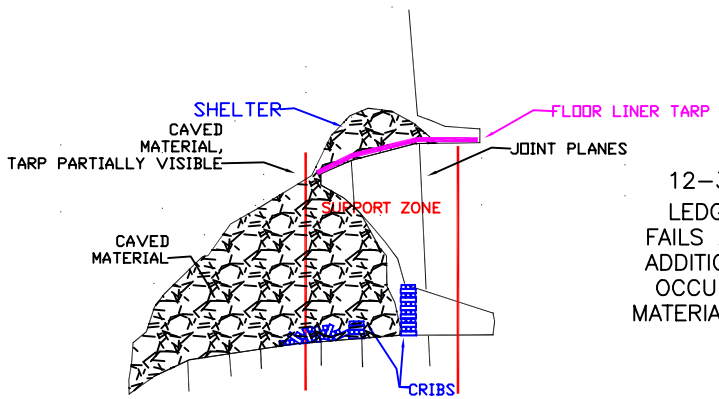
D

12–3–03, 12:00PM
LEDGE ABOVE SHELTER FAILS ALONG JOINT PLANE. ADDITIONAL SHEAR FAILURE OCCURS IN LOWER CAVE. MATERIAL FILLS LOWER CAVE.
