Geotechnical Investigation of
Cut Slopes at the Belina Mine Complex
and Haul Road
Carbon County, Utah

Valley Camp of Utah,
Helper, Utah

Morrison-Knudsen Co., Inc.
Boise, Idaho

October, 1983

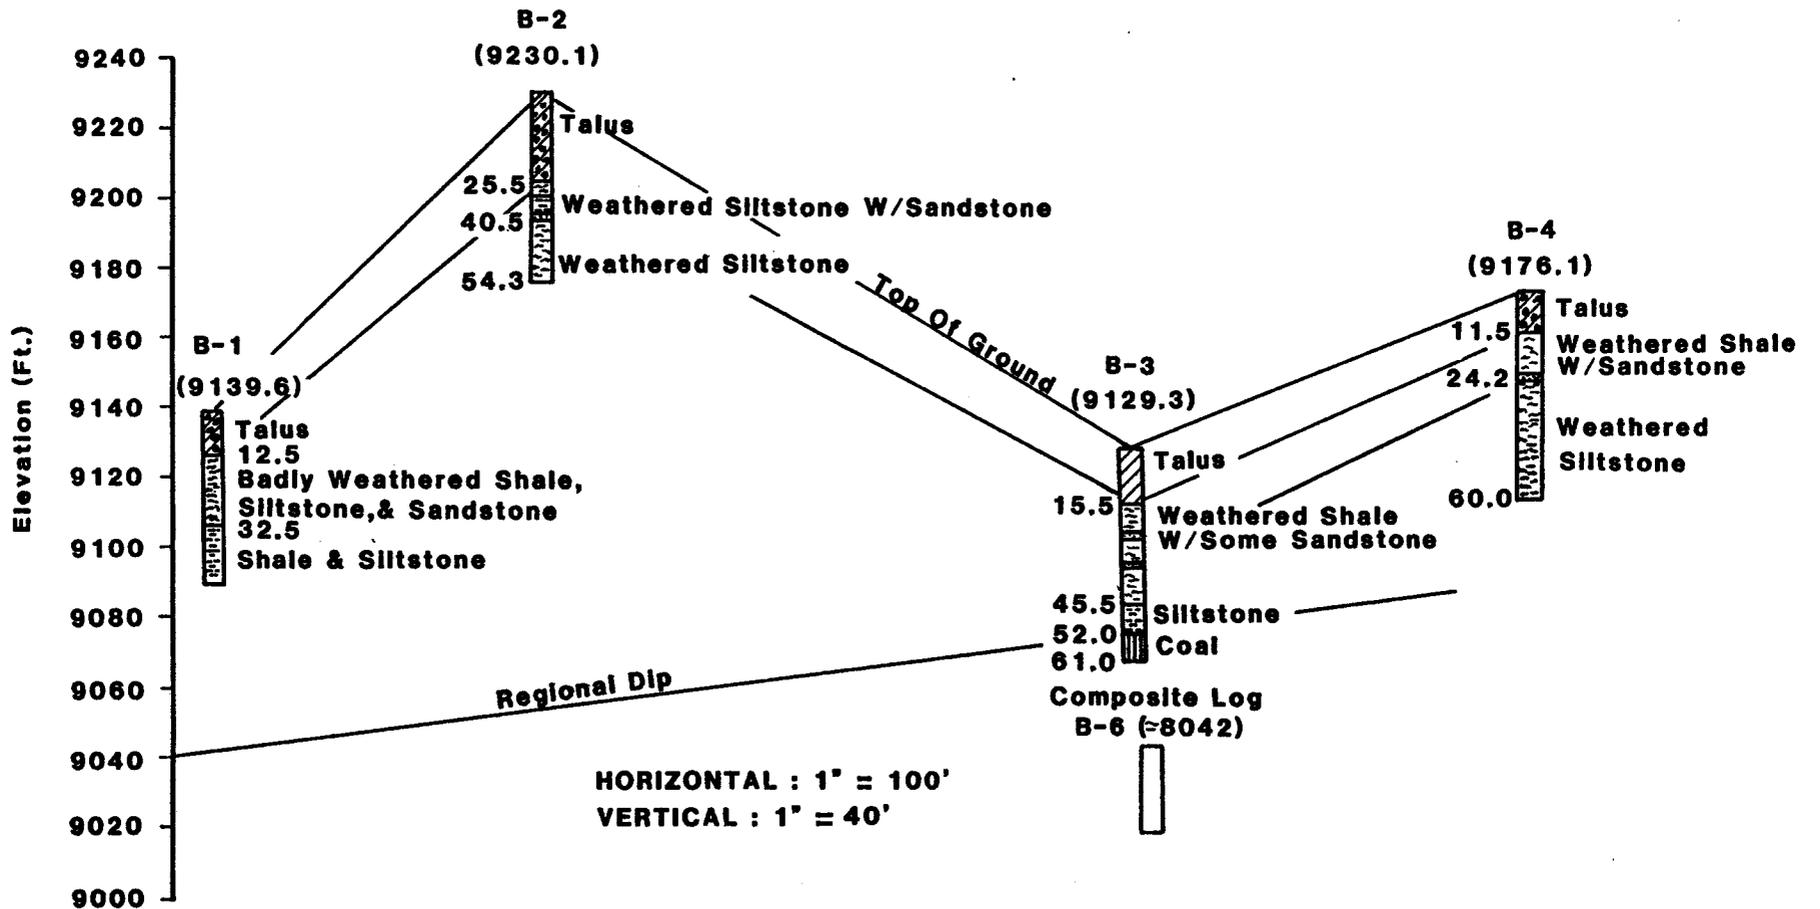
**VALLEY CAMP OF UTAH, INC.
 BELINA MINE, CARBON COUNTY
 GENERALIZED BACKSLOPE SECTION
 FIGURE 14**

A generalized backslope lithologic section is presented in this report as Figure 14, which represents data obtained from the four backslope borings.

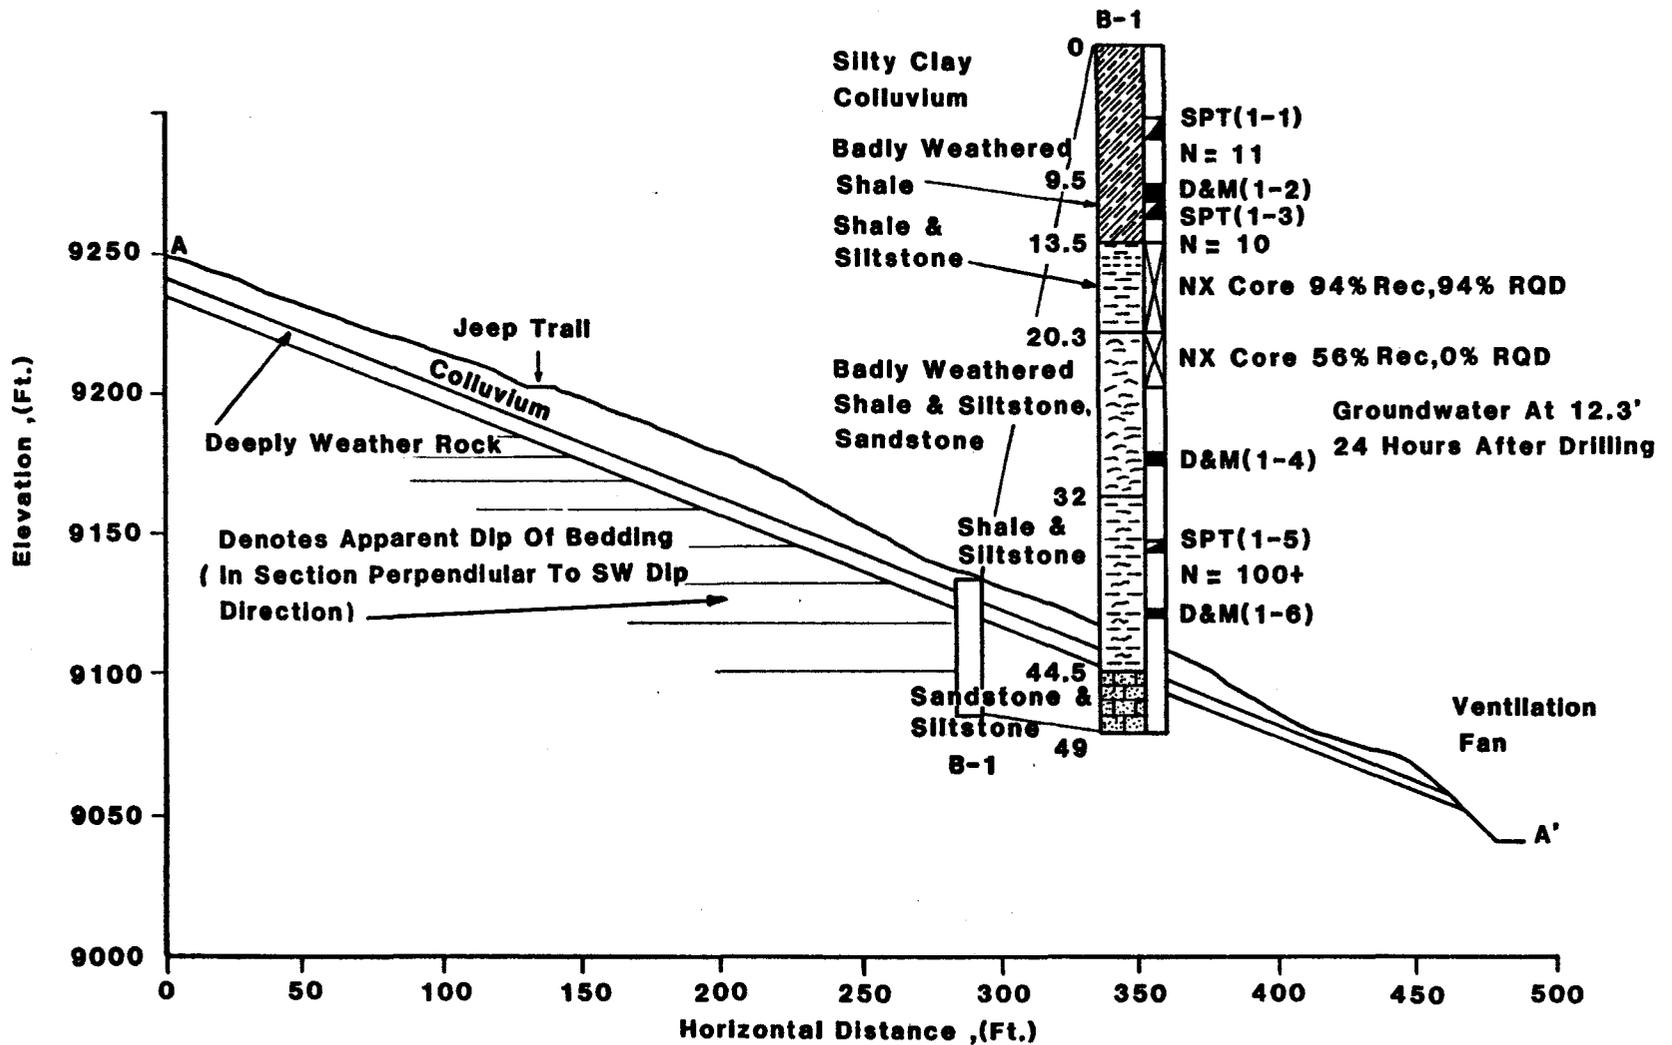
VALLEY CAMP OF UTAH, INC.
 BELINA MINE, CARBON COUNTY
 UPPER PORTAL BACKSLOPE SECTION A - A'
FIGURE 15

Sections A-A' and B-B' (Figures 15 and 16) present simplified geologic cross sections through boring nos. 1 and 2, respectively. The sections also show

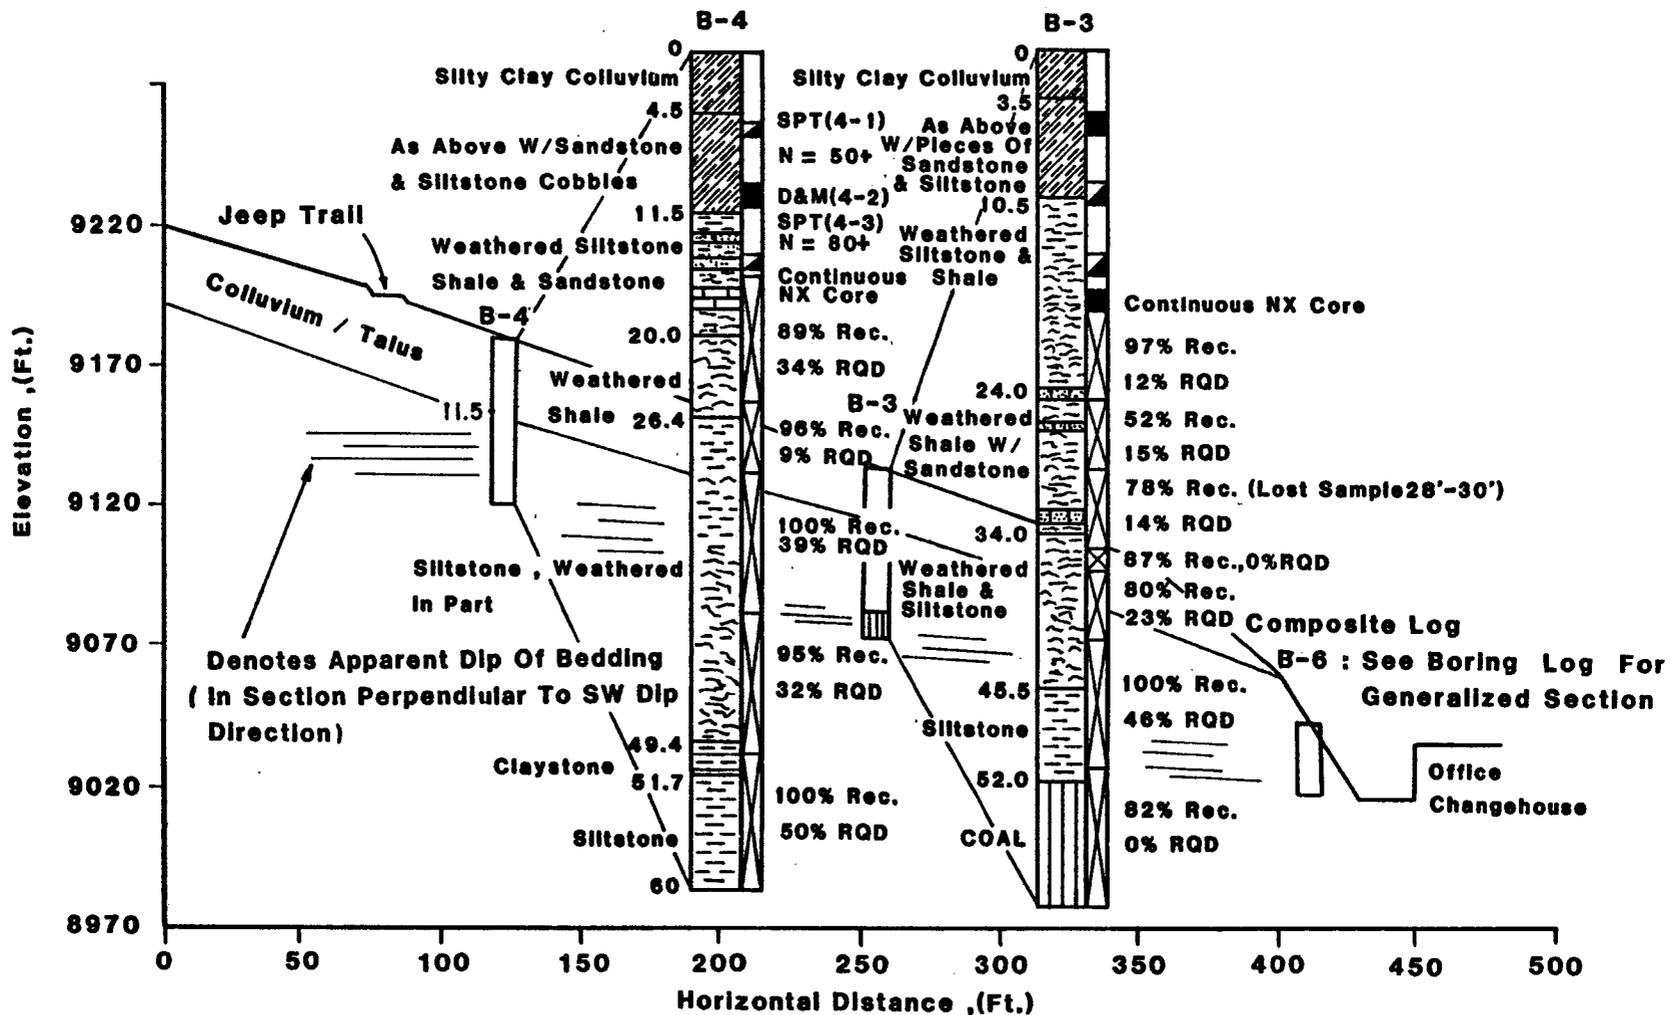
VALLEY CAMP OF UTAH, INC.
 BELINA MINE, CARBON COUNTY
 UPPER PORTAL BACKSLOPE SECTION C - C'
FIGURE 17

Section C-C' (Figure 17) presents the generalized geologic section of this slope.

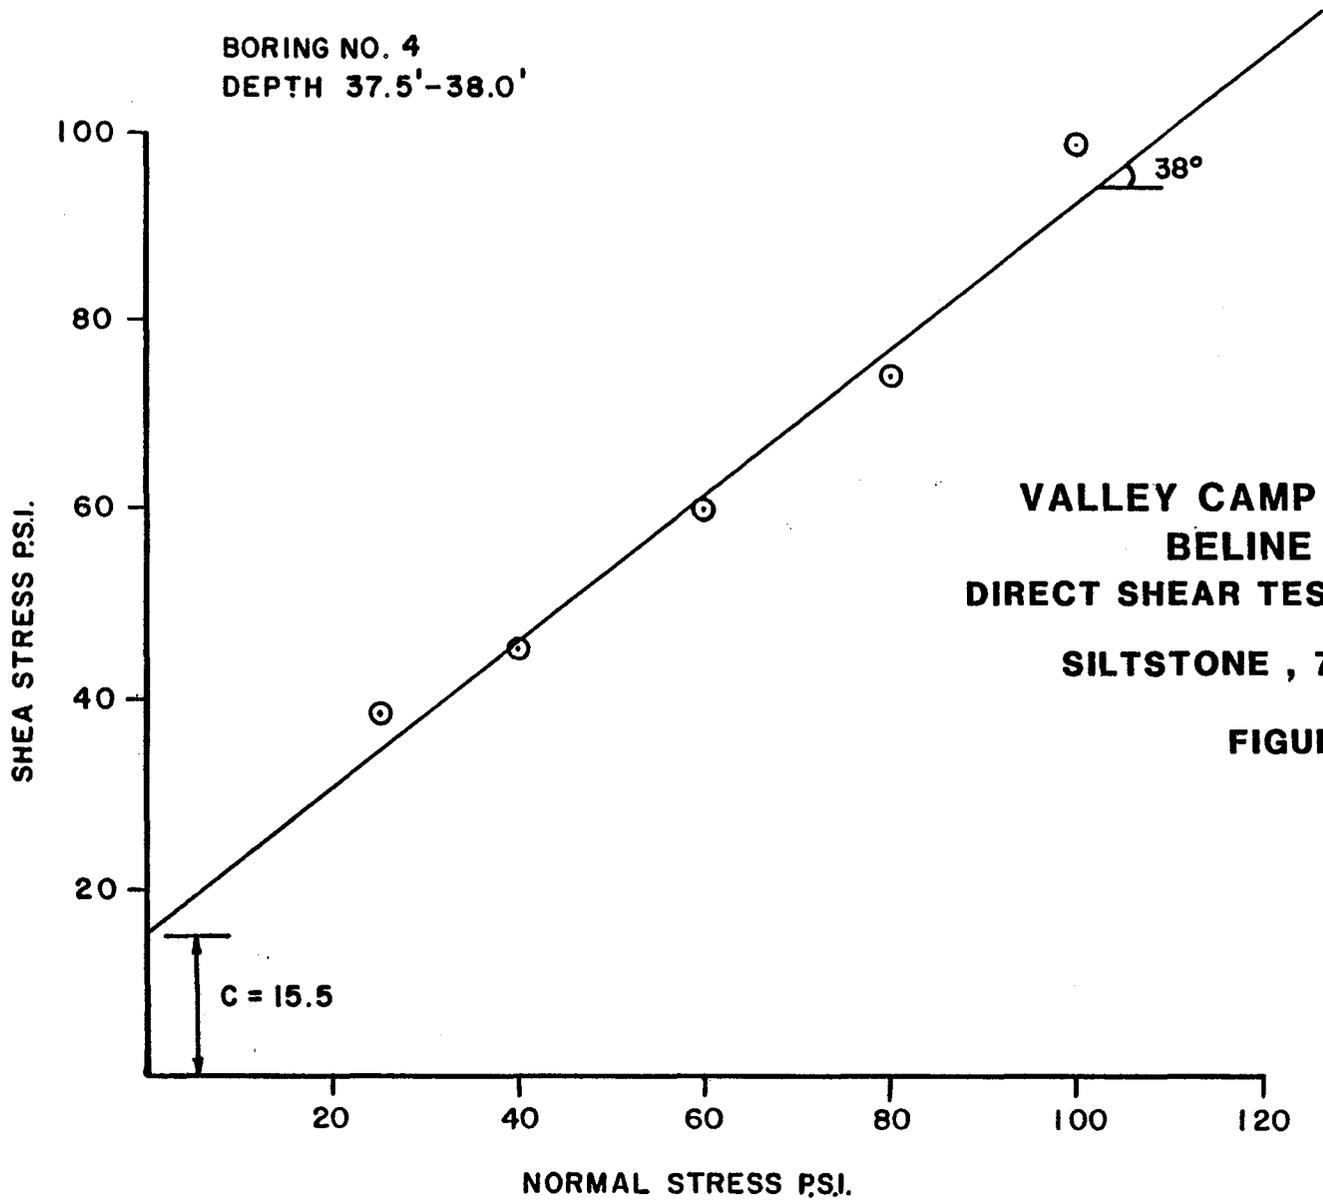
FIGURE 20

VALLEY CAMP OF UTAH , INC.
BELINE MINE
DIRECT SHEAR TEST ON DISCONTIUIITY :
SILTSTONE , 77% OPEN JOINT
