Canyon Fuel Company, LLC  
**Skyline Mines**

C/007/005

2006 Annual Report

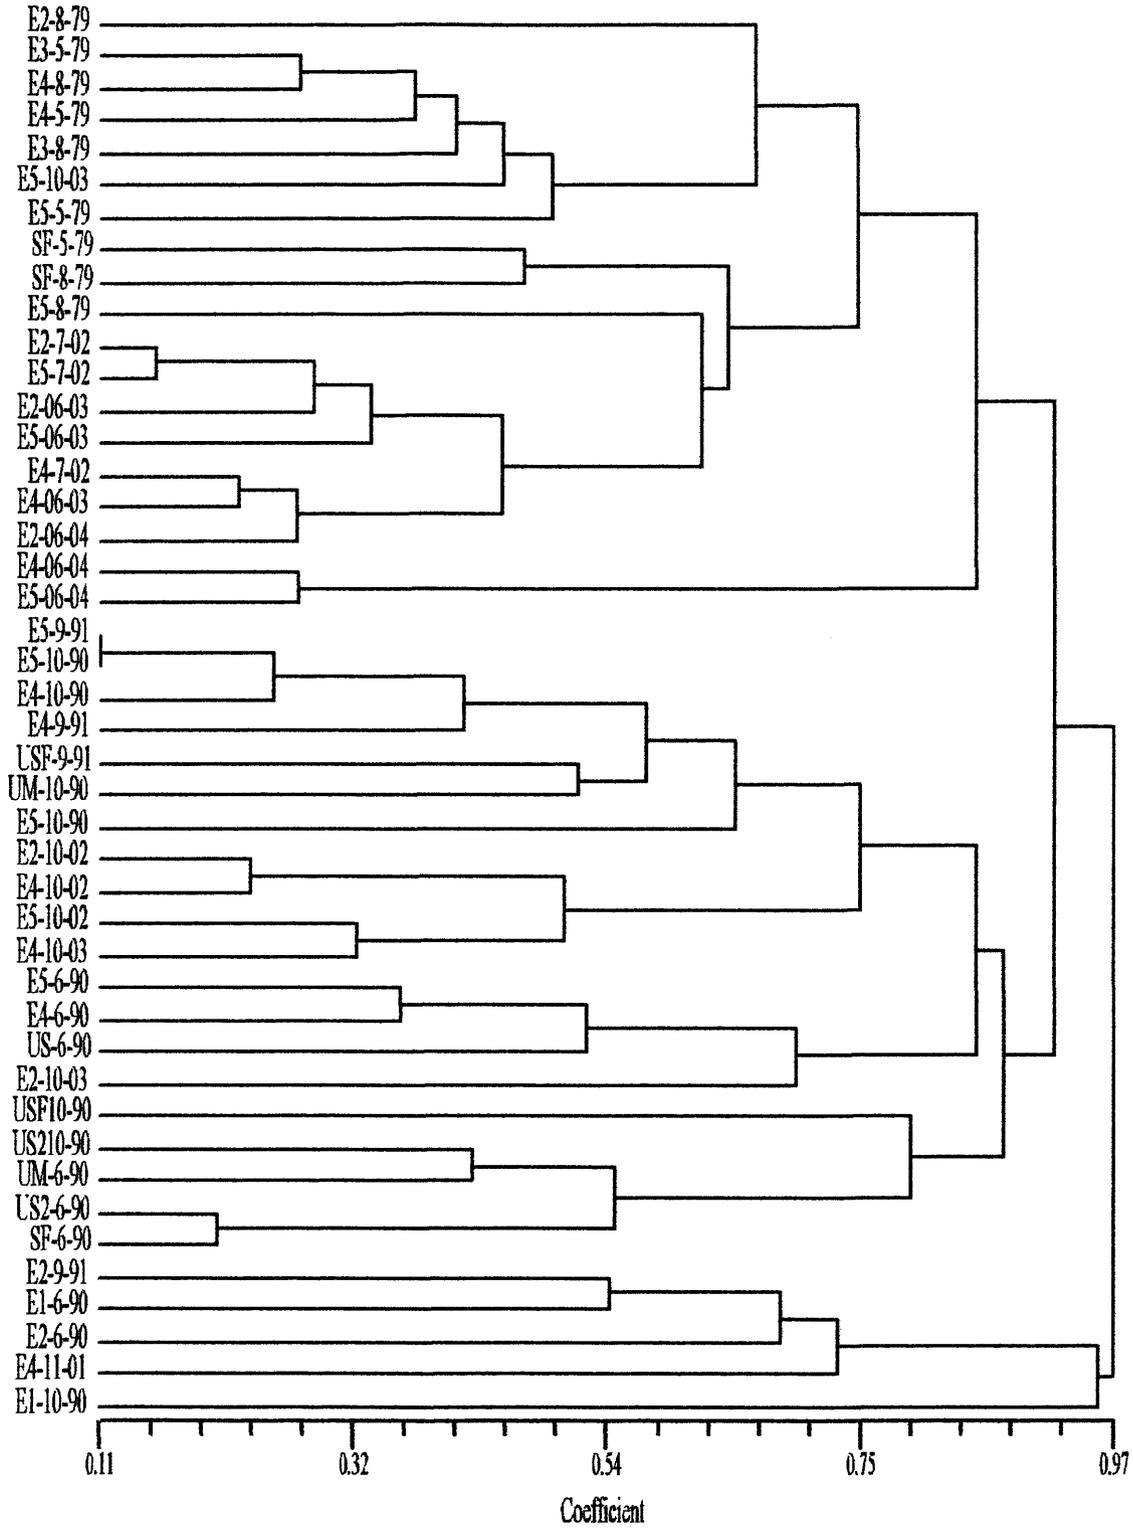
Figure 1. UPGMA cluster dendrogram of relationships among stations and dates sampled.

The final analysis utilized in this study was clustering. This approach generates a visual representation of the relationships among samples based upon their similarity or dissimilarity to one another. The dissimilarity index utilized in this study considers both quantitative counts of individuals within each taxon and their relative densities. The cluster results (Figure 1) separate the majority of the spring-summer samples, including all of the reference samples, into one cluster while the fall samples are part of a second cluster. The exceptions are eight spring samples taken in the 1990s and one sample taken in fall, 2003, at station EC5. The 1990 samples occur in the fall cluster but show a high dissimilarity to other members of the fall grouping. The fall, 2003, samples from EC5 placed that station in the spring-summer samples with it being most similar to the 1979 reference samples. The overall separation of spring-summer samples from the fall samples illustrates very clearly the effect of seasonality.

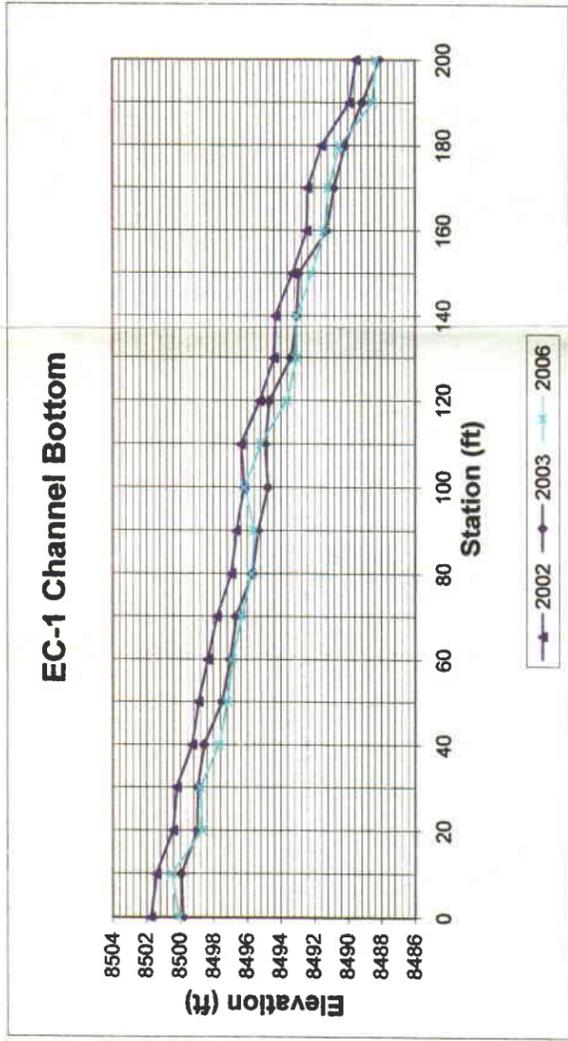
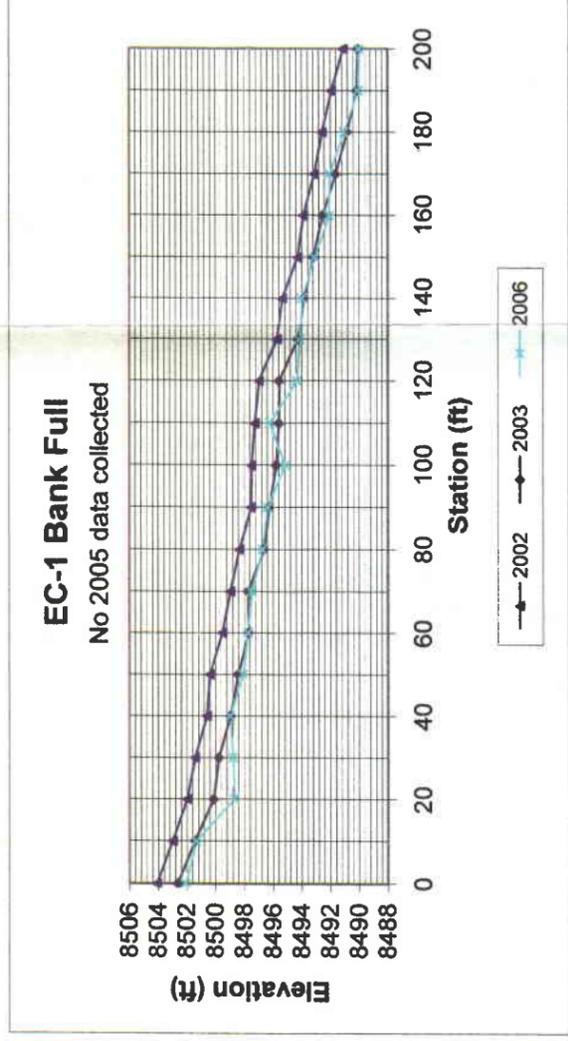
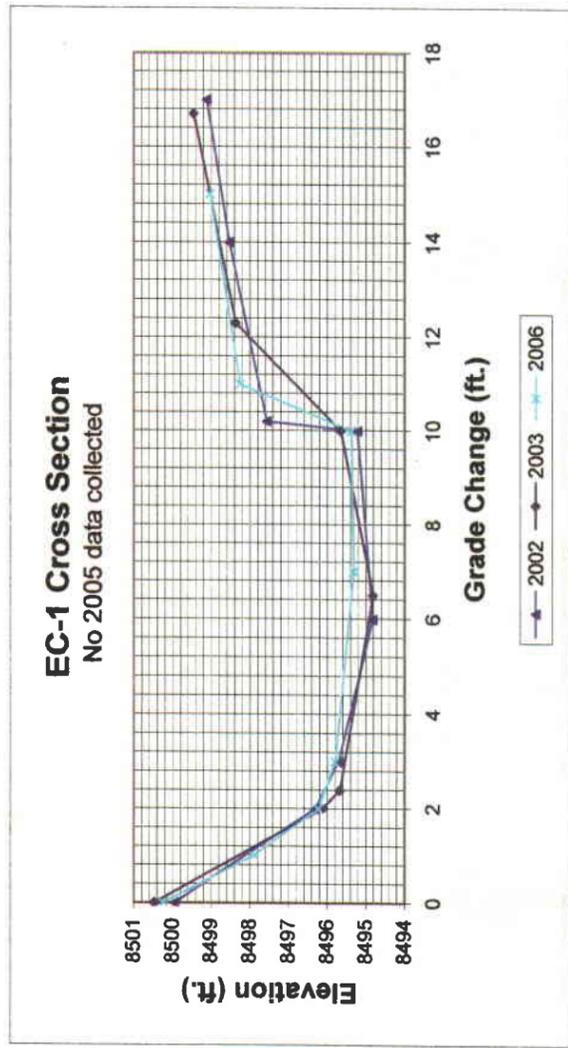
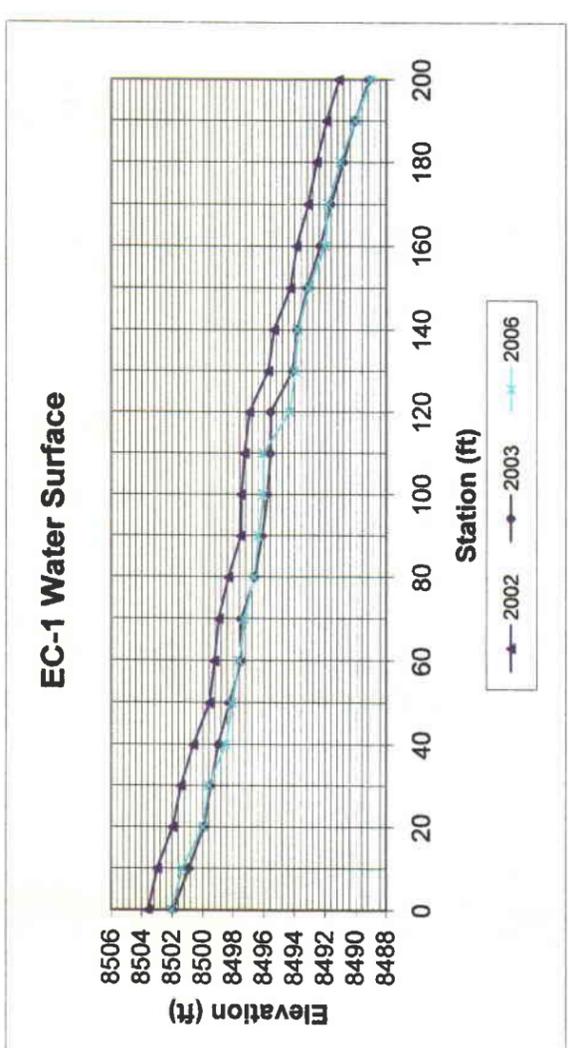
FIGURE 3-1. EC-1 CROSS-SECTION AND PROFILES

As indicated in the 2003 annual report (EarthFax, 2003), differences between 2002 and 2006 at EC-1 are likely due to a longitudinal shift in the profile end points along the channel. To assess this effect, Figure 3-1 includes not only the 2002 and 2006 profile data, but also the 2003 profile data. As indicated, essentially no difference exists between the 2003 and 2006 profiles, indicating that the shift occurred in the 2002 survey.

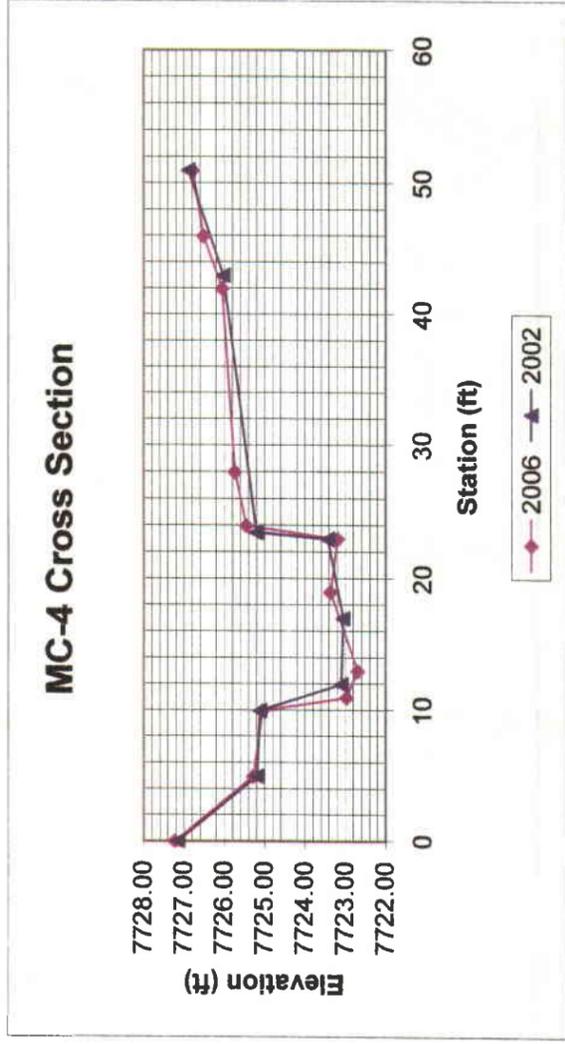
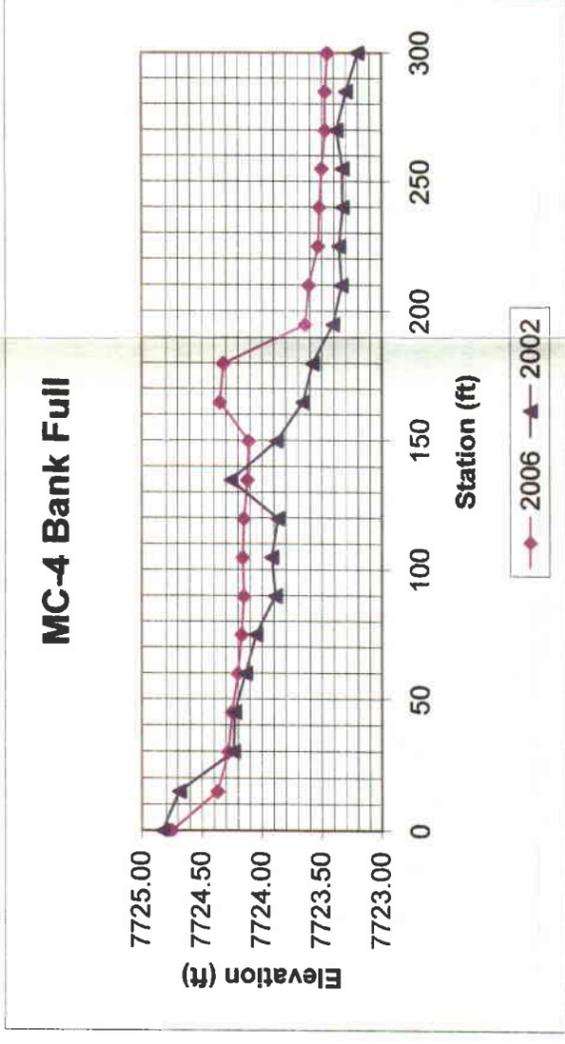
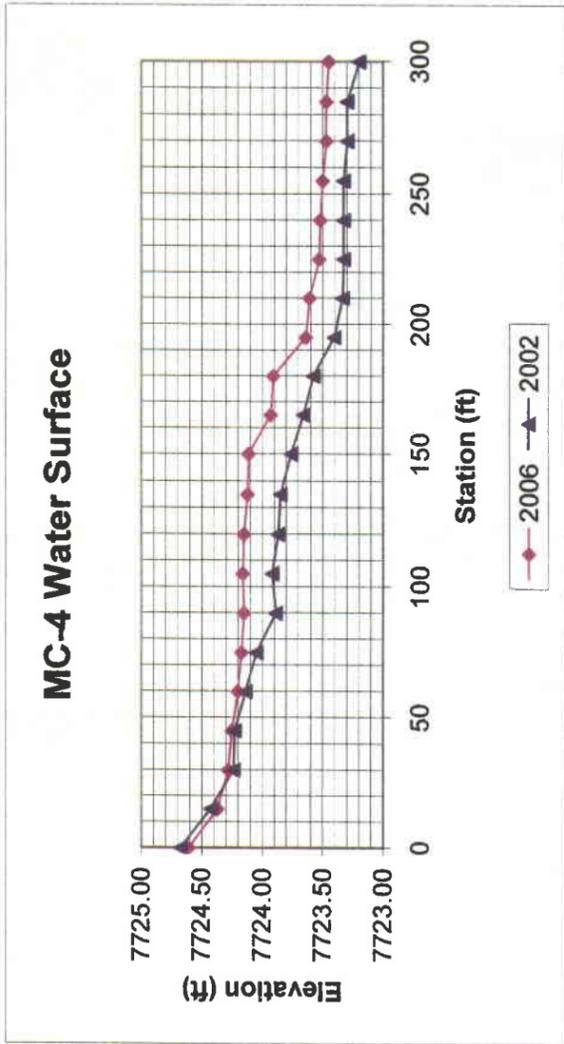
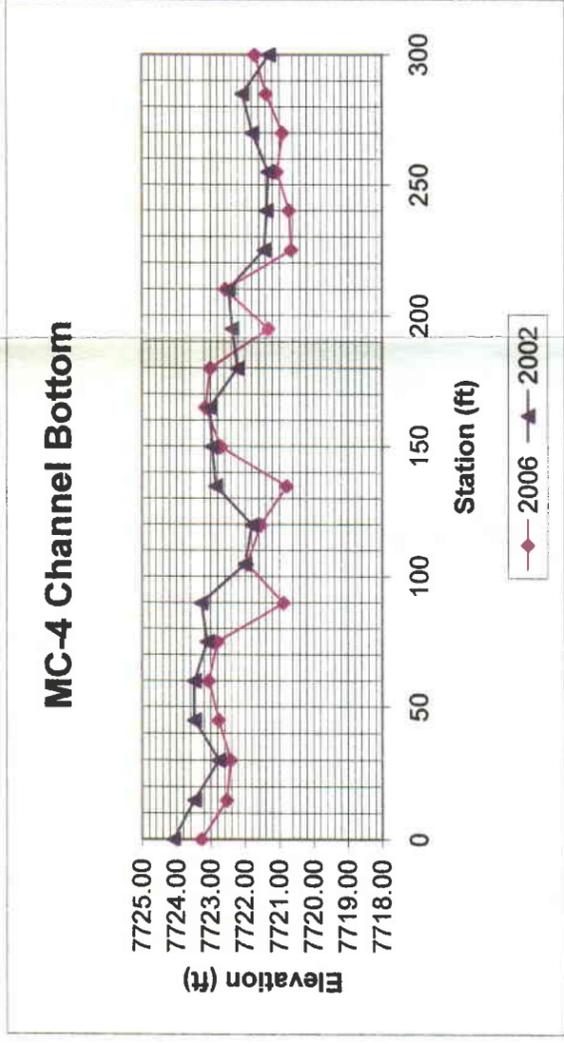
FIGURE 3-7. MC-4 CROSS-SECTION AND PROFILES

The channel bottom at MC-4 exhibited more variation in 2006 than was apparent in prior years. Visual observations of the stream channel at this location indicated short stretches of aggradation and degradation that did not previously exist in the reach. This reach exists within a pasture that is heavily grazed, with banks that show signs of extensive damage from livestock access to the stream.

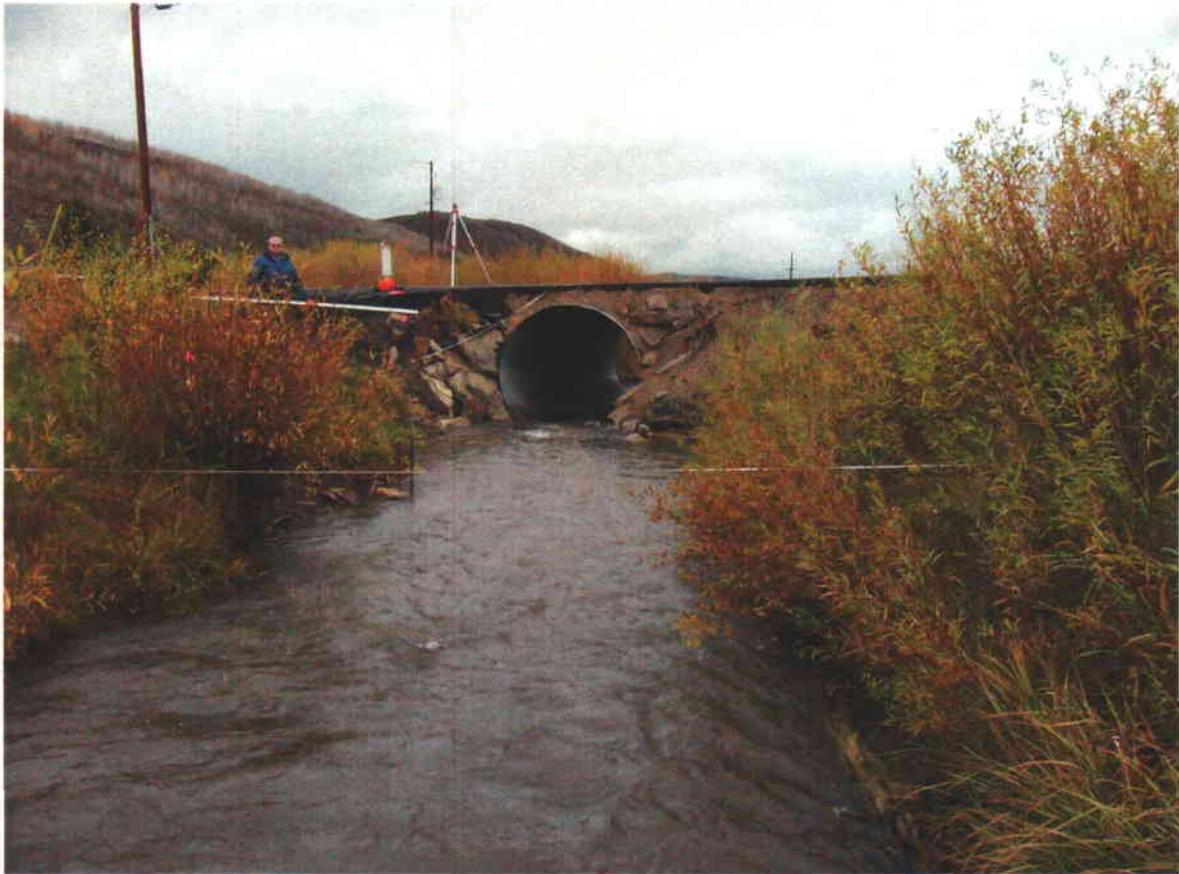
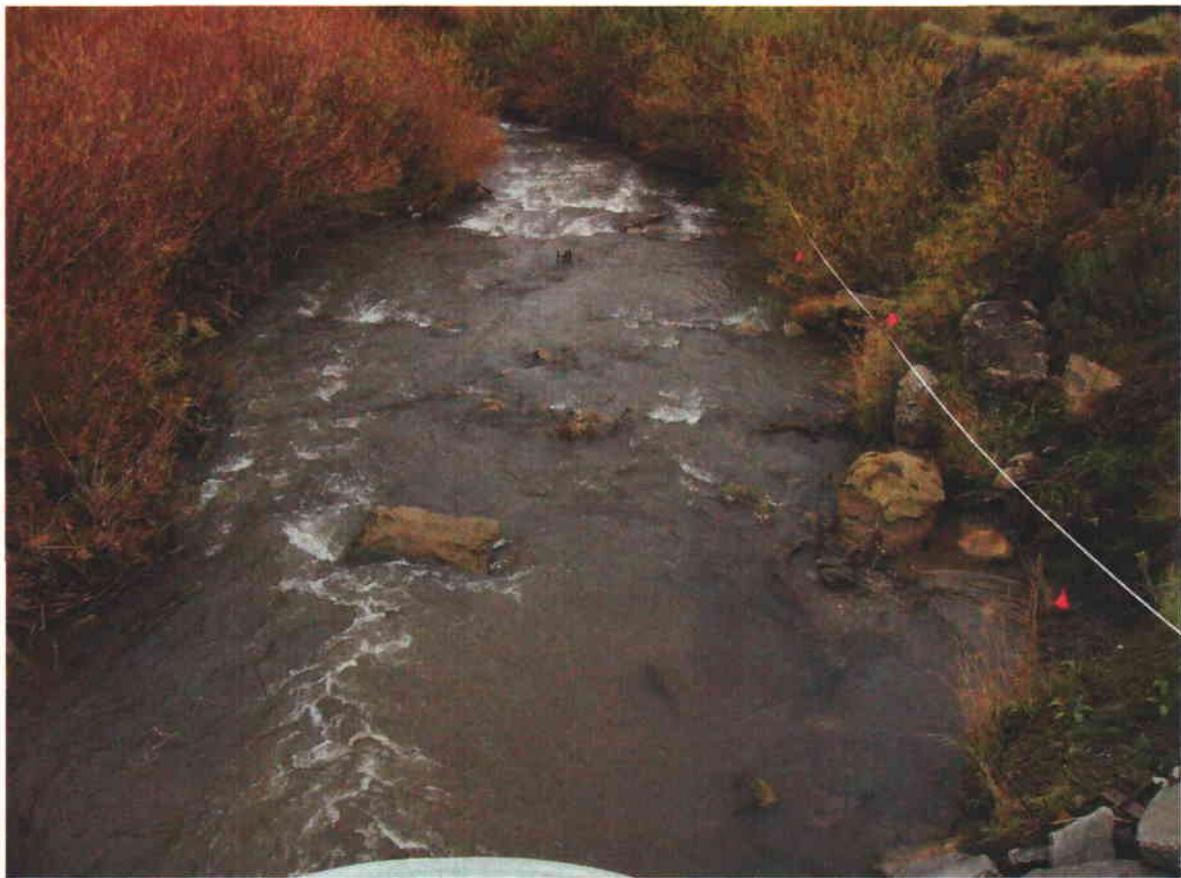
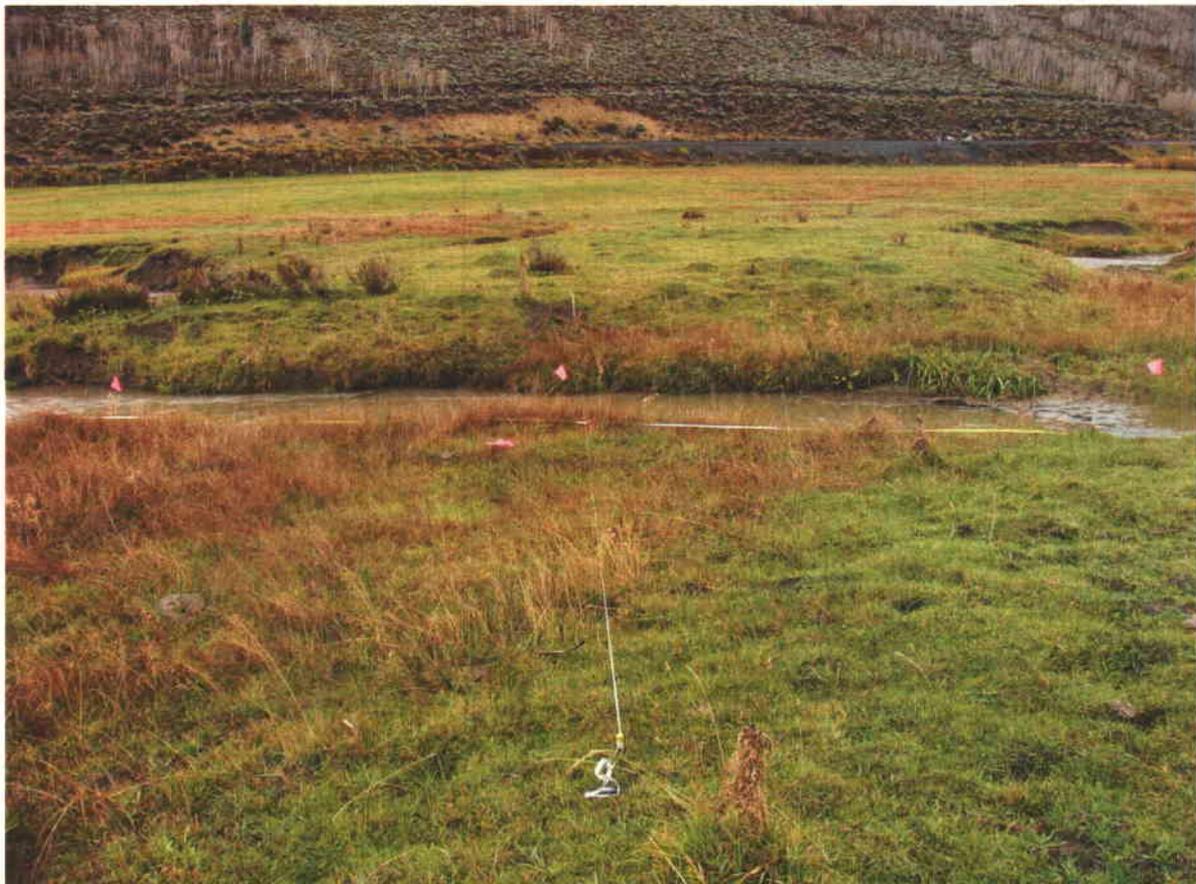
MC-3 upstream view

MC-3 upper downstream view

MC-3 lower downstream view

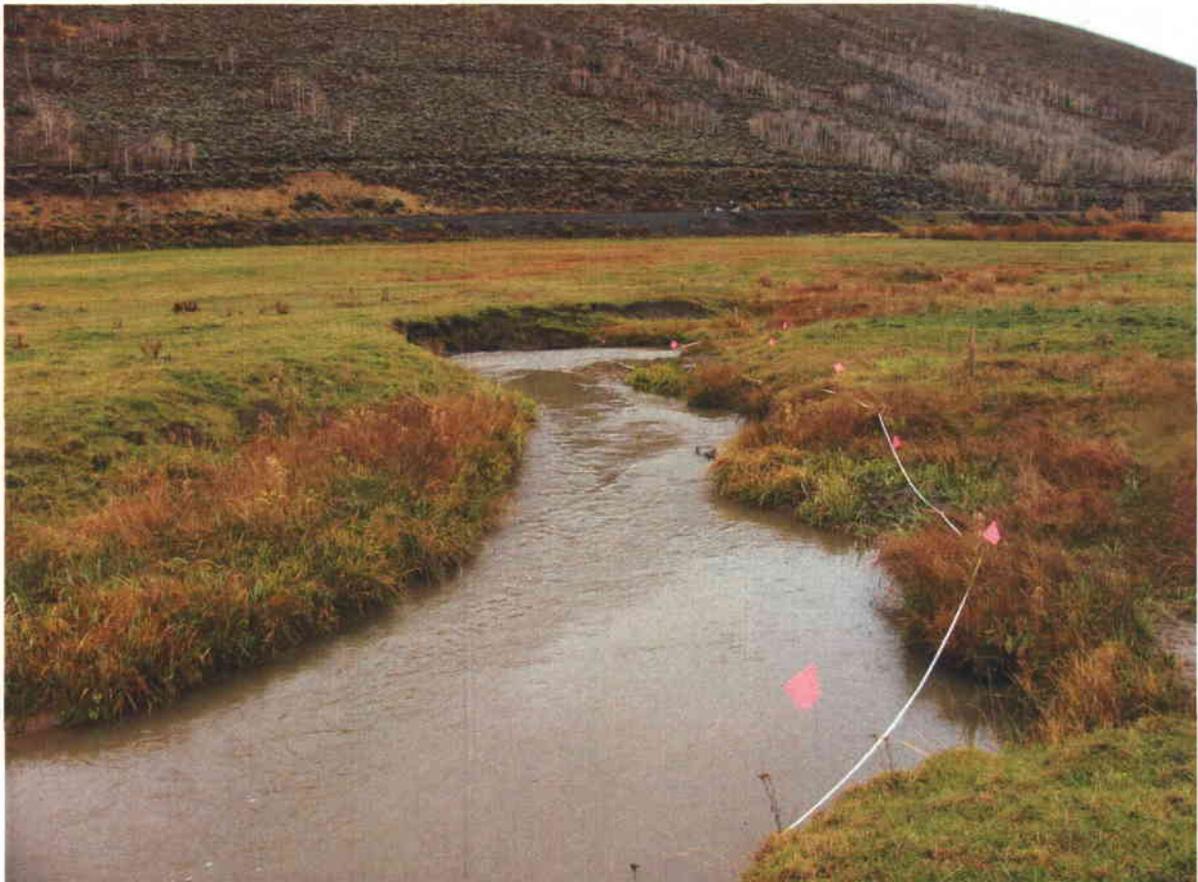
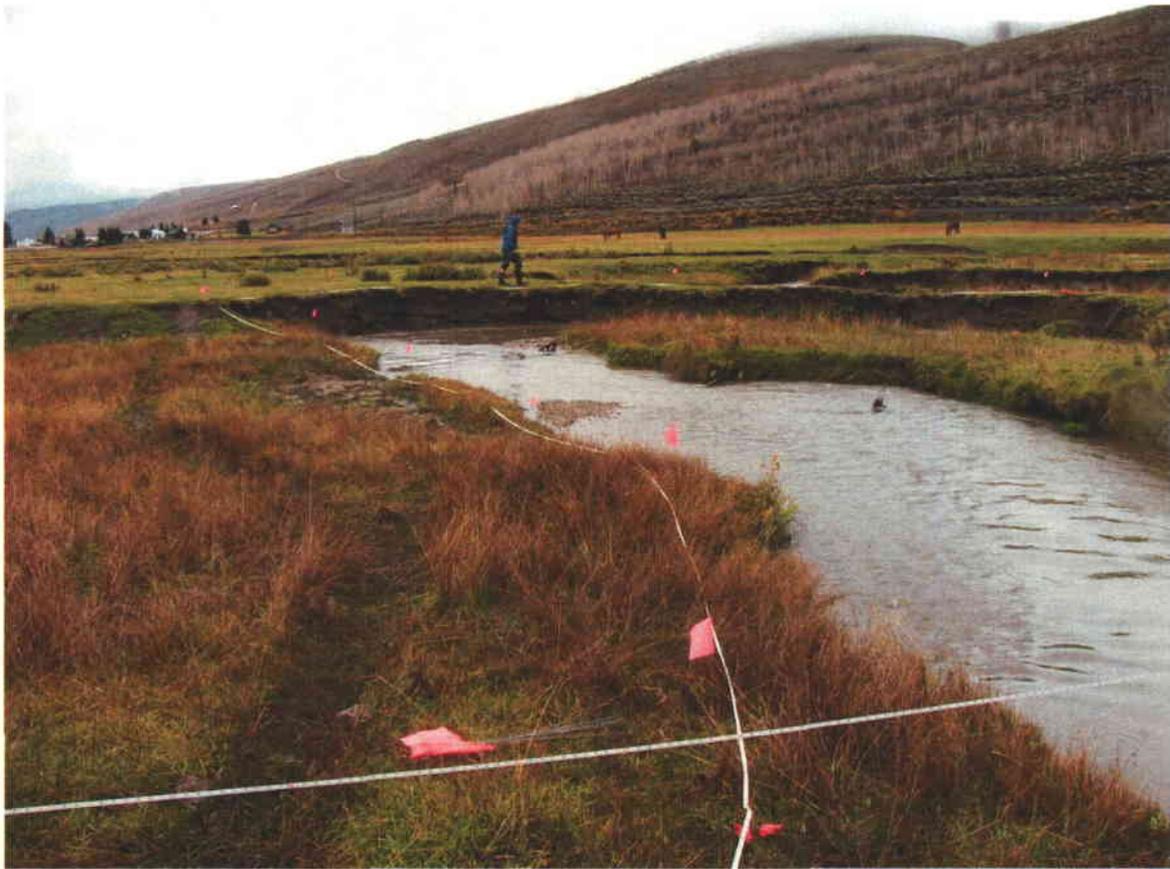
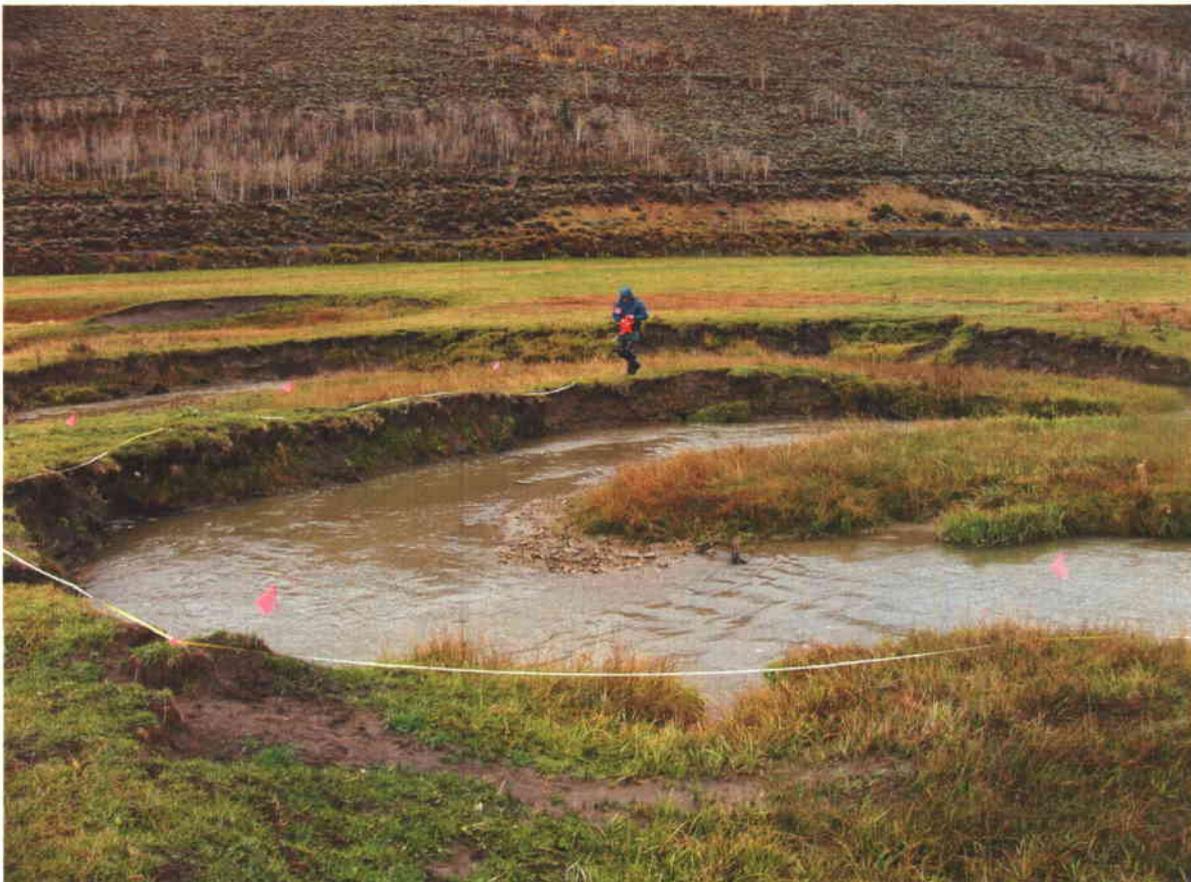
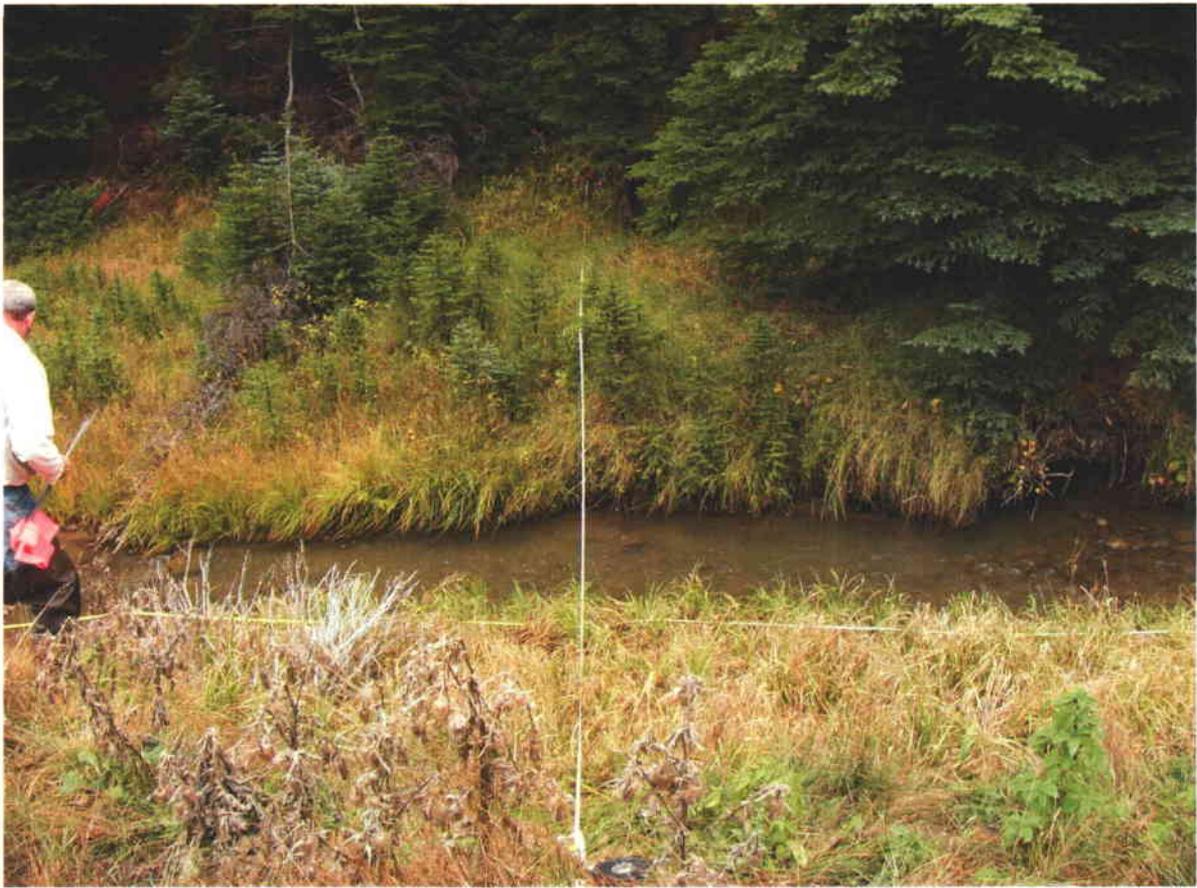
MC-4 lower upstream view

MC-4 upper upstream view

MC-4 upper downstream view

MC-4 lower downstream view
