OGMCOAL - 0070006 Star Point Insp Rpt 3208

Inspection Report

InspectionID Report Number: 3208

Permitee: **PLATEAU MINING CORP**
 Operator: **PLATEAU MINING CORP**
 Site: **STAR POINT MINE**
 Address: **PO BOX 30, HELPER UT 84526-0030**
 County: **CARBON**
 Permit Type: **PERMANENT COAL PROGRAM**
 Permit Status: **RECLAIMED**

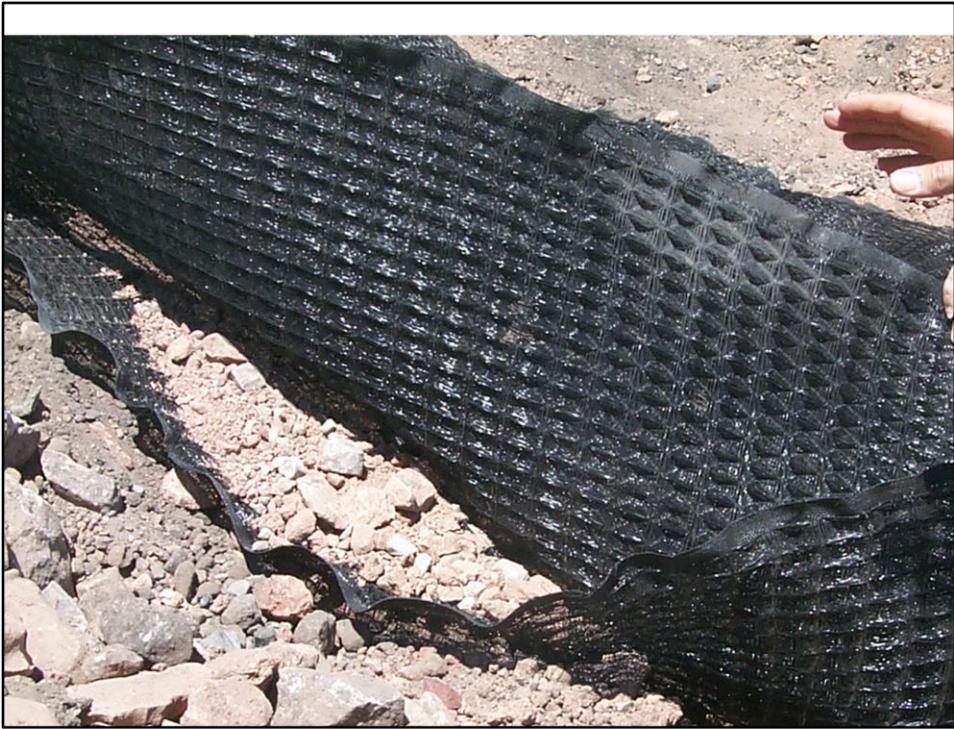
Geotextile is placed on the prepared drainage and covered with soil.

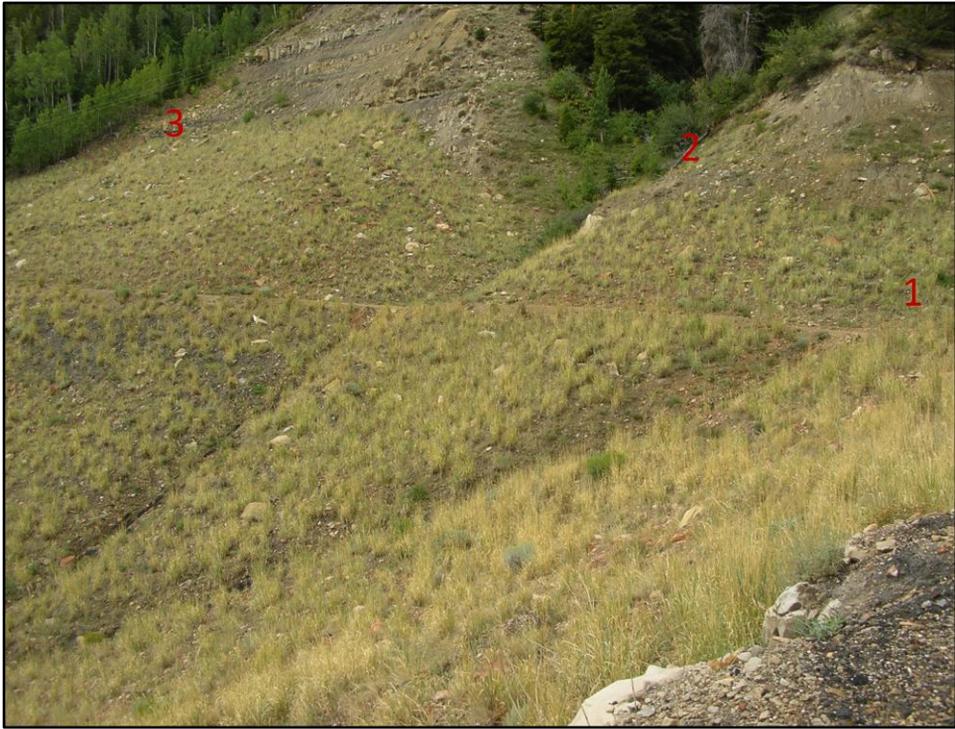
Appearance in 2012

Pyramat installation in 2002 and appearance in 2012. Two Tons/ac hay was incorporated into the slopes with gouging. One T/ac straw mulch was blown on the surface. The site was seeded, and a hydromulch with tackifier was applied. The seeding was accomplished in late August or early September.

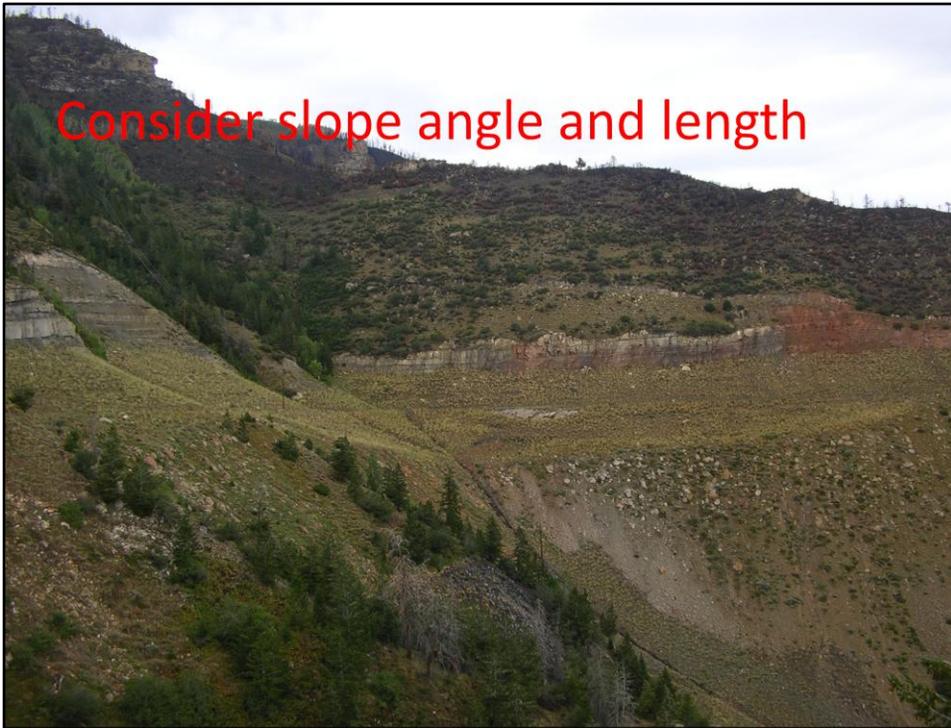
Location 5 has filled in with vegetation.

Geotextile works well on slopes less than 1.5h : 1v and on shorter slope lengths. The steep slope below the road has a run of several hundred feet at a 1.5h:1 v slope. Geotextile treated drainages are more stable, but soil movement beneath the geotextile installations is noticeable.

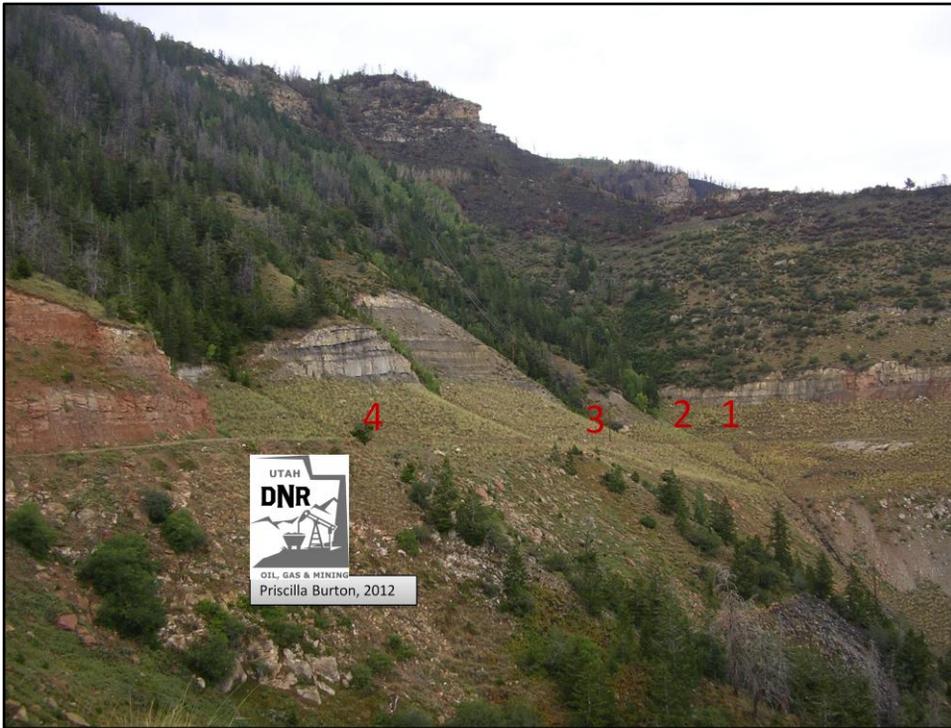
Continuing on down the slope from the confluence of 3 with 1 & 2, the rock channel is stable.

Geotextile installations are especially useful on slopes less than 1.5h:1v. Pyromat is manufactured by Permathene.
