STABILITY ANALYSIS

KAISER STEEL DIKES  
SUNNYSIDE, UTAH

March 1984

Rollins, Brown and Gunnell, Inc.  
Professional Engineers  
1435 West 820 North, P.O. Box 711  
Provo, Utah 84603

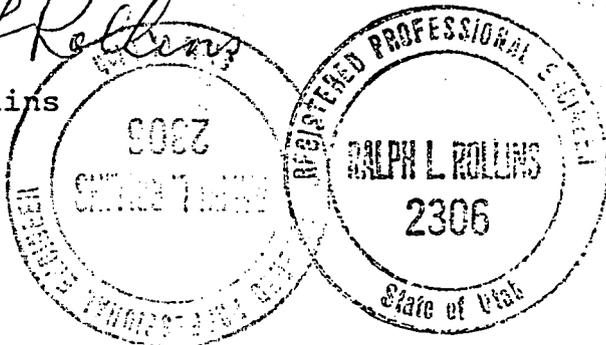
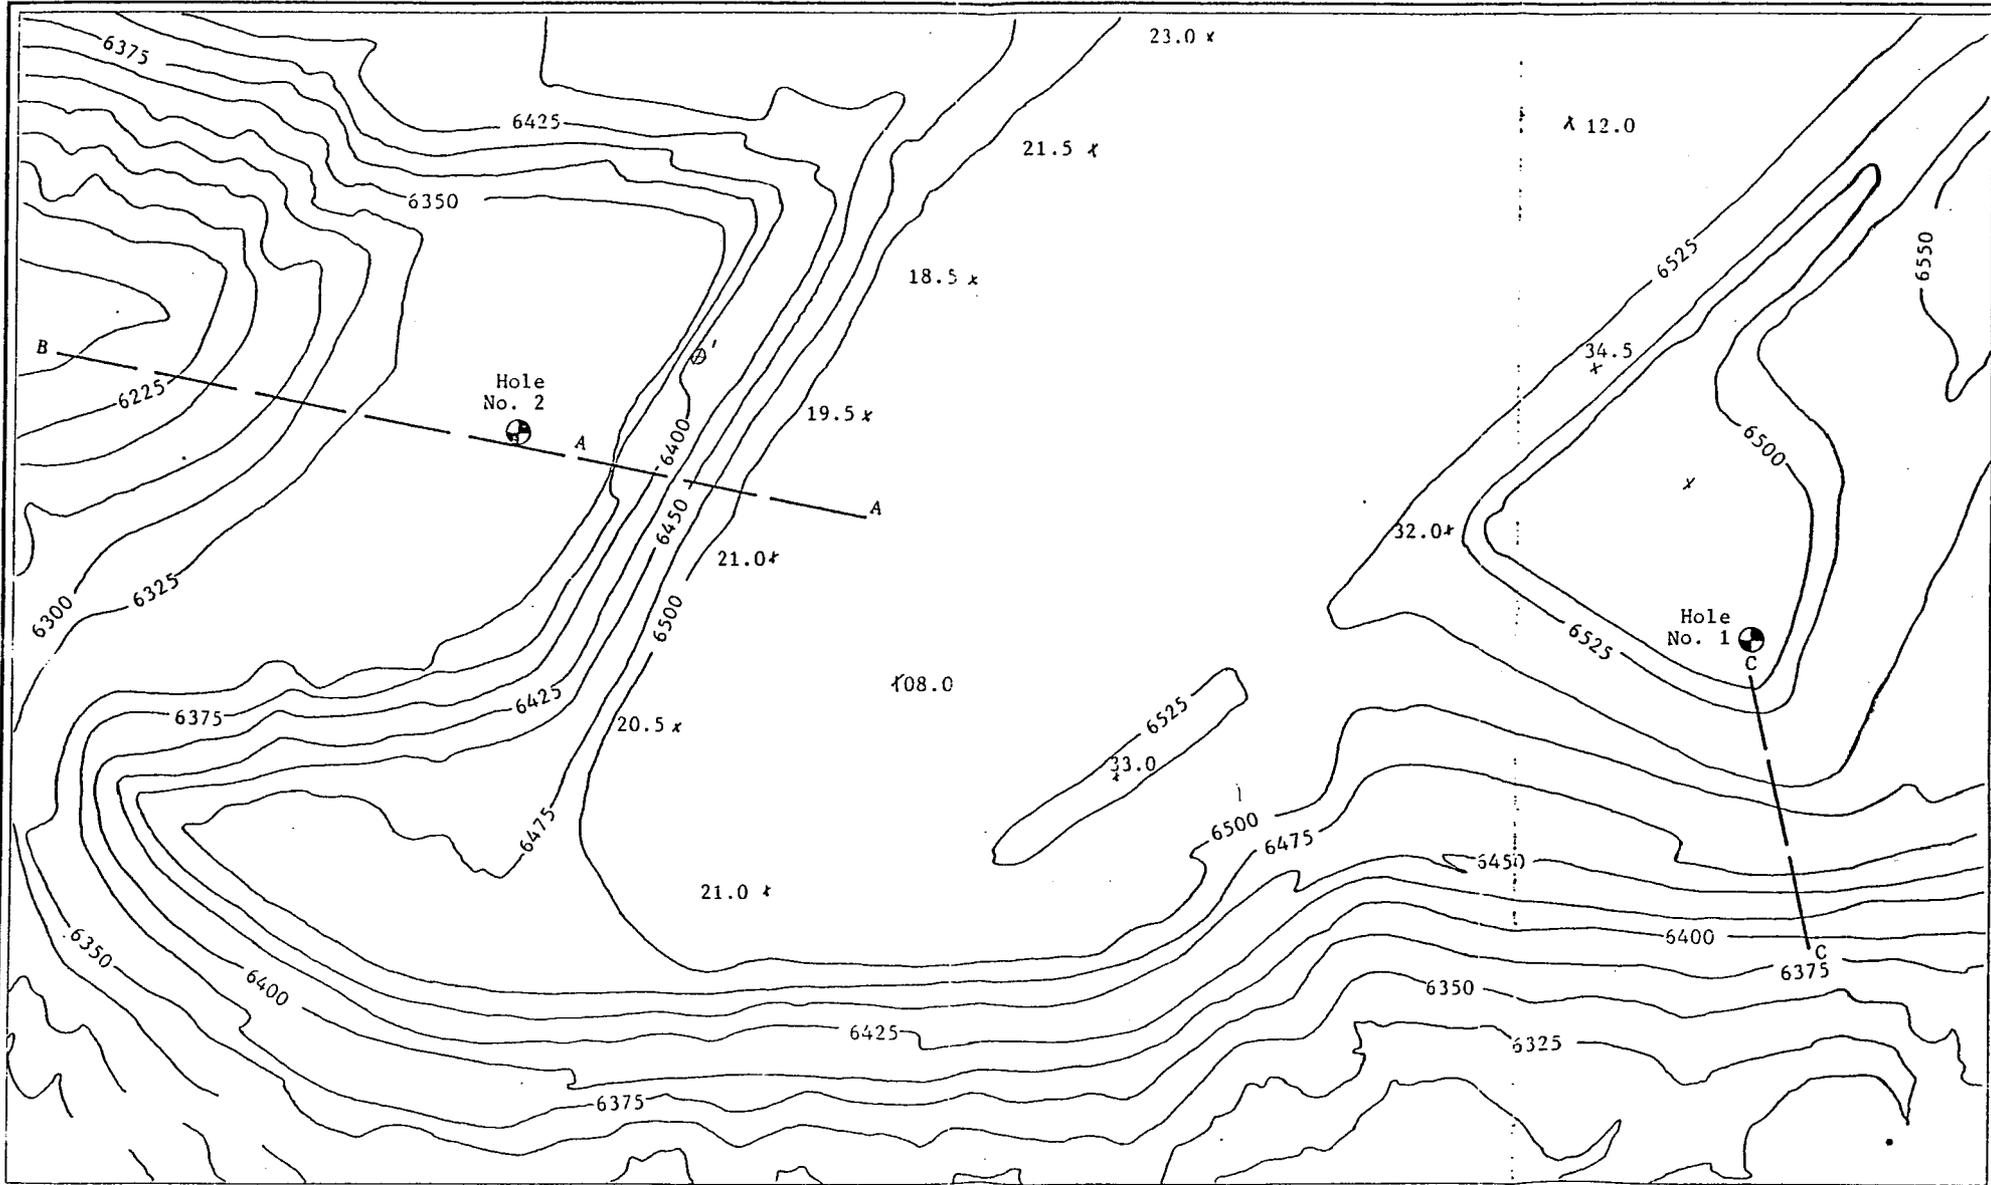
FIGURE  
NO 1

The refuse disposal area for the Kaiser Mine is located south of Sunnyside, Utah. The main disposal area is presented in Figure No. 1, and the location of the east and west side dikes are presented in this figure. The contours of the dike area are also shown in Figure No. 1. The slope at both the east and west side dike is apparent from the topography shown in these figures. Refuse from the Kaiser Mine is currently being disposed of at the west side dike. At the time this investigation was performed, the dike was being extended to the west and had only reached a portion of its final height. It is our understanding that some effort is being made to densify the refuse currently being disposed of in this fill. The east side dike is inactive, and no refuse material is being disposed of in this area.

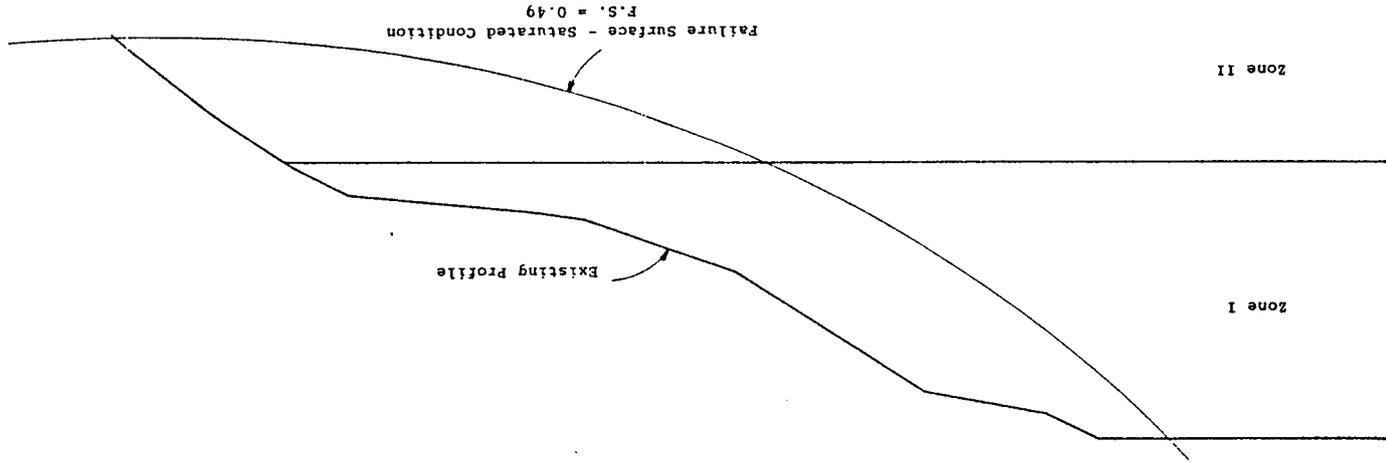
SLOPE STABILITY ANALYSIS FOR RECLAIMED AREAS

As requested, we have performed this analysis with the slope under saturated conditions. The analysis indicates that the slope under saturated conditions has a factor of safety of only 0.49, which is obviously insufficient for a stable slope. The results of the analysis along with the failure surface are presented on Figure No. 1.

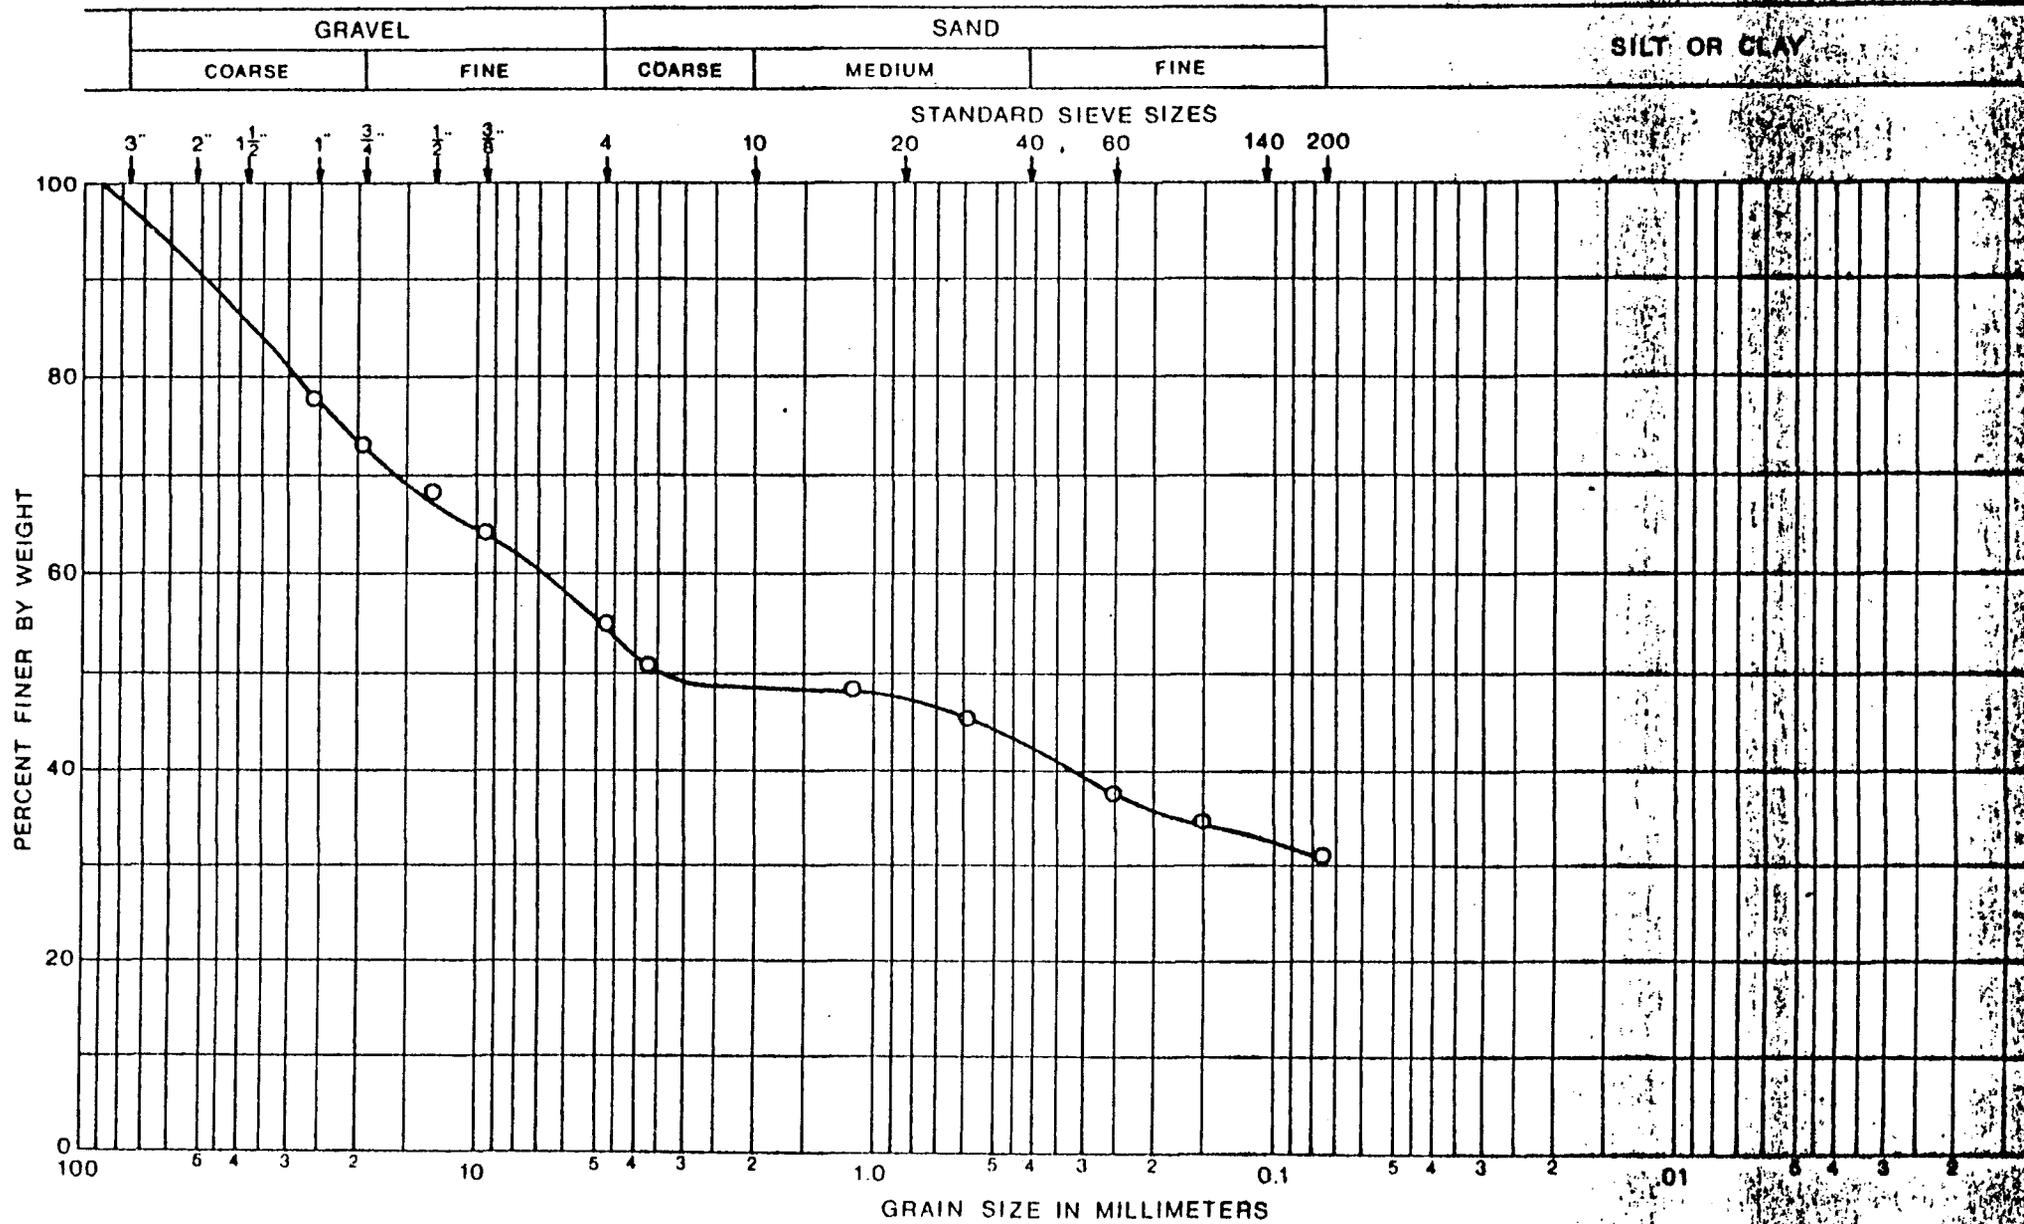
FIGURE NO. 4

The cut slope at the Whitman Fan site is presented in Figure No. 1. It will be noted that the slope consists predominantly of granular type soils. The results of a particle size distribution analysis performed on a representative sample obtained from the slope is presented in Figure No. 4, and it will be noted that approximately 70 percent of the material in the sample is granular type material. The remainder of the sample consisted predominantly of low-plasticity cohesive soils.

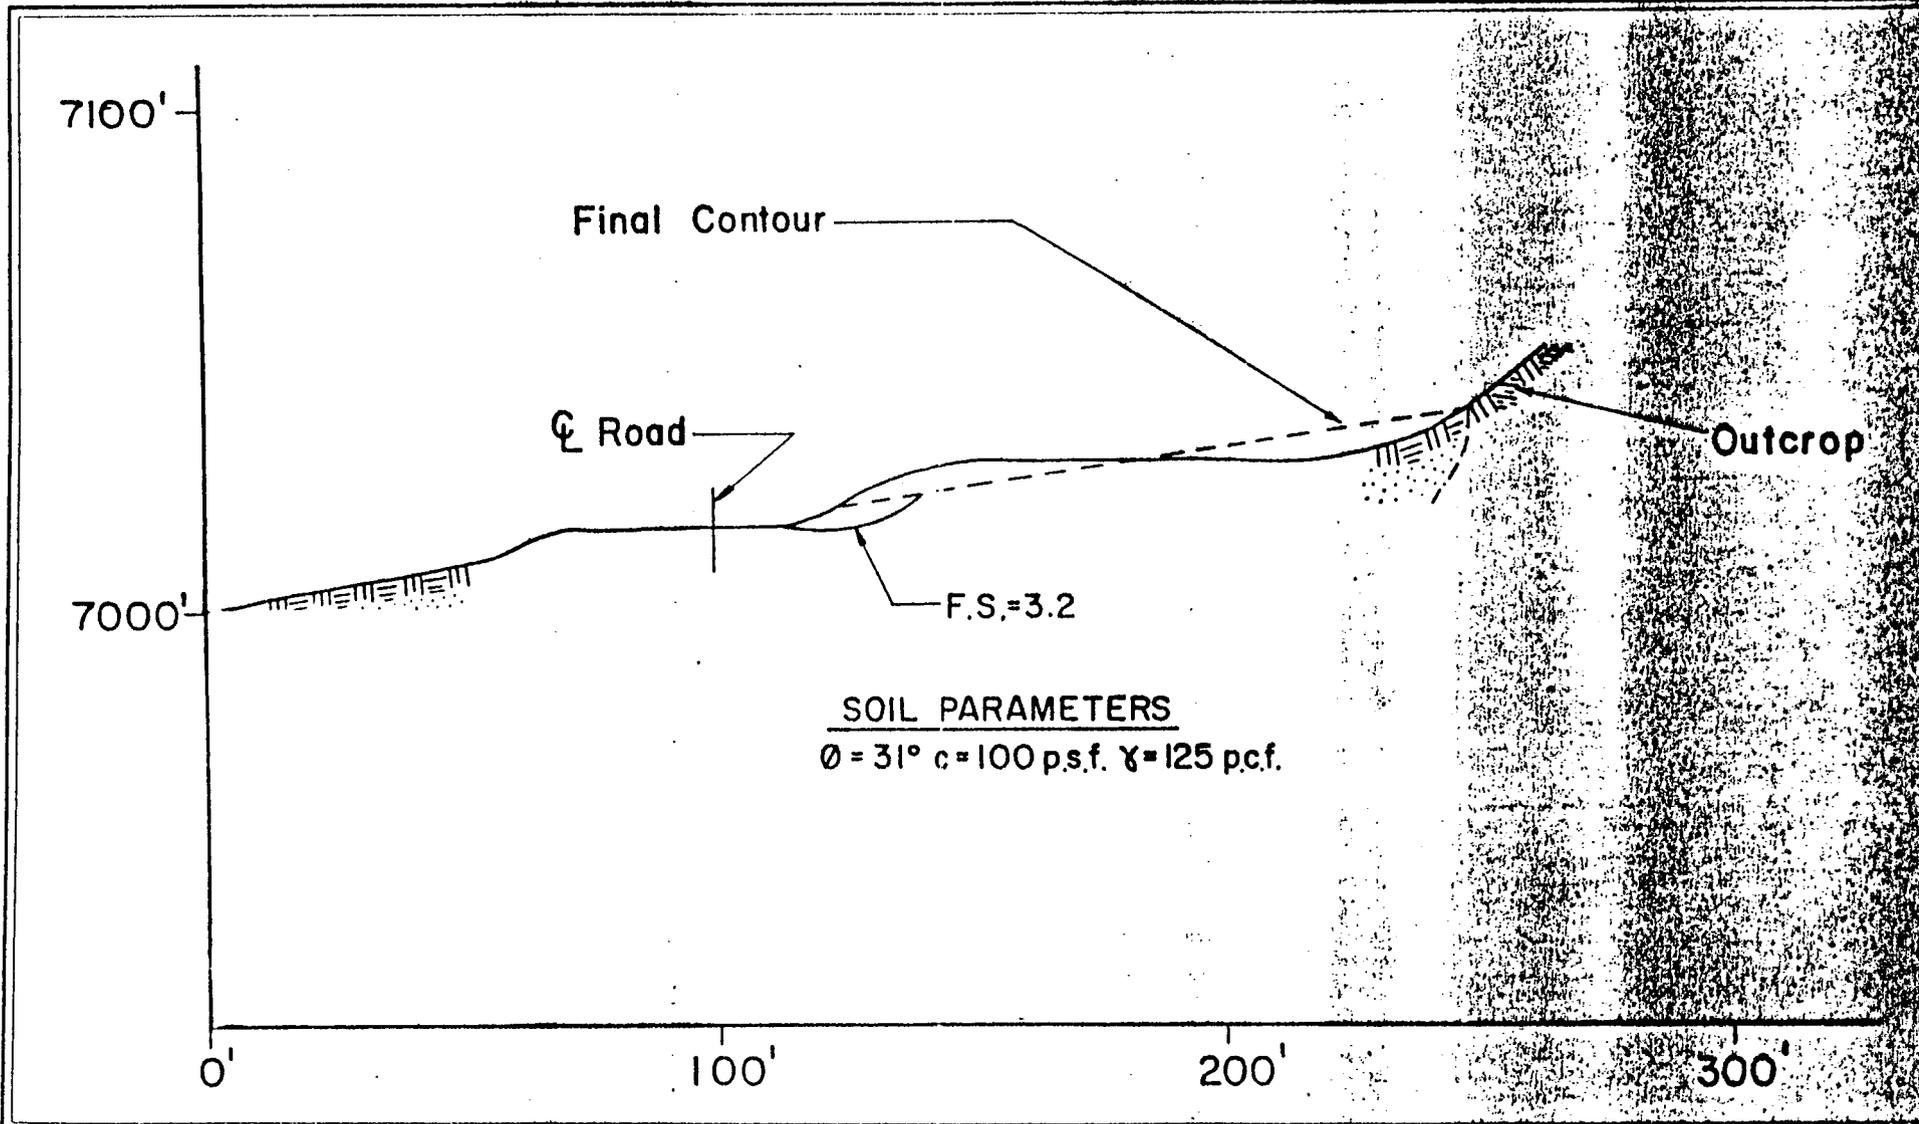
FIGURE NO. 5

A profile through the existing slope is presented in Figure No. 5 along with the proposed restored slope. The shear strength parameters used in the stability analysis for this slope are indicated in Figure No. 5, and the results of the stability computations indicate a factor of safety of 3.2. The height of this slope is small, and there is little doubt that the slope will be stable in its restored state.

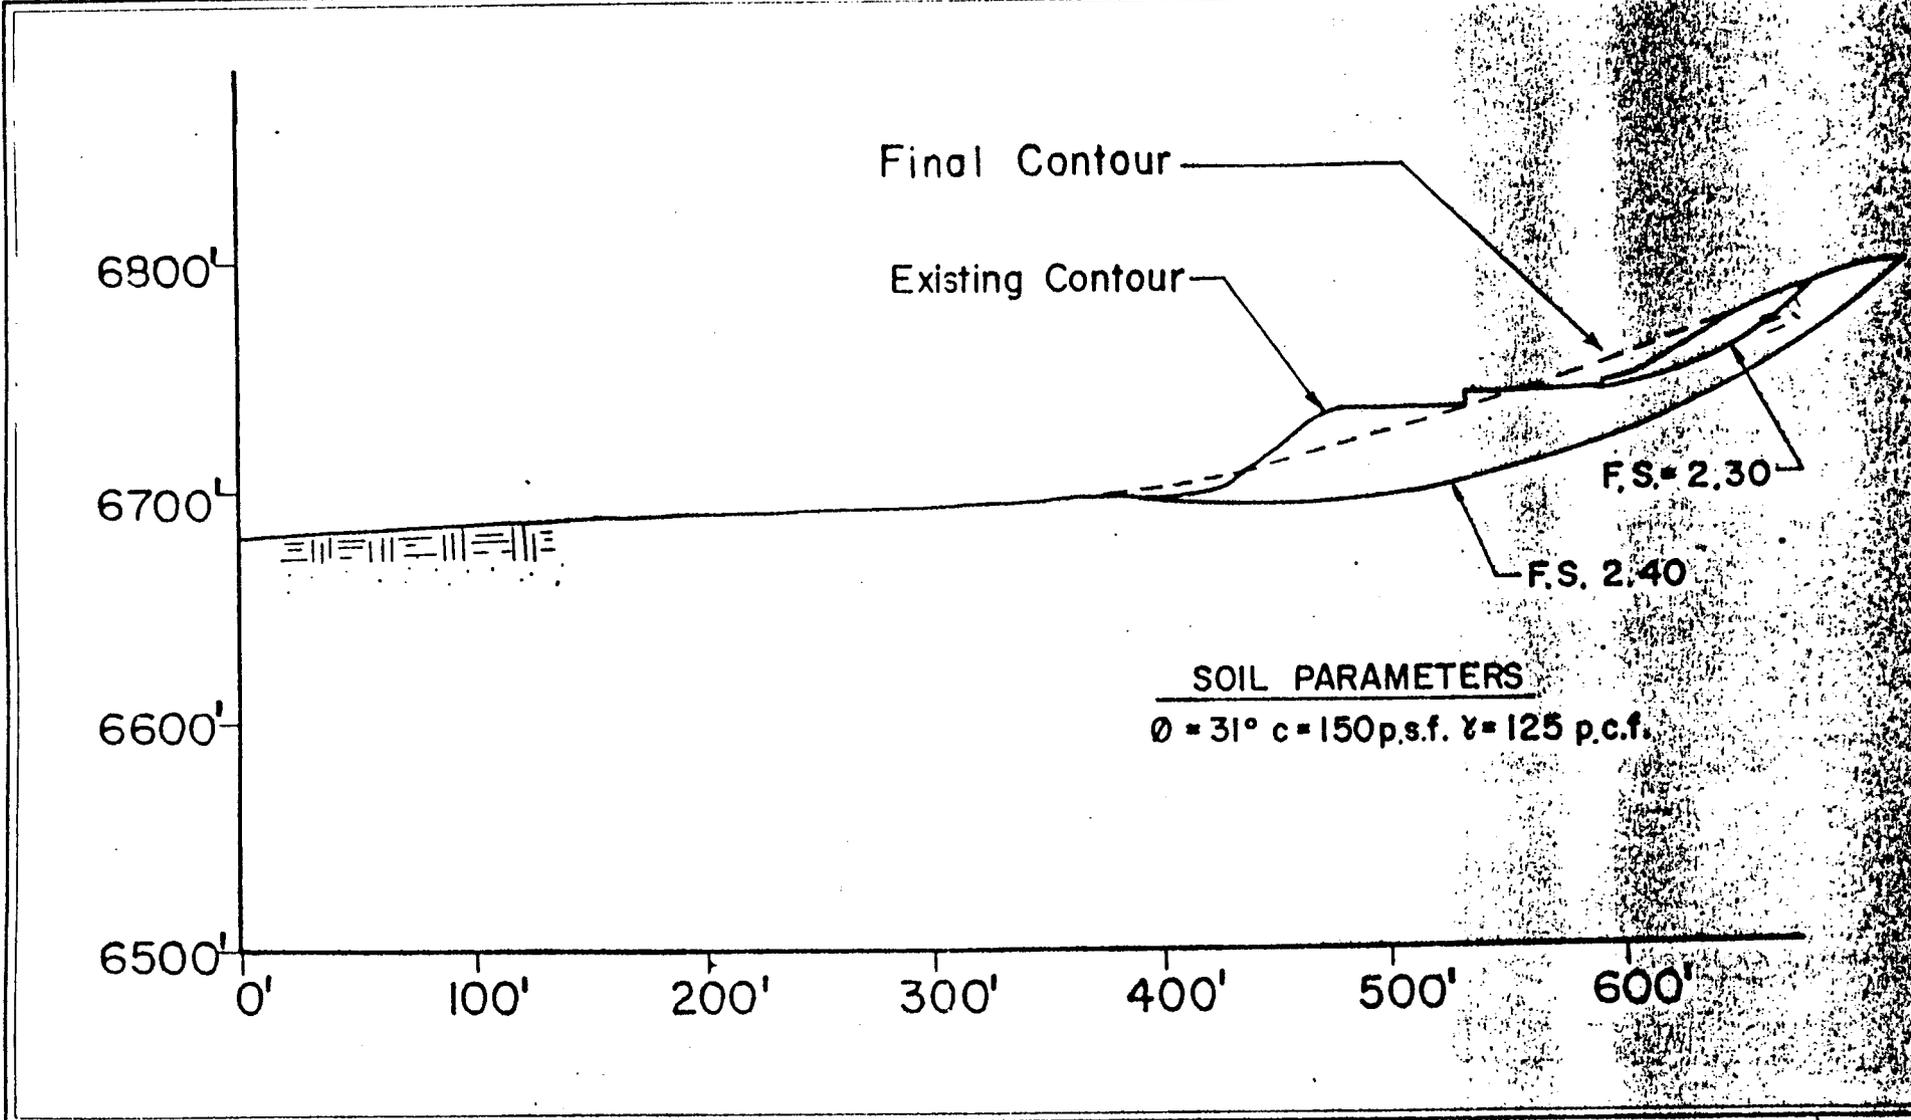
PLATE NO. 7

It will be observed that about 70 percent of the material in this sample are granular type soils, while the remainder of the sample are low-plasticity silts and clays. The shear strength parameters used in the stability analysis for the Prep Plant slope are shown in Figure No. 7, and it will be noted that a friction angle of 31 degrees and a cohesion of 150 psi were used in the analysis. It will be observed that the stability computations were performed for the overall slope, and for a small slope within the overall conditions. The factors of safety associated with these slopes were 2.3 and 2.4, respectively. The results of the stability analysis indicate that the finished slope will be stable with a relatively high factor of safety.
