SURFACE HYDROLOGY AND CULVERT ADEQUACY
OF THE HIAWATHA AND MOHRLAND, UTAH AREAS

Prepared for
UNITED STATES FUEL COMPANY

By
VAUGHN HANSEN ASSOCIATES

August 1978

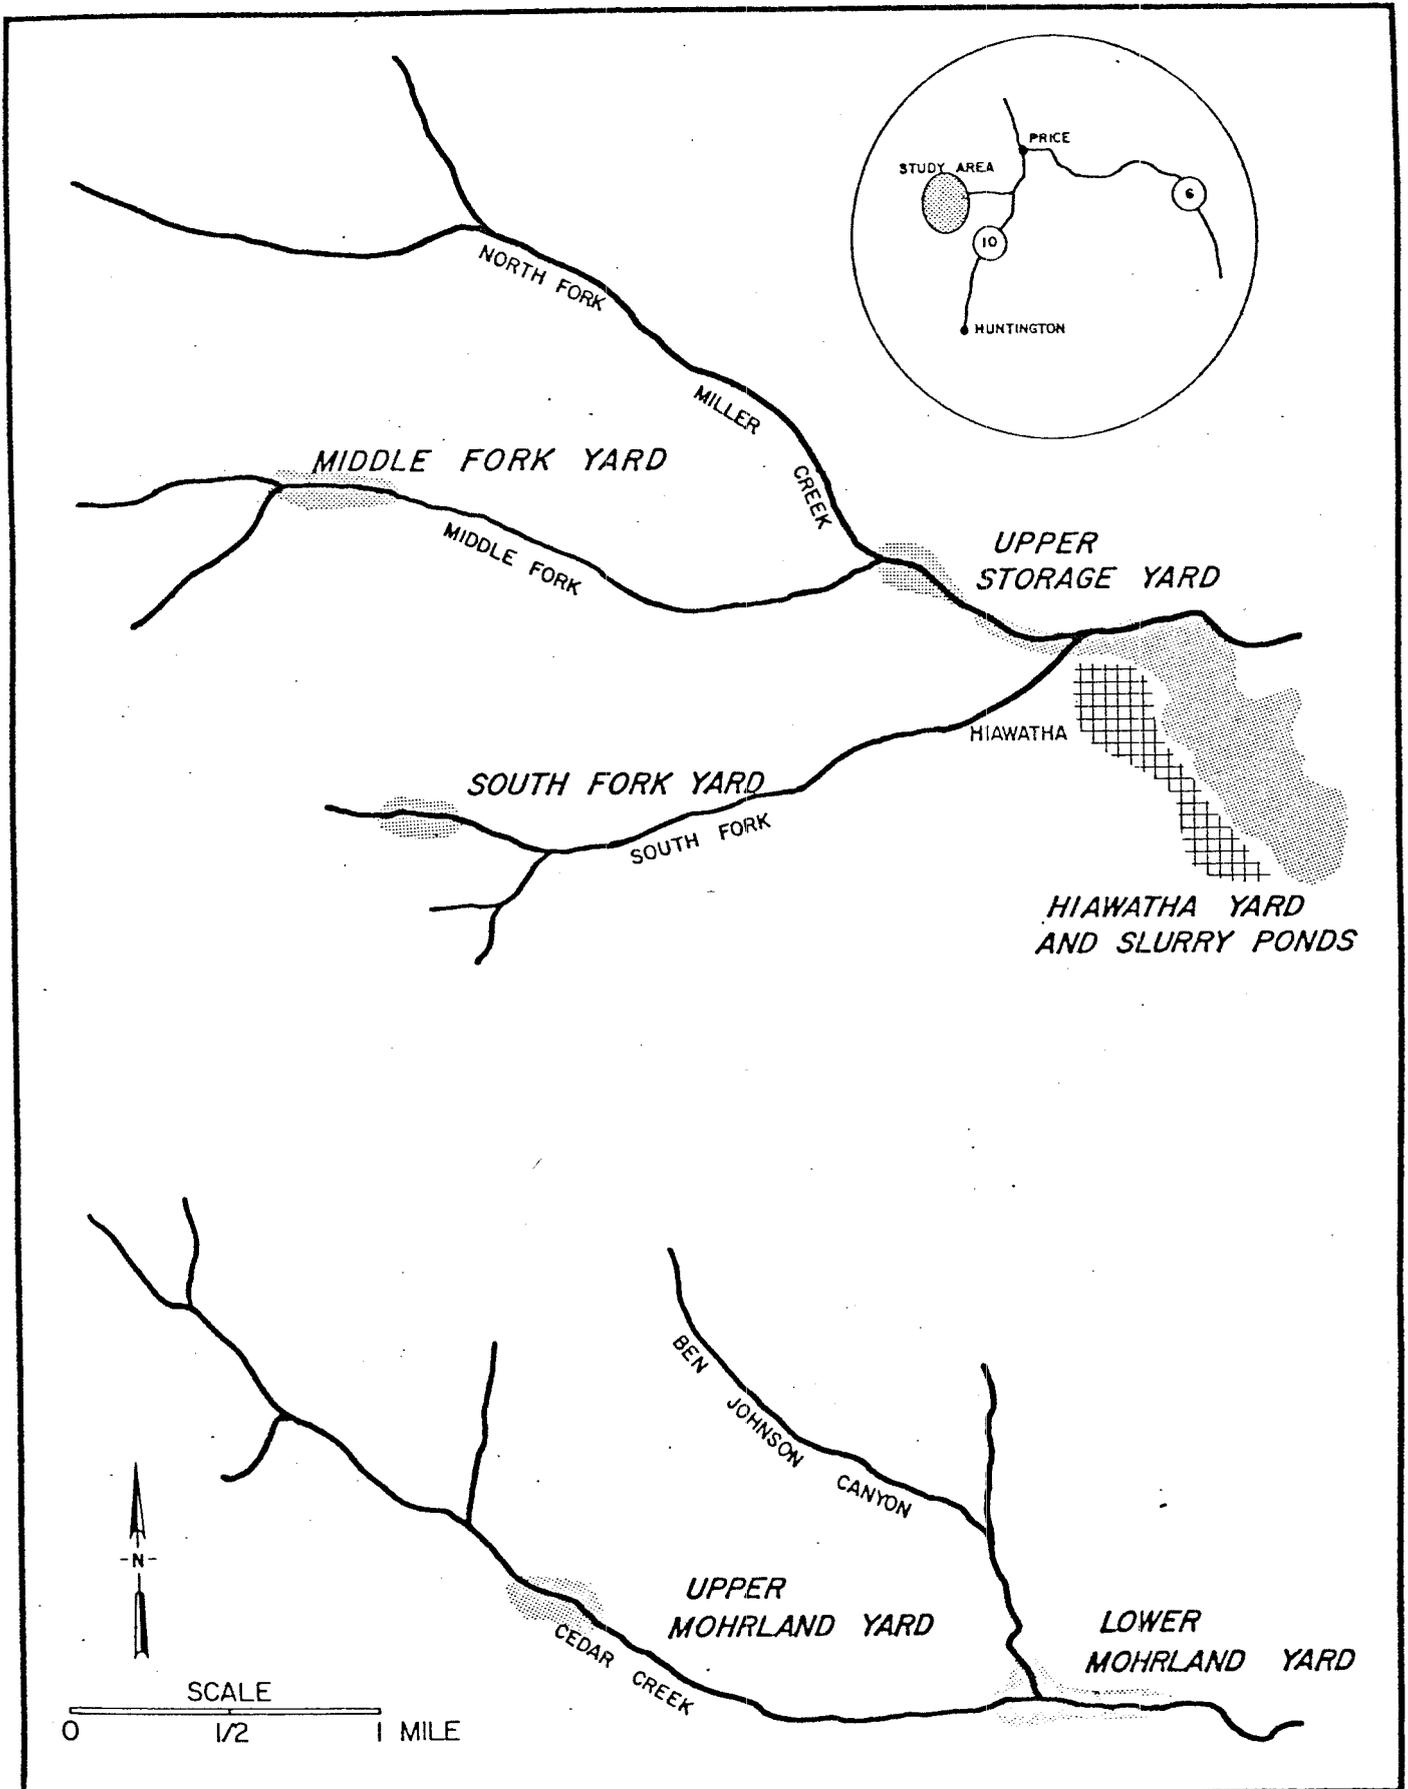
Figure 1. U.S. Fuel Company facilities studied.

Six surface facilities and their respective watersheds and drainage structures were studied for runoff potential (see Figure 1). Four of these (the Hiawatha yard and slurry ponds, the upper coal storage yard, the middle fork yard, and the lower Mohrland yard) are actively in use. The remaining two facilities (the south fork yard and the upper Mohrland yard) receive only limited use at the present time.

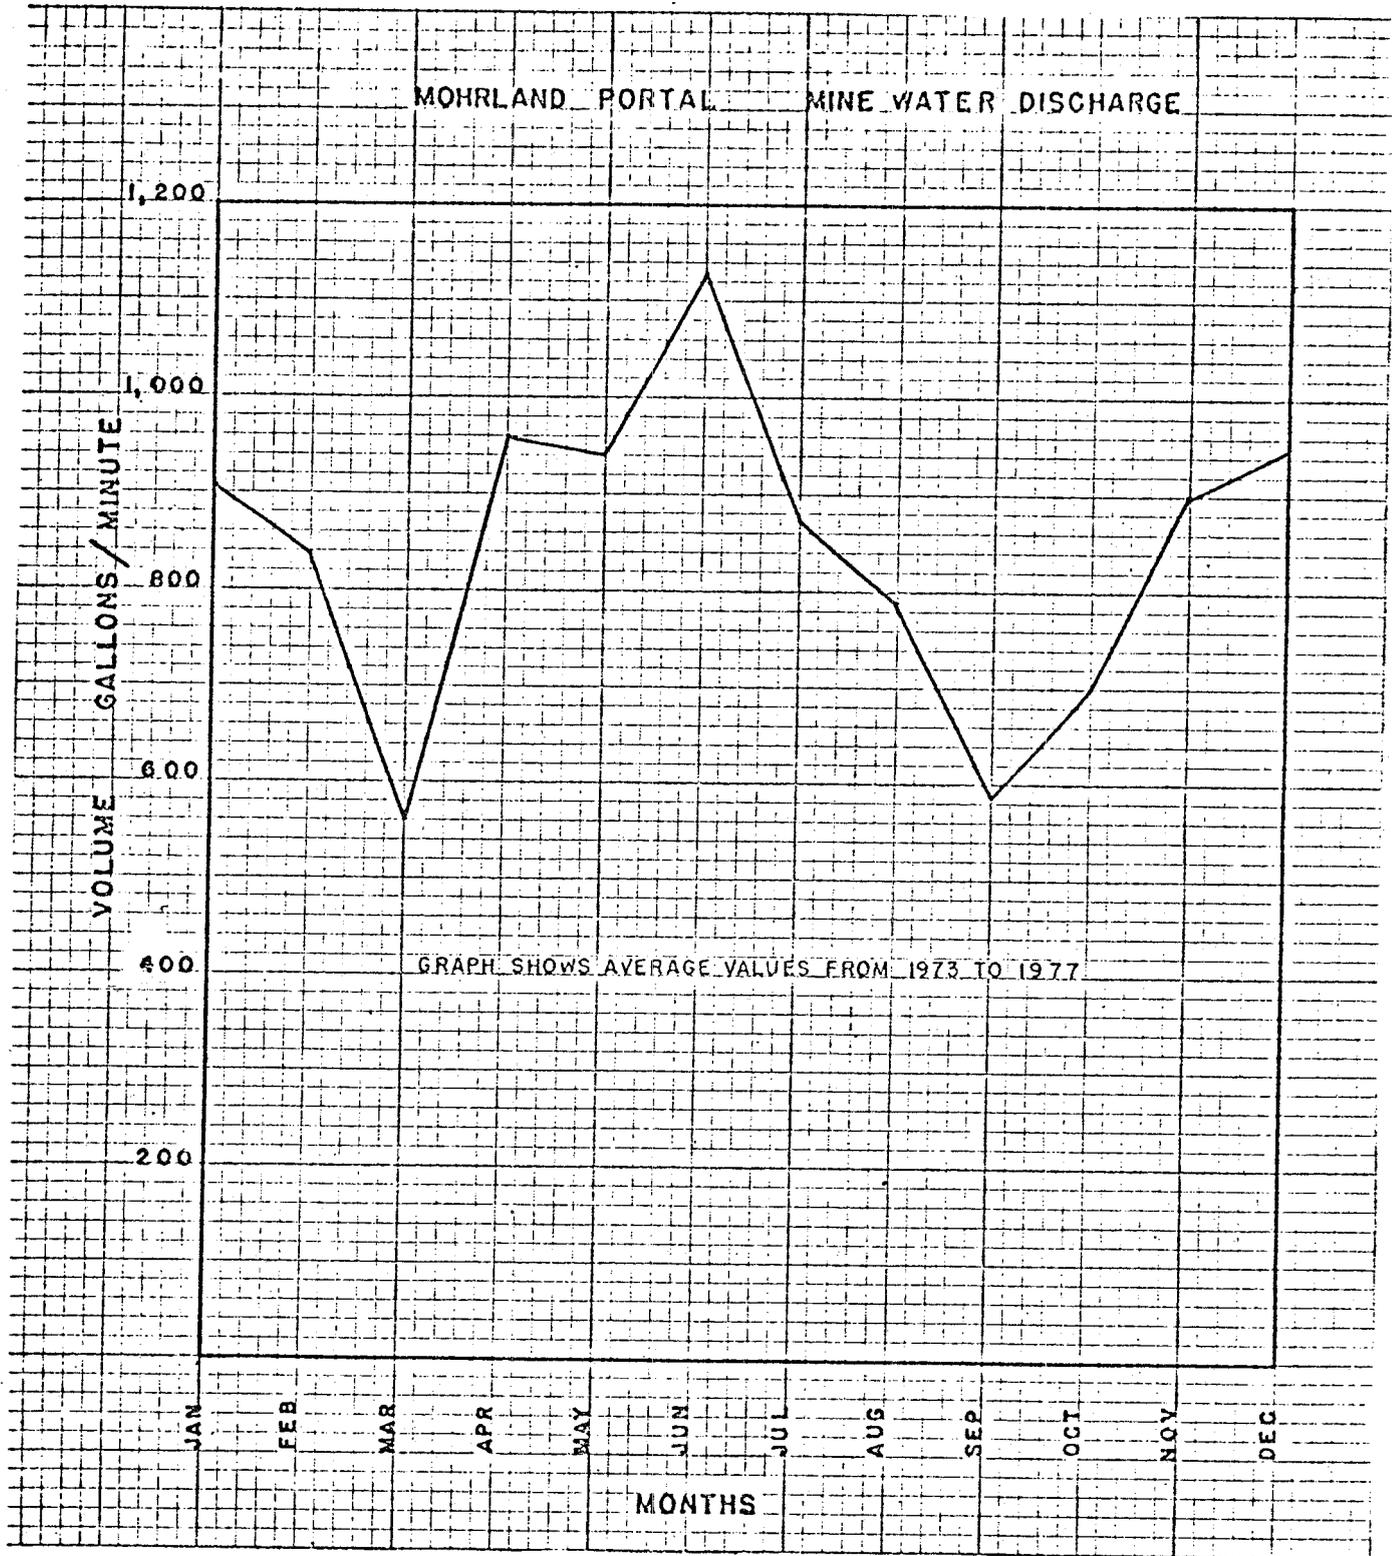
FIGURE 14

Water is encountered from time to time underground in the course of mining. Usually it occurs in the form of drippers or small steady trickles from the floor and roof. These generally tend to decrease and dry up as development advances. Large water flows have been encountered in the past mainly due to contact with the Bear Canyon fault which is apparently a major ground water channel. Old mine workings have contacted the fault at several points and this probably accounts for much of the mine water discharge that flows from the Mohrland portal. Since the dip of the beds in this area are toward the southwest, all water encountered in mining tends to flow to the most southwesterly opening, namely the Mohrland portal. Table 4 and Figure 14 gives quality and quantity data for the mine discharge water.

CHEMICAL ANALYSIS
OF
MOHRLAND PORTAL MINE WATER DISCHARGE
