# United States Department of the Interior

RE: Soldier Canyon Mine Resource Recovery and Protection Plan  
(R2P2) Modification, 3rd West Pillars Section

SOLDIER CREEK COAL COMPANY  
SOLDIER CANYON MINE  
ROCK CANOYN SEAM  
APPROVED MINE MAP

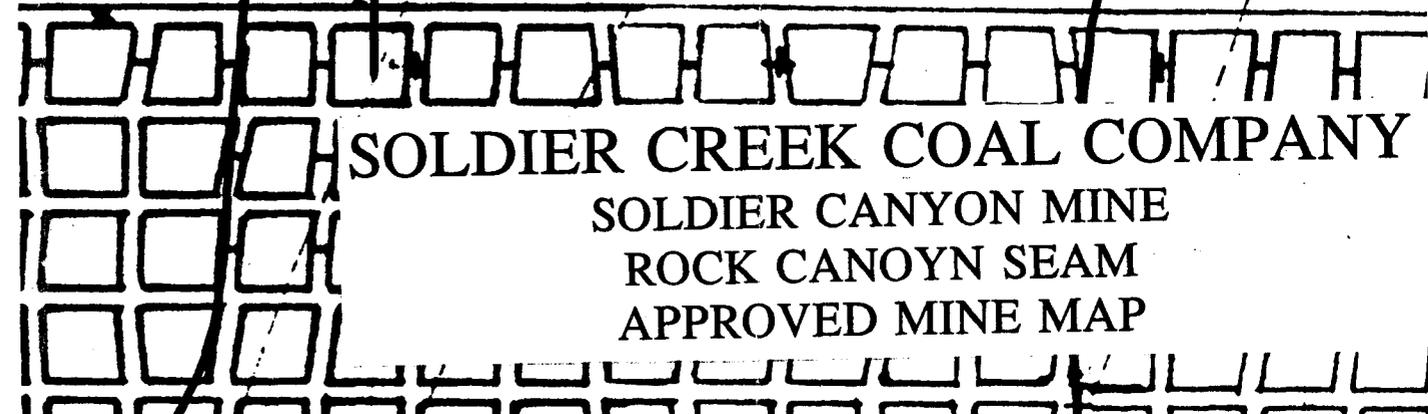
The approved plan for pillar retreat mining in the 3rd West Pillars section was to mine pillar rows from west to east with each row consisting of eight pillars. One pillar in each row was left on the south side for a bleeder. Presently, the continuous miner is mining in the 3rd pillar of pillar row #13 inby the 19th crosscut. Due to severe bouncing activities, the company proposed to abandon this row and the other three pillar rows to the east (rows #14 - #16). Starting with row #17, SCCC plans to pull only six pillars across the panel instead of the eight originally planned. This would leave two pillars on the north side and one pillar on the south side for protection and a bleeder (please see enclosure).

The combination of a shale roof, the sandstone formation above the shale, and marginal pillar sizes have created an unsafe condition. The proposed plan of leaving three complete rows and one partial row (30 pillars) should be an adequate barrier to support the overriding stresses. Leaving two pillars on the north side will move mining activities to a location under lower overburden as additional precaution against further bounces. Under the present circumstances, Price Coal Office personnel agree with this proposal to abandon these pillars to reduce safety risks to the mining crew. Geologic study and adequate pillar design by SCCC is strongly encouraged in the future to ensure maximum economic recovery.
