Canyon Fuel Company, LLC
Soldier/Dugout Canyon Mines
P.O. Box 1029
Wellington, Utan 84542
Phone: (435) 637-6360
Fax: (435) 636-2897

SUBJECT: Earthen Seals Damaged at Soldier Canyon Mine - July 1, 2000

**LIGHTING INCIDENT
and IGNITION**

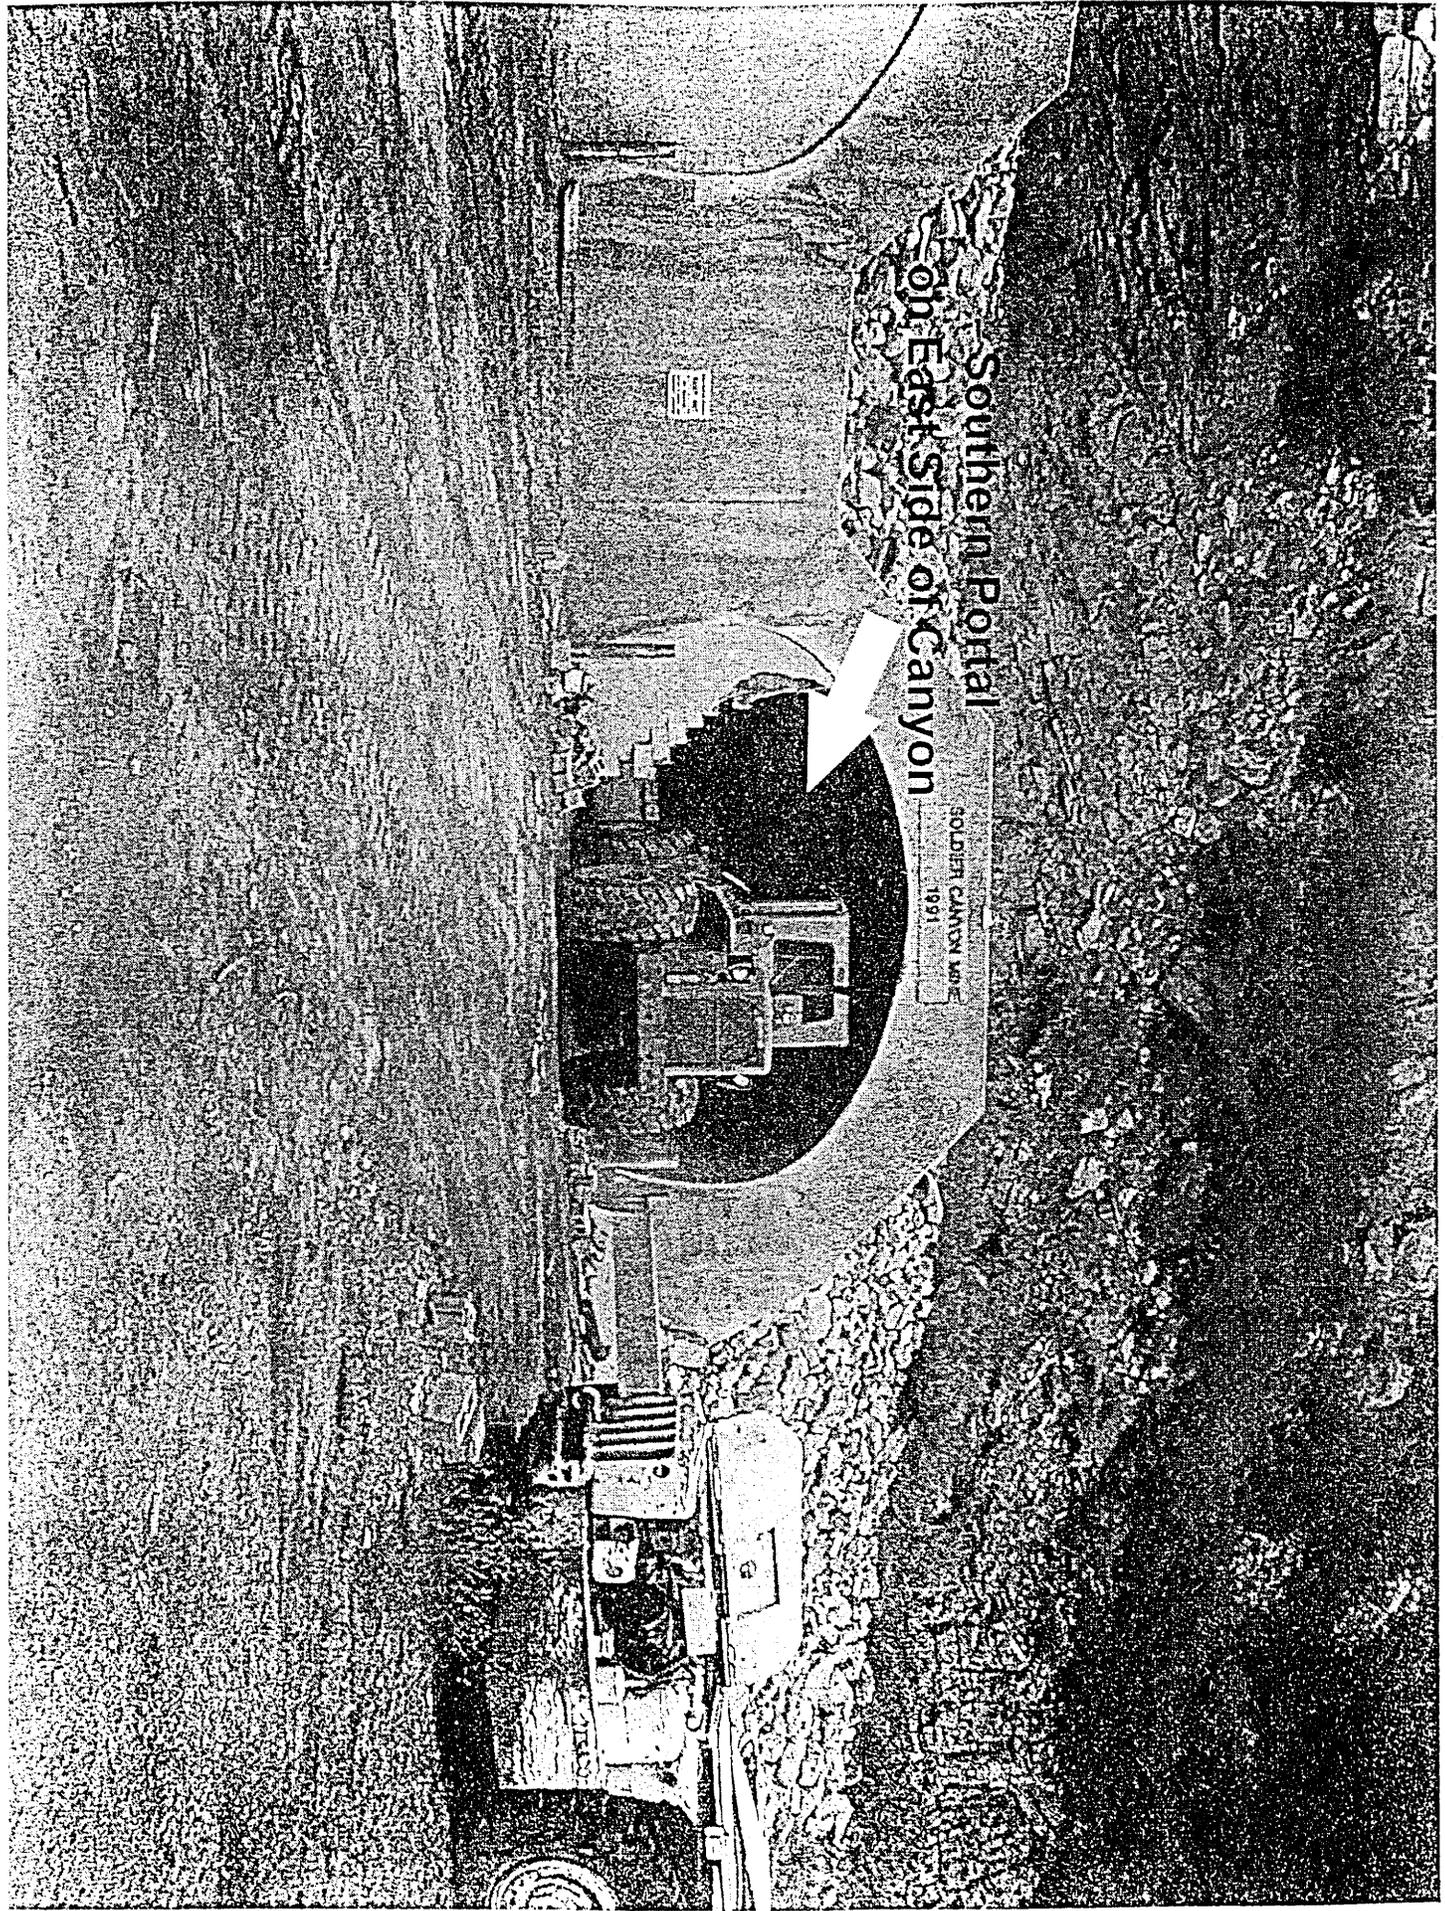
Southern Portal
on East Side of Canyon

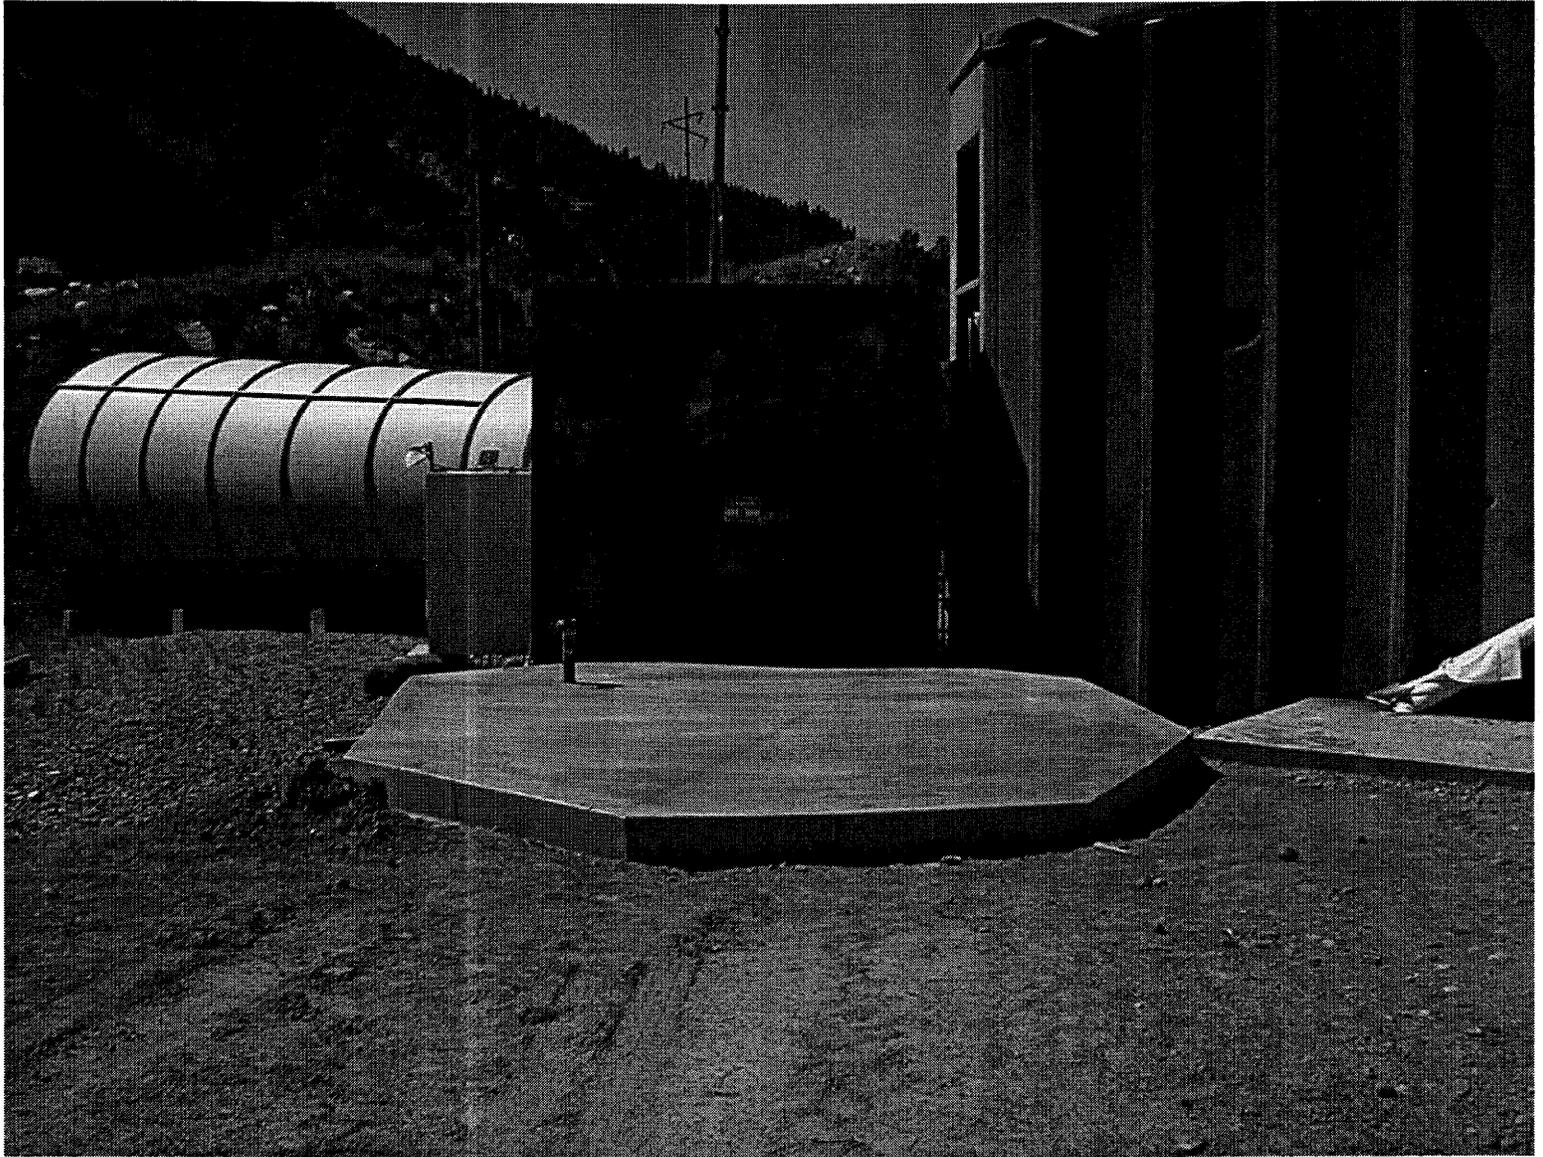
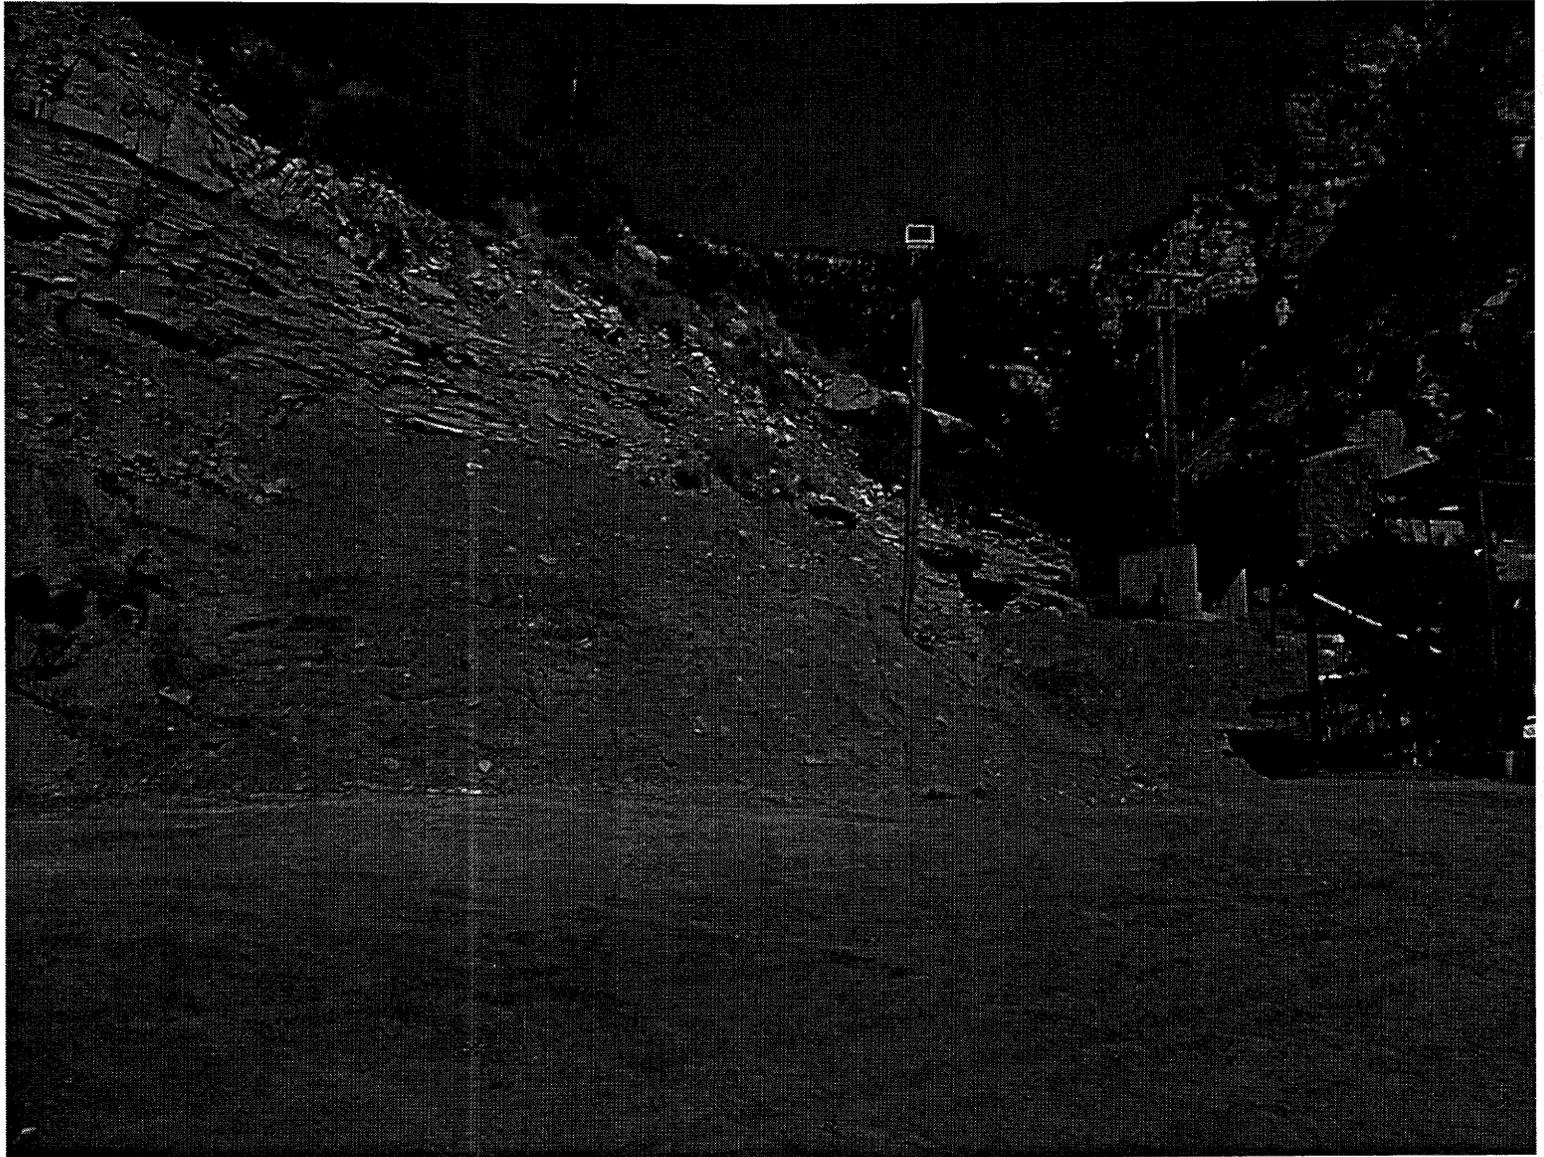
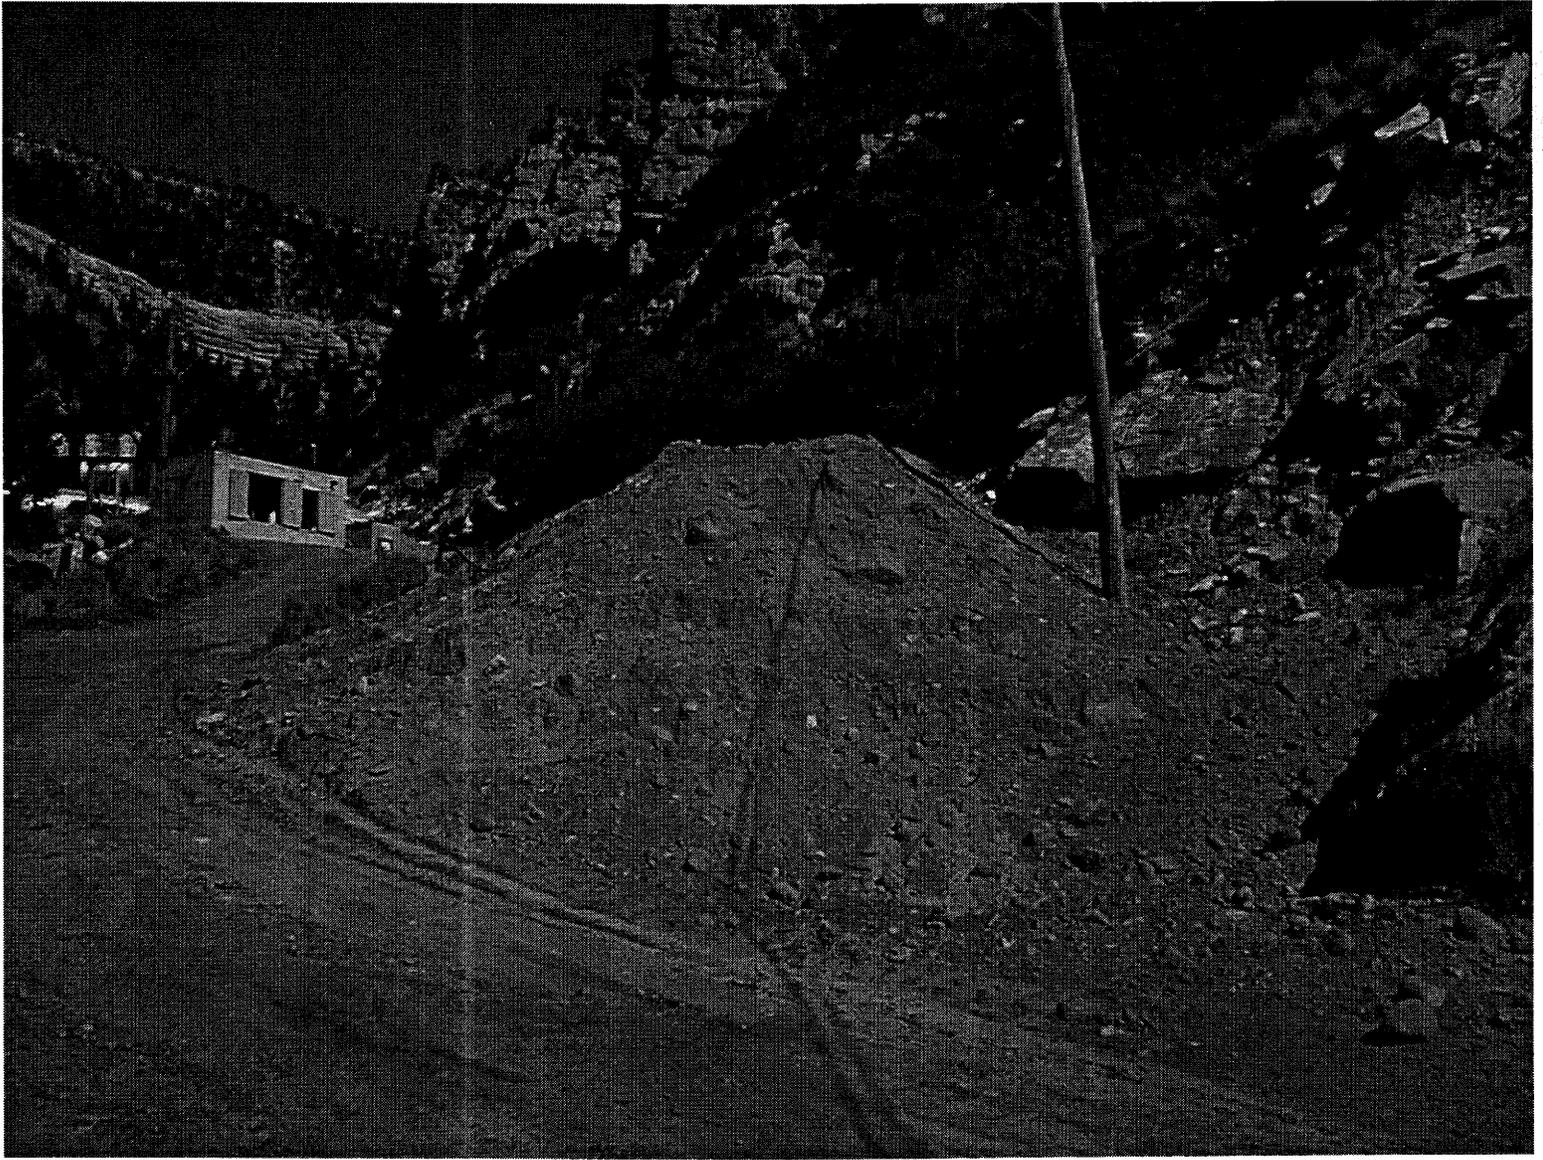
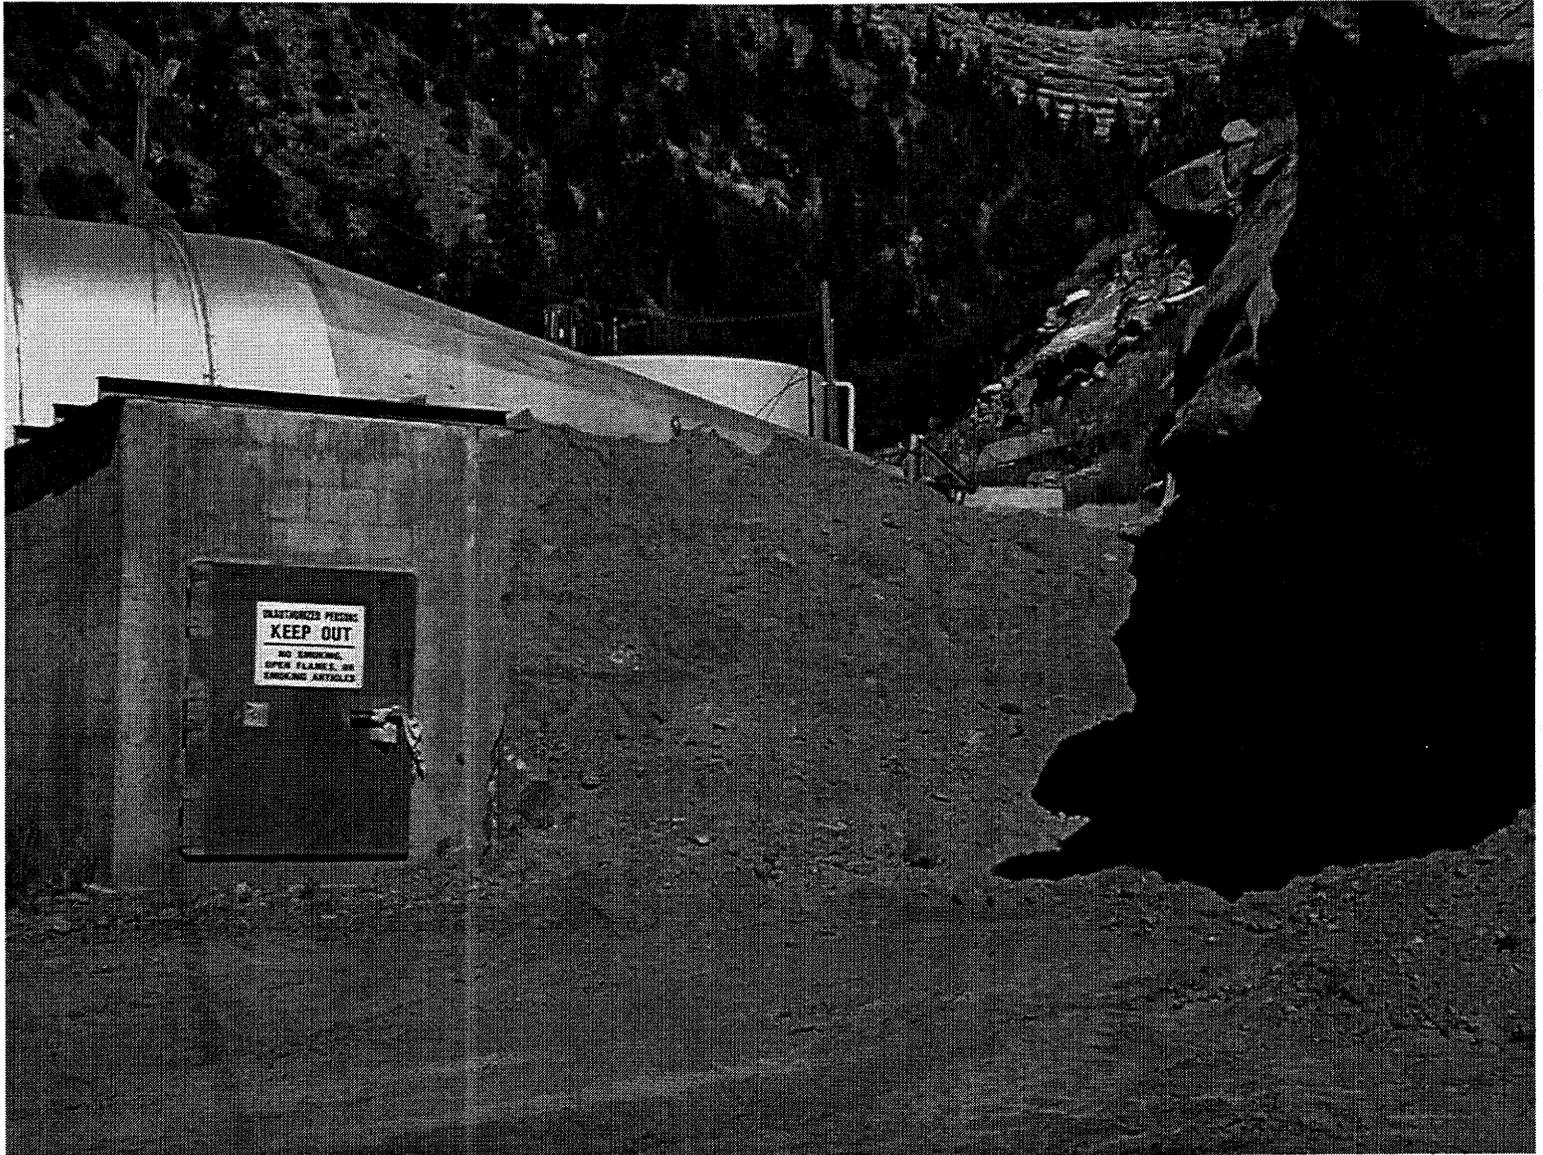
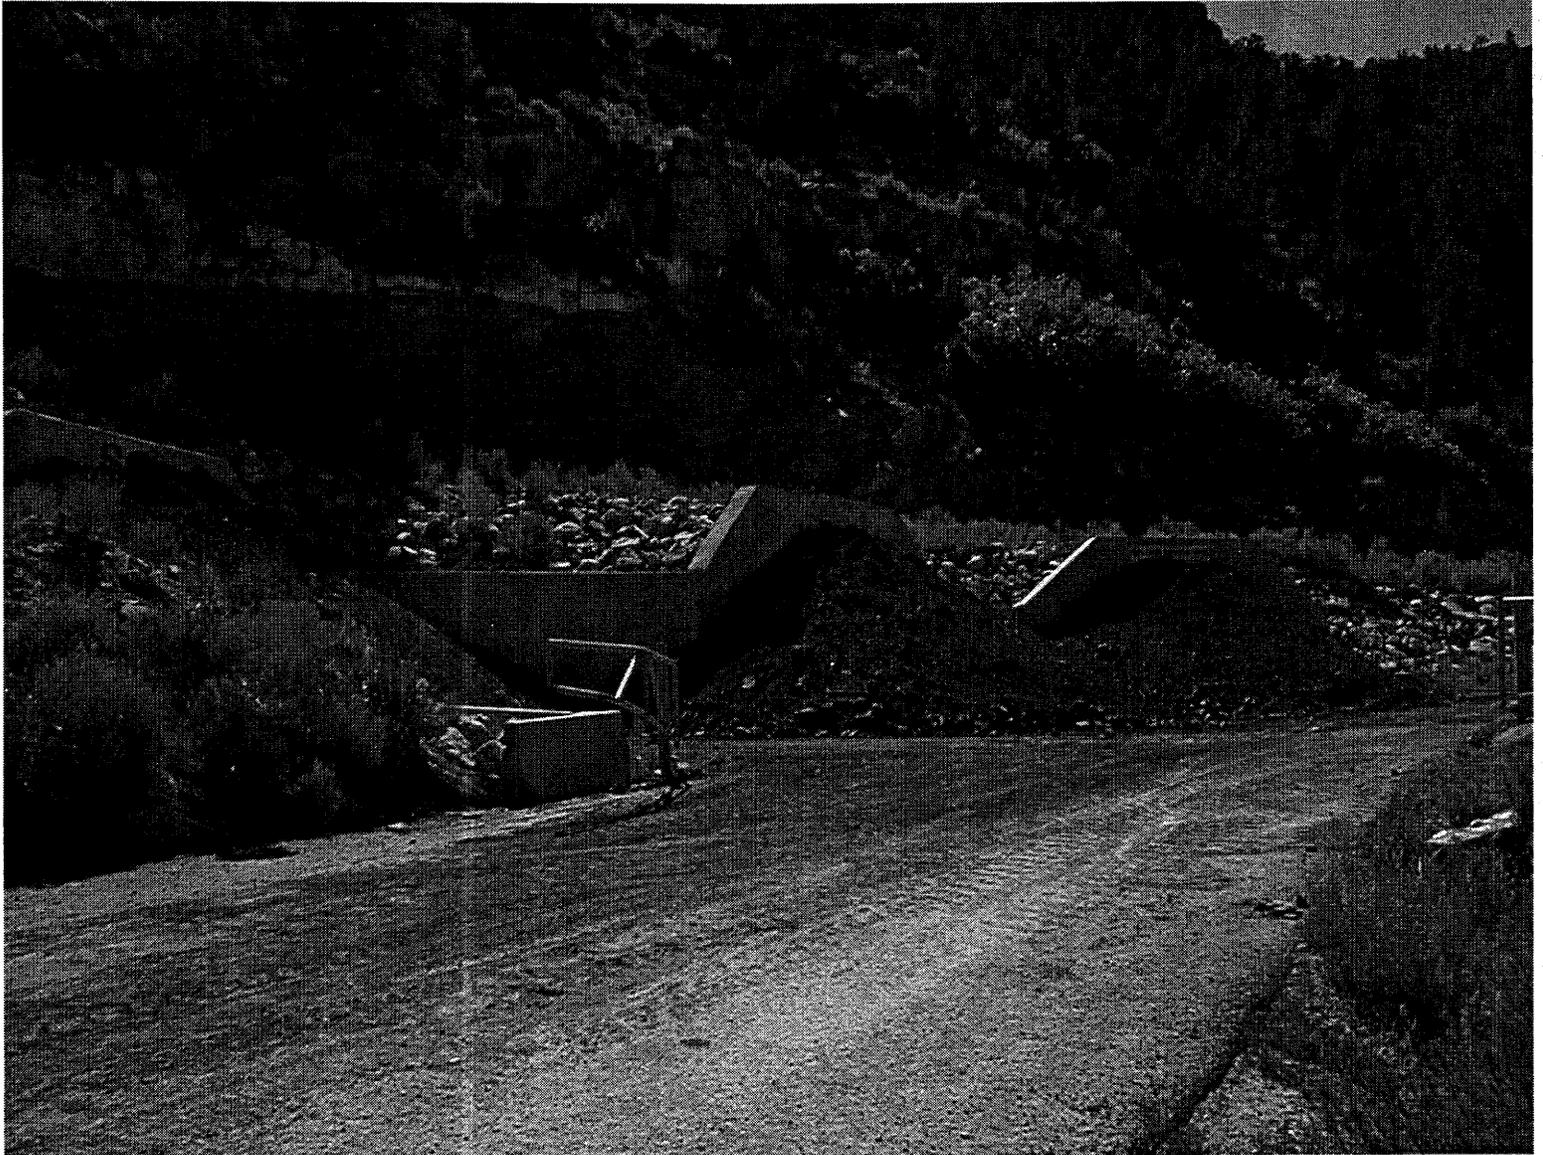
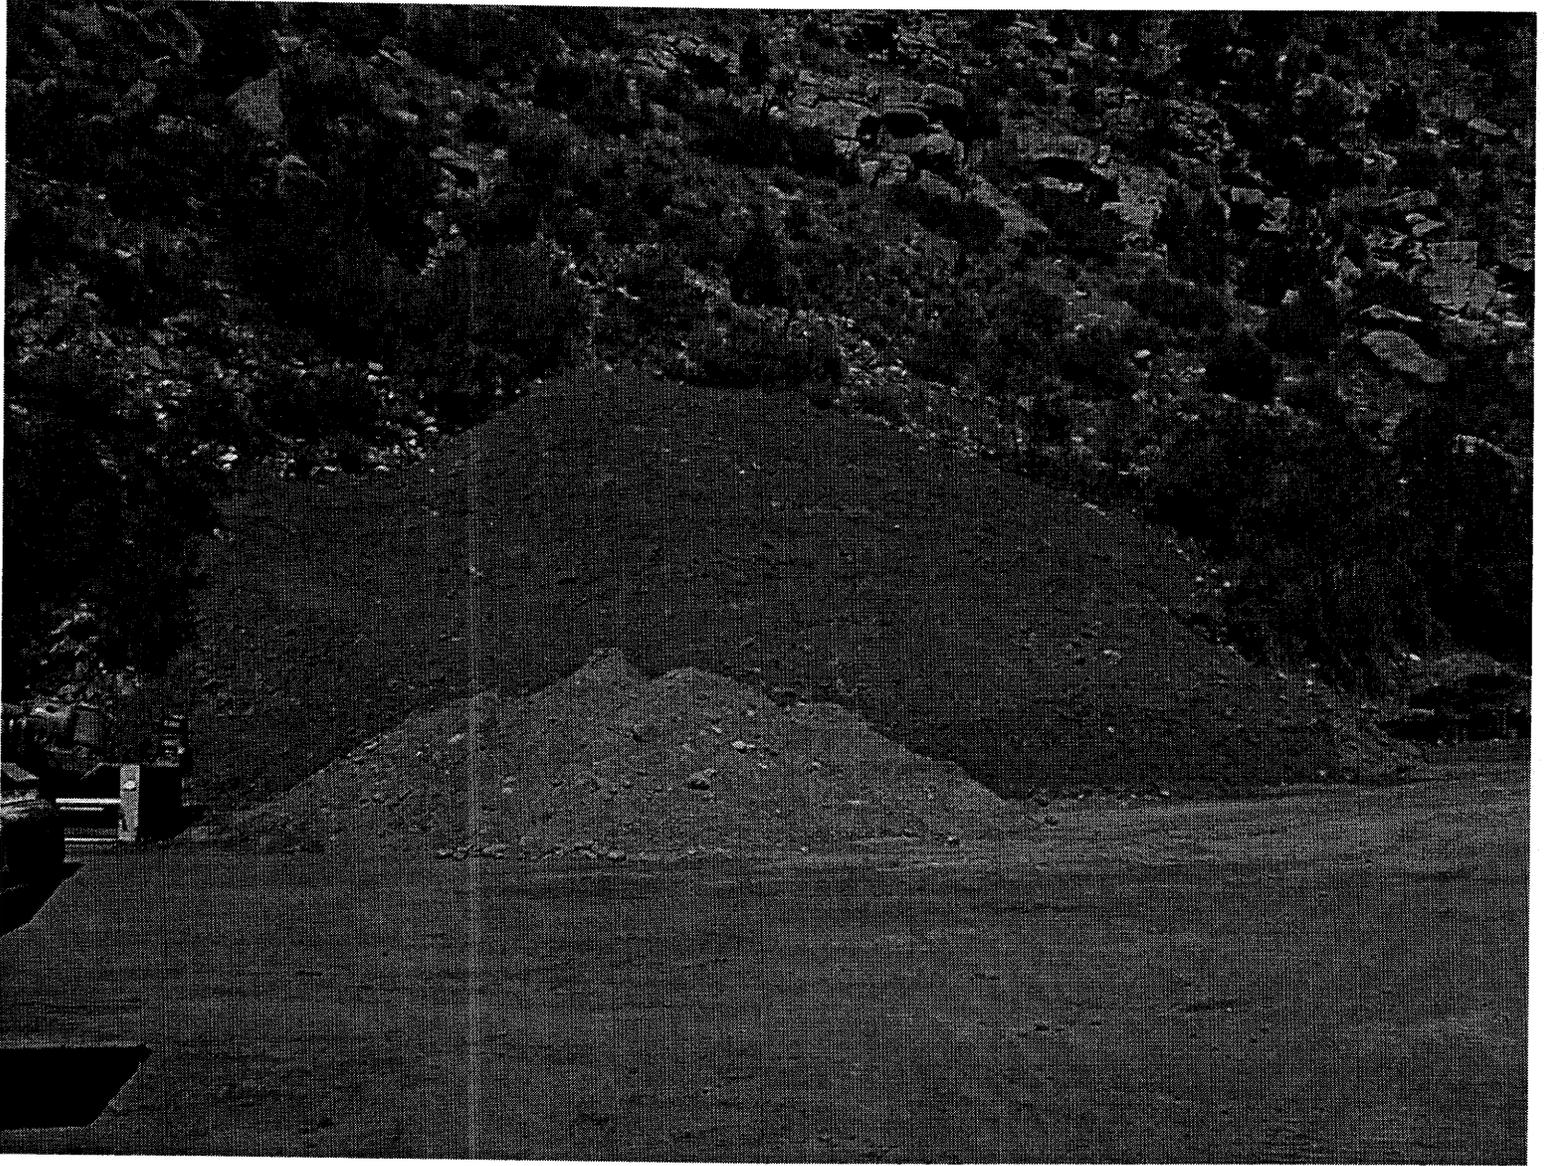
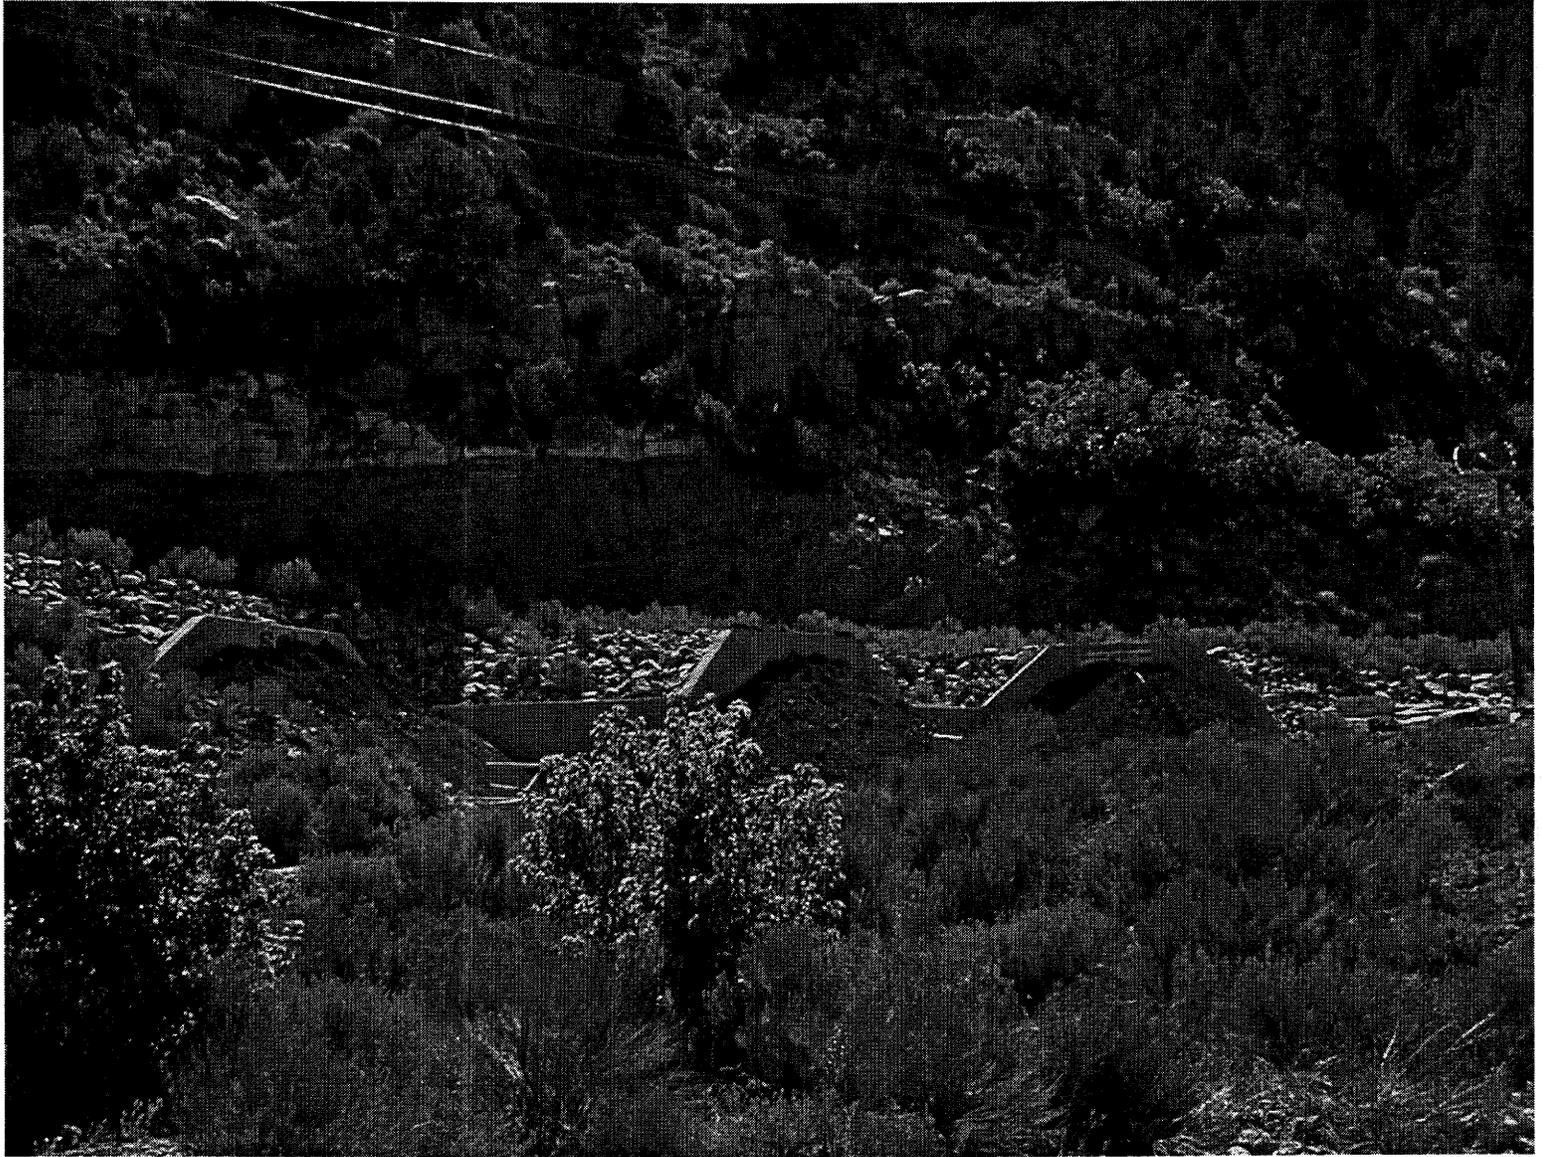
PHOTOGRAPHS TAKEN DURING
RESEALING OF THE PORTALS
FOLLOWING THE 72 HOUR
MONITORING PERIOD

MSHA's Gene Ray arrived at the site shortly after Bridge's initial assessment of damage and issued a K-Order. Plans were immediately written up and submitted to Gene Ray. The plan reflected resealing all damaged portals with earthen material. At the time the plan was assimilated, Portals A,C, and especially E were intaking, and the shaft was exhausting. The plan reflected sealing the intaking portals first and then dumping earthen material down the shaft until the dirt was above the top of the shaft bottom. Prior to commencement of sealing activities, the shaft was liberating over 500 ppm CO and approximately 40% methane. The plan reflected monitoring each of the portals as dirt was pushed inside of them. Gene Ray accepted the plan and at that time Commissioner Bill Krompel was contacted related to using the crusher reject located at the county's gravel pit located on the Dugout Canyon road. Krompel agreed to allow the reject to be used for the emergency resealing project. Shortly after, Gene Ray left and MSHA's Jerry Lemmon arrived to assist in monitoring activities as the resealing commenced.
